PHASE 1 SITE INVESTIGATION

1 Adrian Street, Dover

Emervest Ltd

Project No. 002NIDOP1

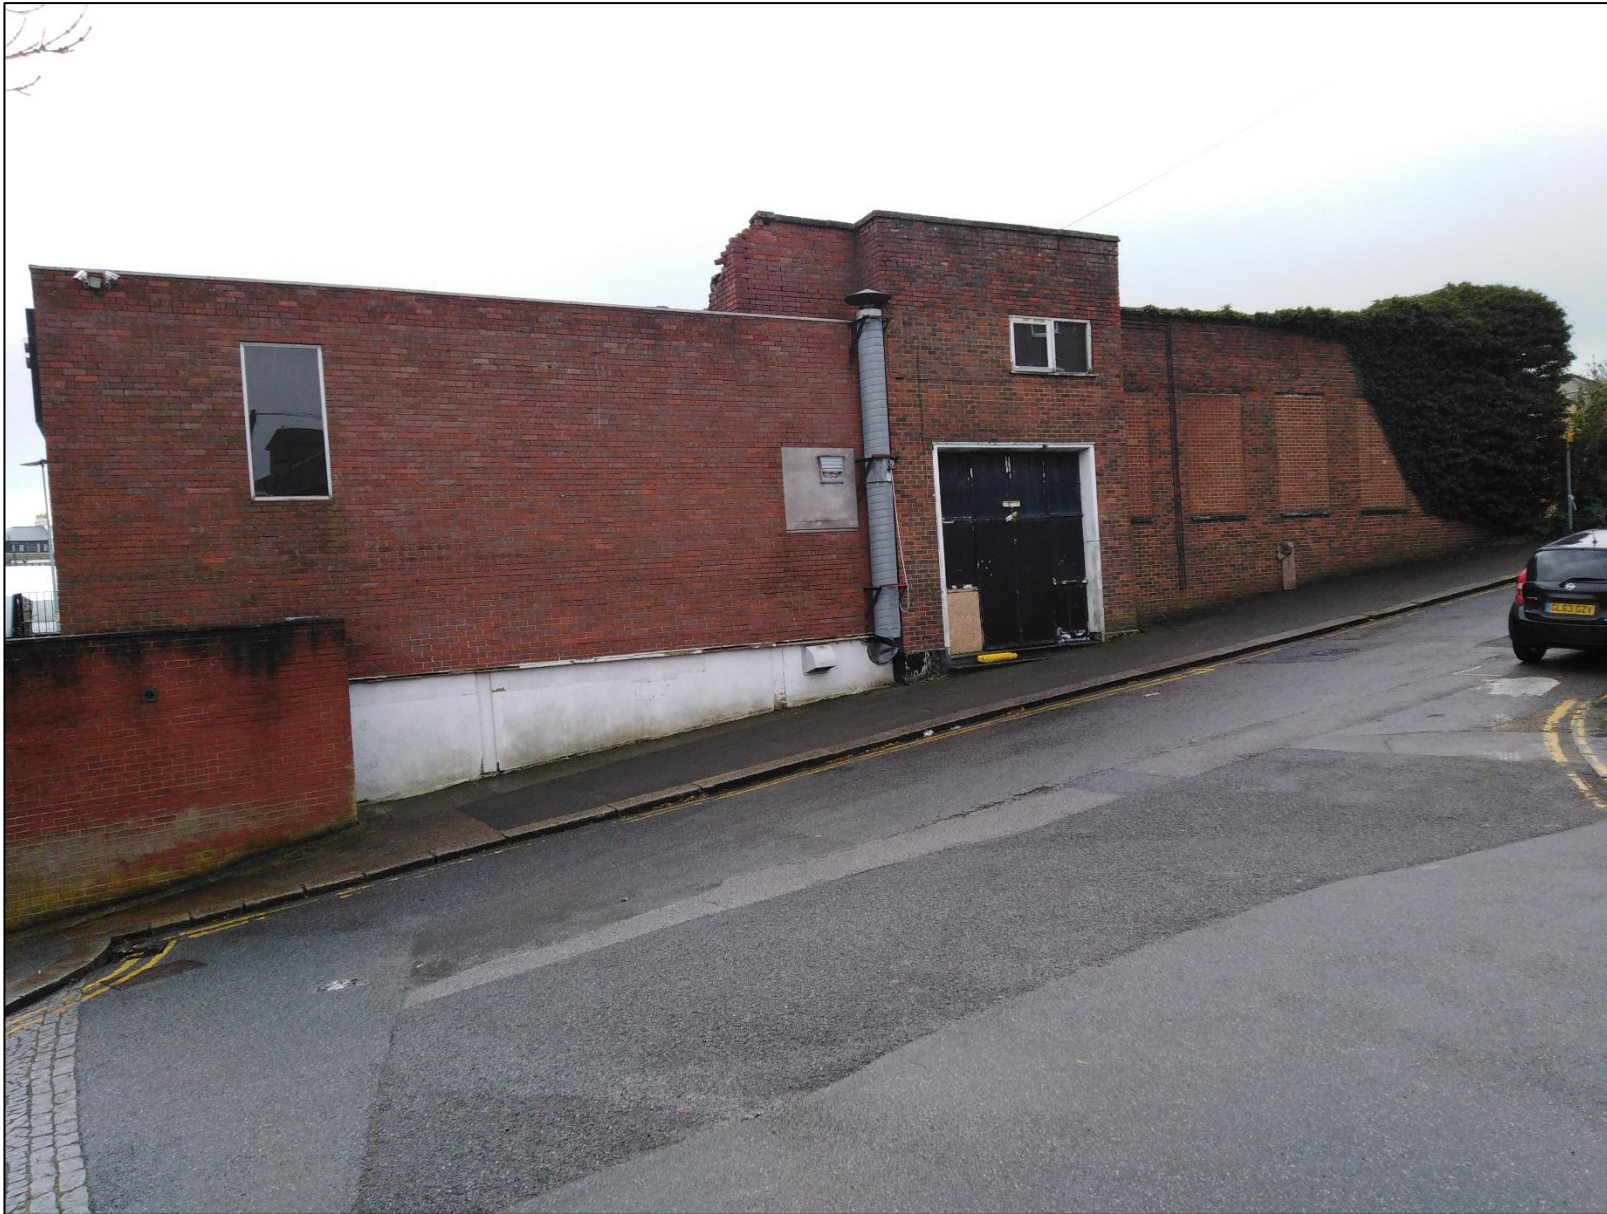
Figure 1. The building on the western part of the site

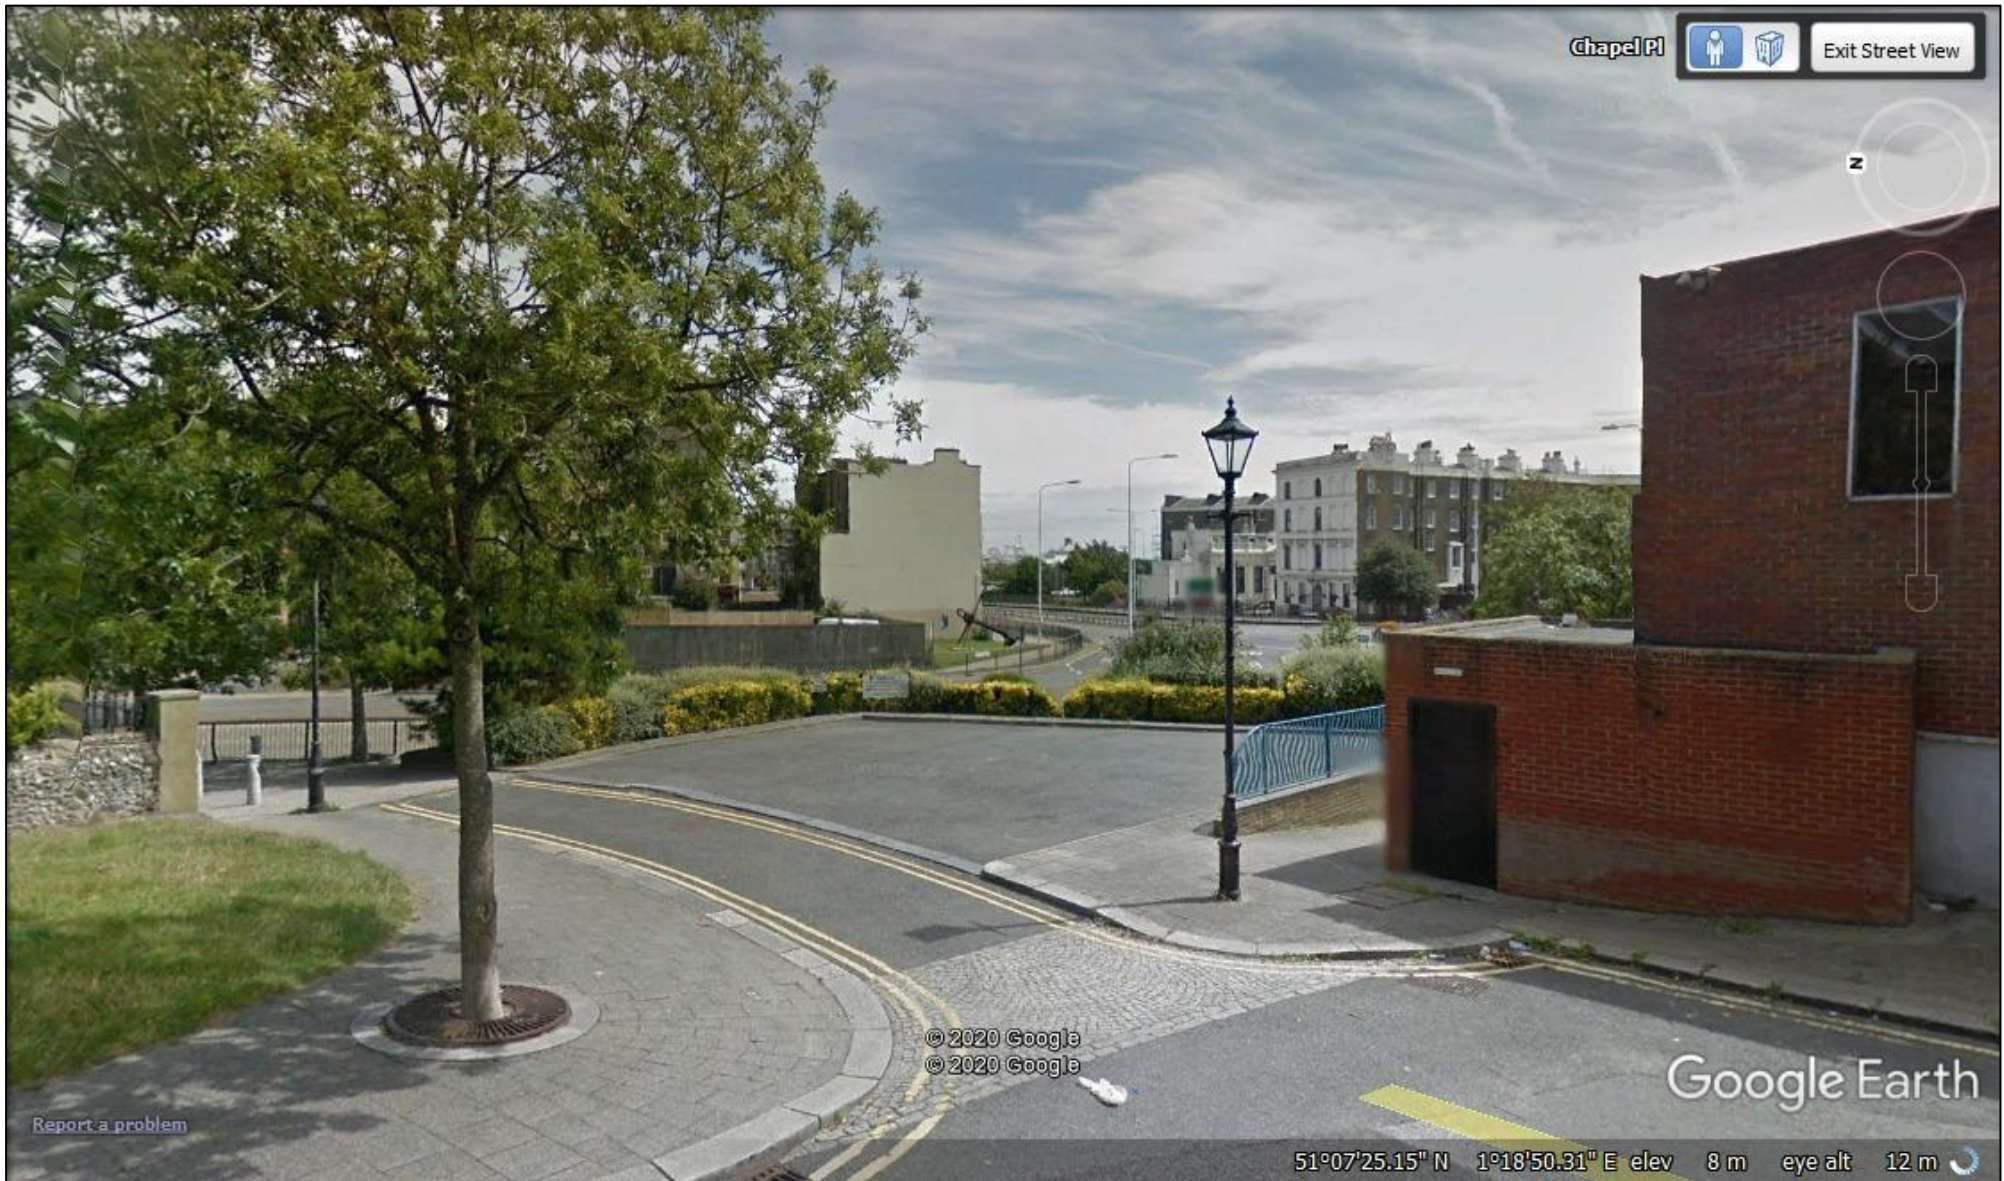
Figure 2. The eastern part of the site showing the car park.

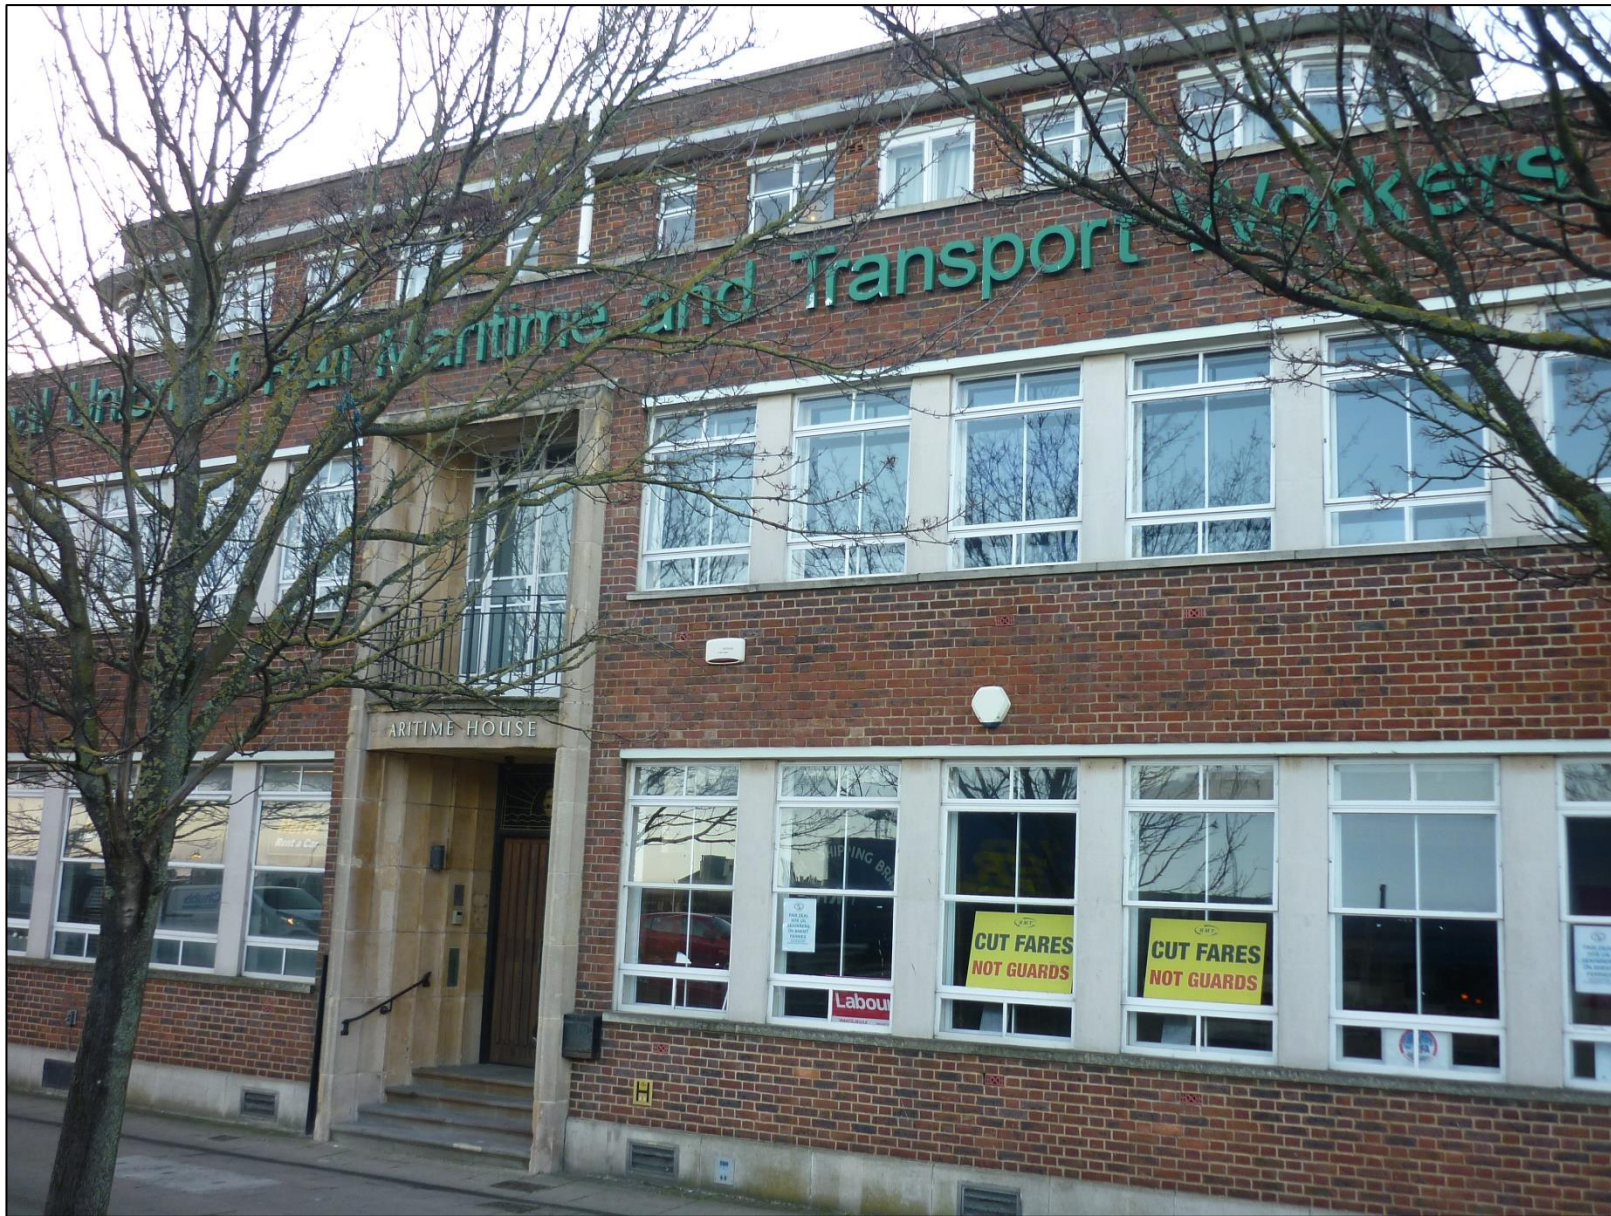
Figure 3. The offices to the south.

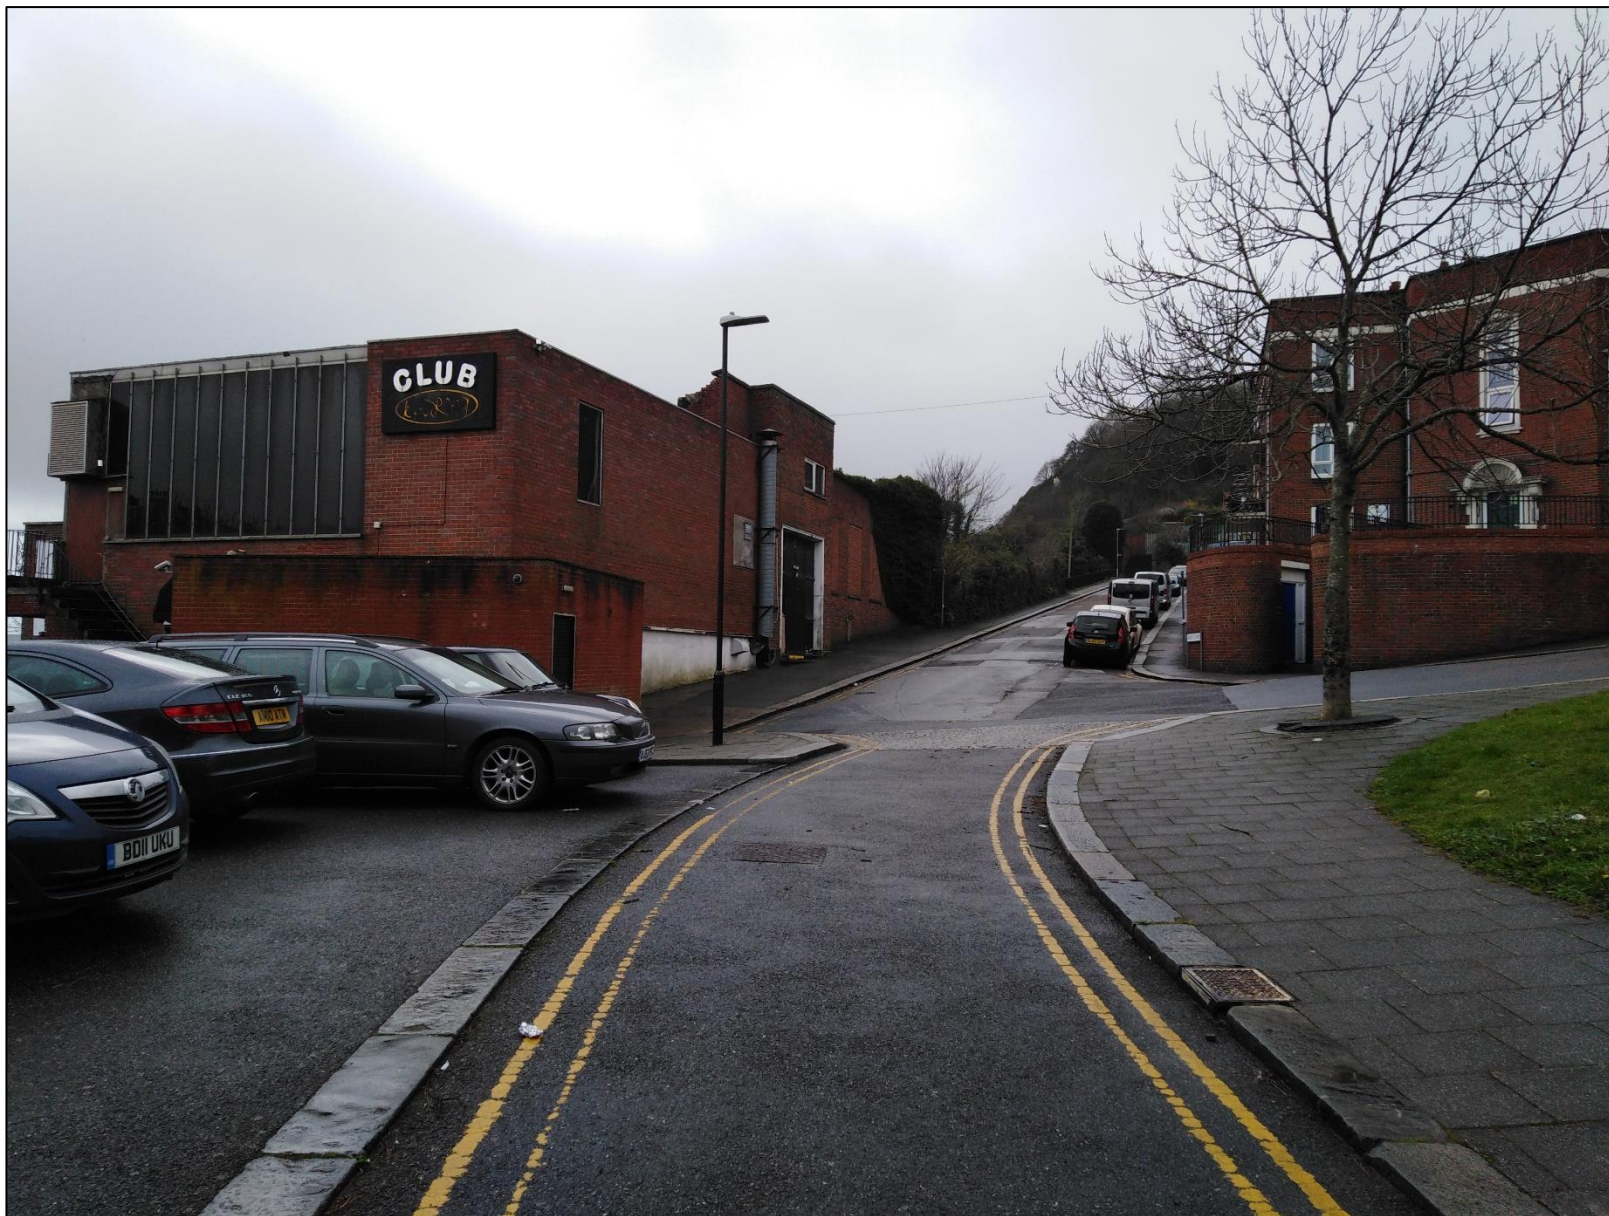
Figure 4. The site from the north east.
