## **Arboricultural Report**

**BS5837 Tree Survey**

**School Lane  
Bapchild  
Sittingbourne  
Kent  
ME9 9NJ**

**1<sup>st</sup> April 2015**

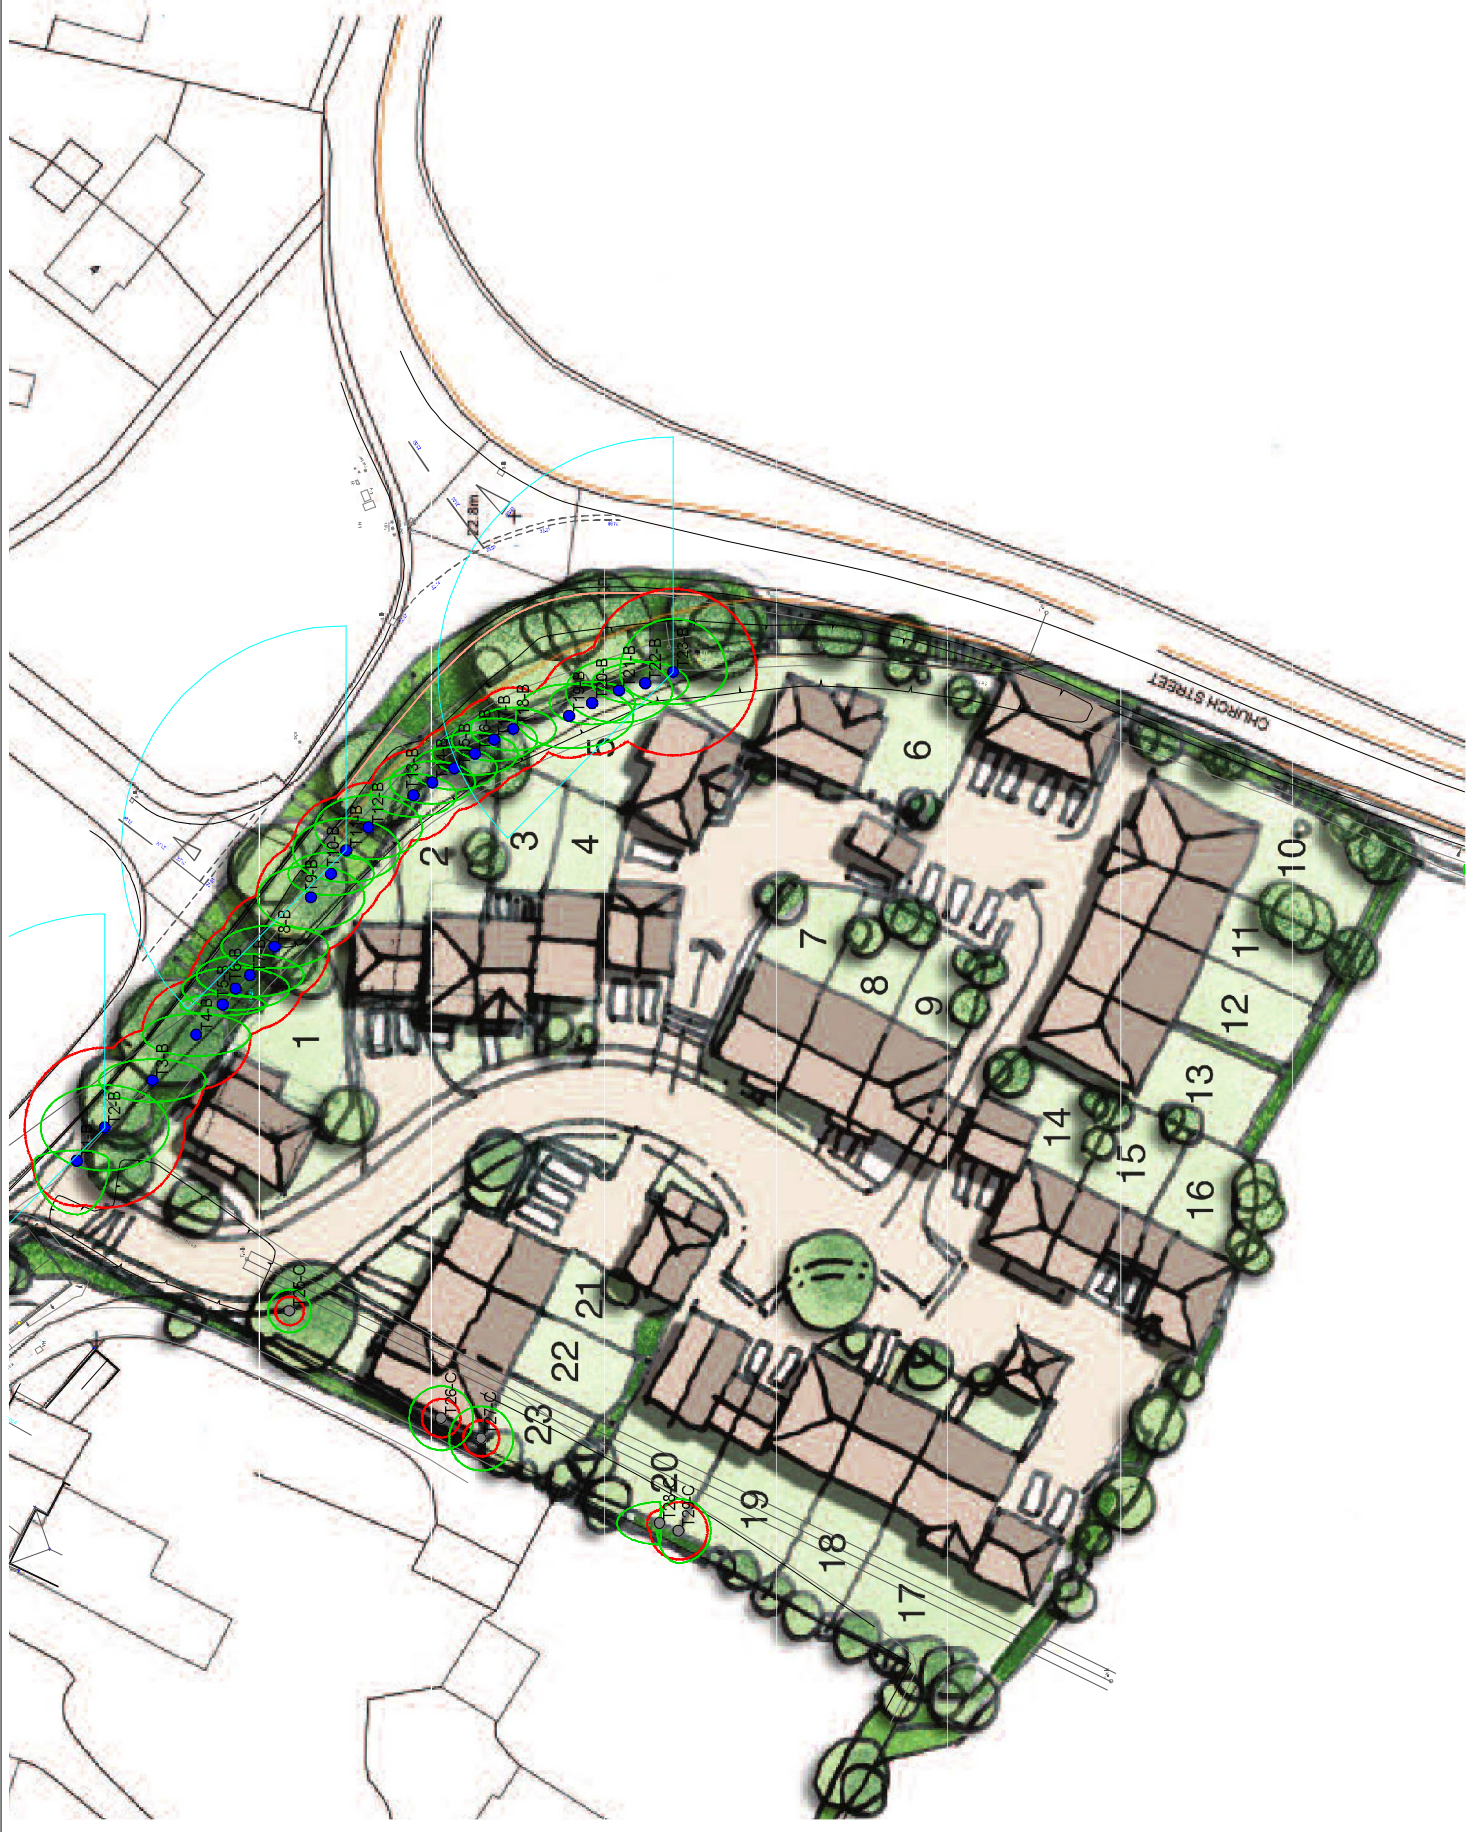
**TREE SURVEY & CONSTRAINTS PLAN**

I would recommend the removal of the Goat Willows (T25 – T29) to allow for the access road to the development site, and as **Category C** trees should not therefore be considered as a constraint to the development.

I would recommend the removal of the **B Category** Poplars (T1 & T2) to reduce the risk of future impact to the driveway by poplar roots. At some point in the future the row of poplar trees will require tree work operations as part of sound arboricultural practice due to the nature of this species.

- The proposed development will involve an incursion to the root protection area of the poplars (T23 & T24). Any works within the Root Protection Areas can be mitigated by the incorporation of non-invasive solutions (as detailed in an arboricultural method statement). It is my professional opinion that this will not result in the significant loss of rooting area and will not result in any significant root damage. This is based upon:
