Rose Hill, Ash

Structural Report

Ref: 22181/KH
By: K Hirst
Date: 28 November 2022
Version: 1.1

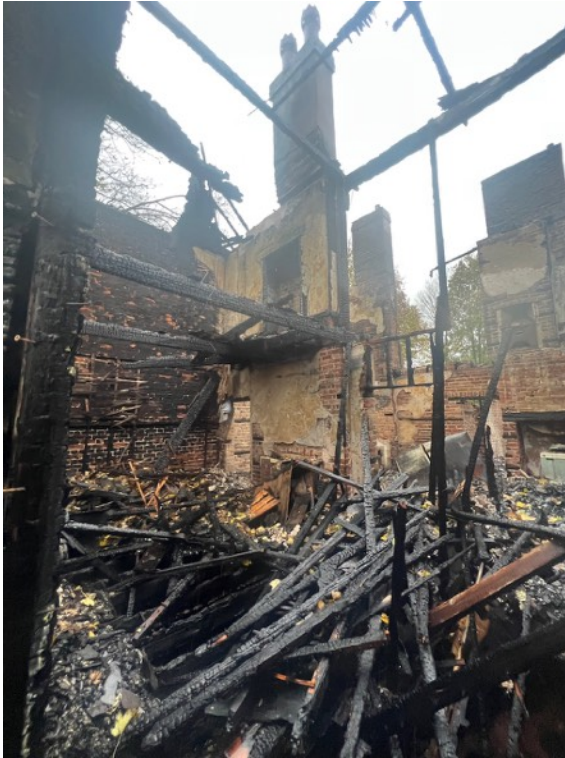
The partially suspended ground floor, first floor, and roof structure have been lost.

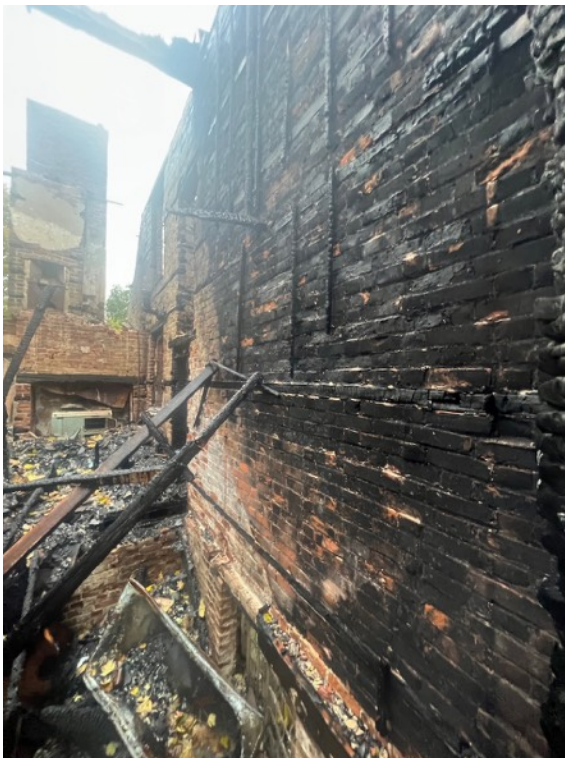
- 3.4. With the embedded timber elements (lintels, wall plates, etc.) being lost, the walls have been effectively reduced in thickness by half in places, creating 'hinge points' in the wall at these locations.

The floor plates and timber lintels built into the external walls have been damaged or lost.

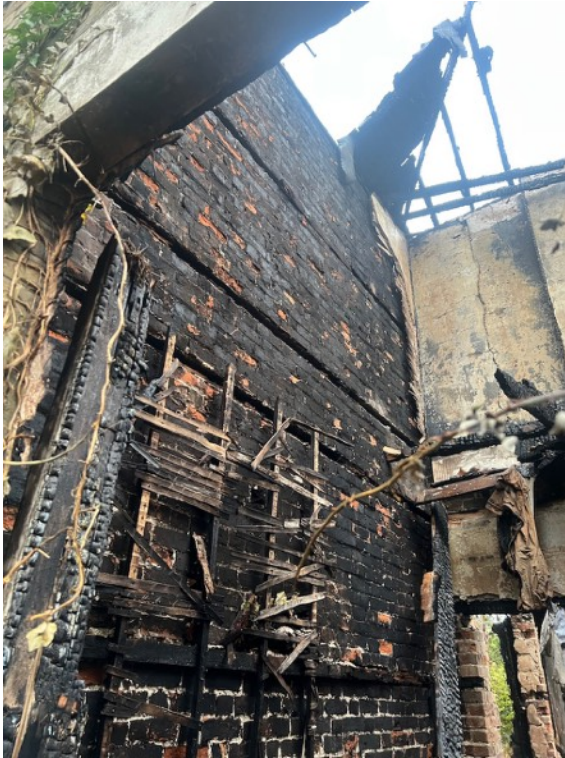
The horizontal timber wall plates built into the solid external masonry walls have been lost in the majority of areas, resulting in pockets or voids in these walls.

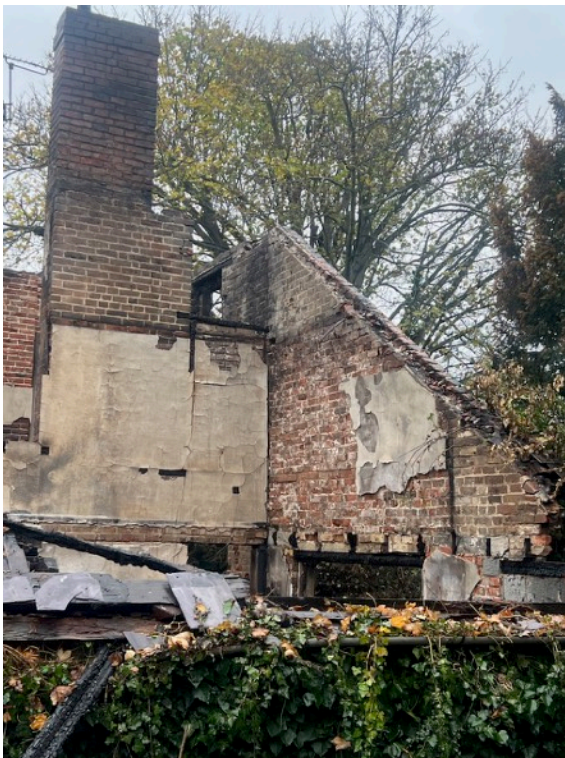
- 3.5. The internal wall arrangement contributed to stiffening the envelope of the structure. These too have been lost.
- 3.6. As a result of the above issues, it is our opinion that the remaining masonry wall elements are unstable and present a real risk of collapse.

Only the perimeter masonry walls and the central brickwork chimney structure remain. All of the internal walls have been lost.

- 3.7. The focus at this point should be solely on eliminating the risks associated with the remaining structure as expediently as possible.
- 3.8. The remaining walls should either be safely demolished or restrained with a temporary framework. The immediacy of carrying out these works cannot be over emphasised. It is a matter of when, not if, the walls will collapse.

- 3.9. It is our opinion that the safest of these options to carry out would be to demolish the remaining walls in a carefully considered manner:
 - 3.9.1. Clearing the debris within the perimeter walls and installing a temporary framework of steel to restrain the existing facade will potentially be a difficult, if not dangerous, operation in itself;
