JF/L469-003

10th October 2024

**RE: THE AGRICULTURAL STORAGE BARN, FORMER NURSERY SITE,
STAPLEHURST ROAD, MARDEN, TONBRIDGE TN12 9BS - STRUCTURAL
REPORT FOLLOWING INSPECTION OF BUILDING**

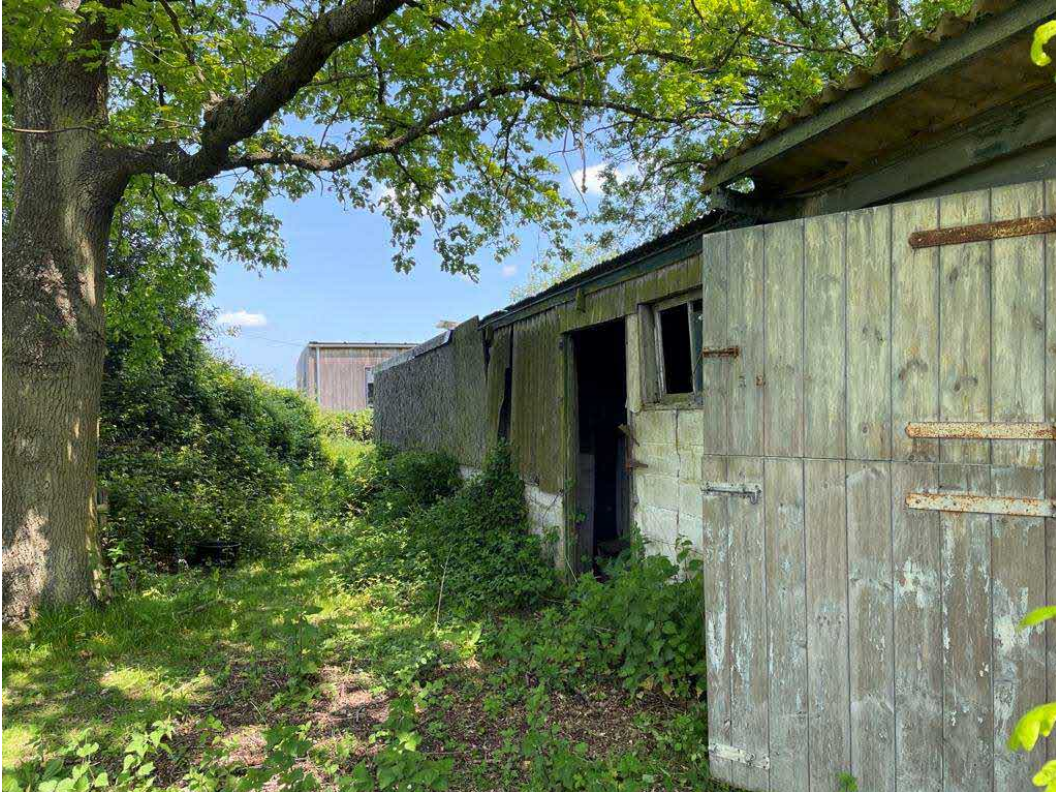
View across front of the Agricultural Storage Barn looking to north with neighbouring residential property visible beyond

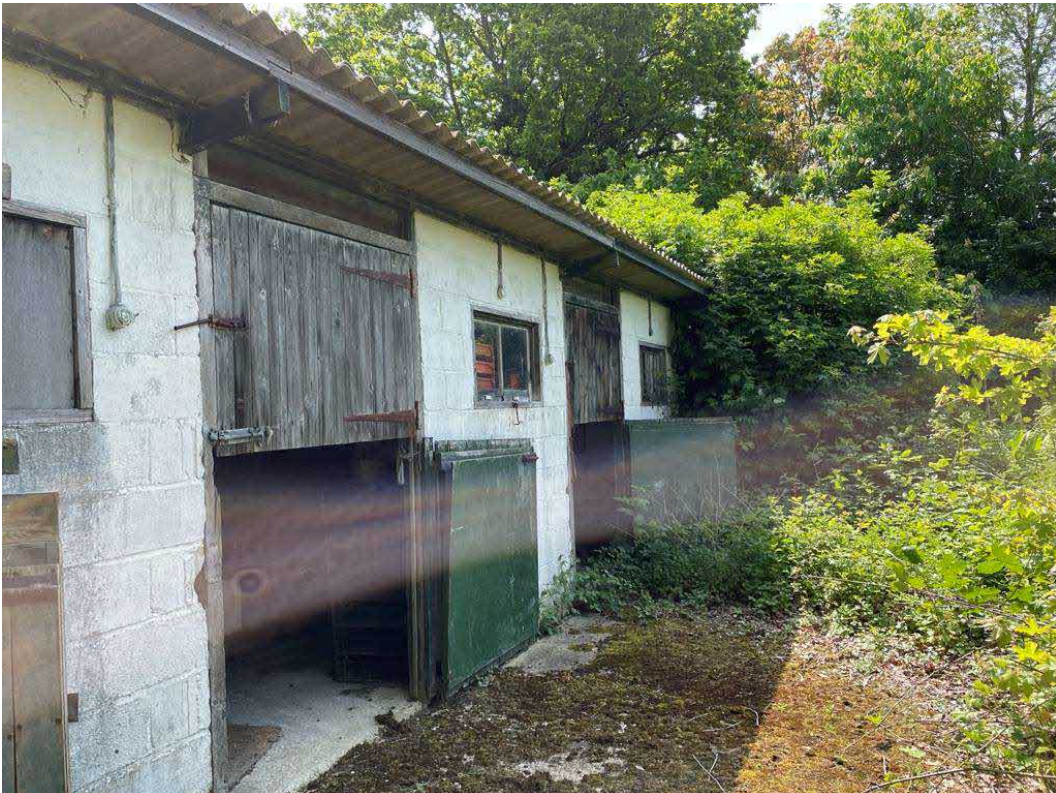
View across front of barn looking to south

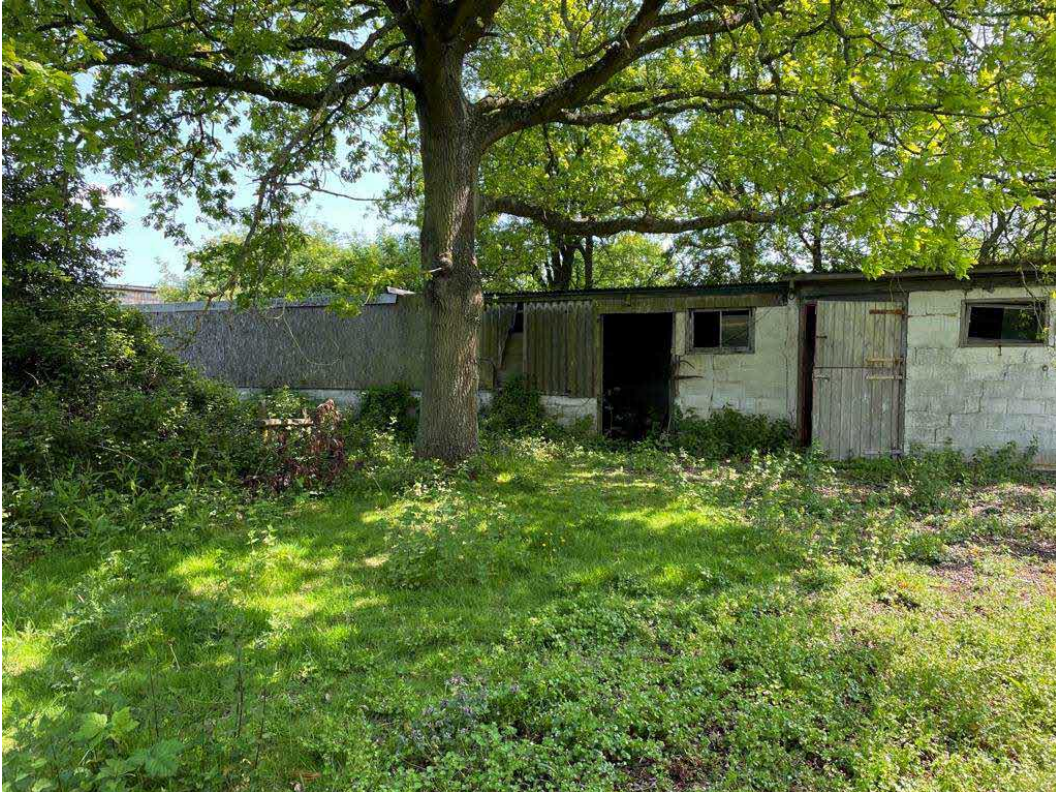
- 7) There is a substantial mature oak tree approx. 4-4.5m from the centre front of the stables of some 18 to 20m height. Access to the southern elevation was not possible externally due to the presence of hedging and dense undergrowth. Access to the rear or east side was gained via the north end of the building where the undergrowth is less dense with hedgerow oak tree close to the rear elevation.

View from west looking toward barn showing mature oak tree in foreground

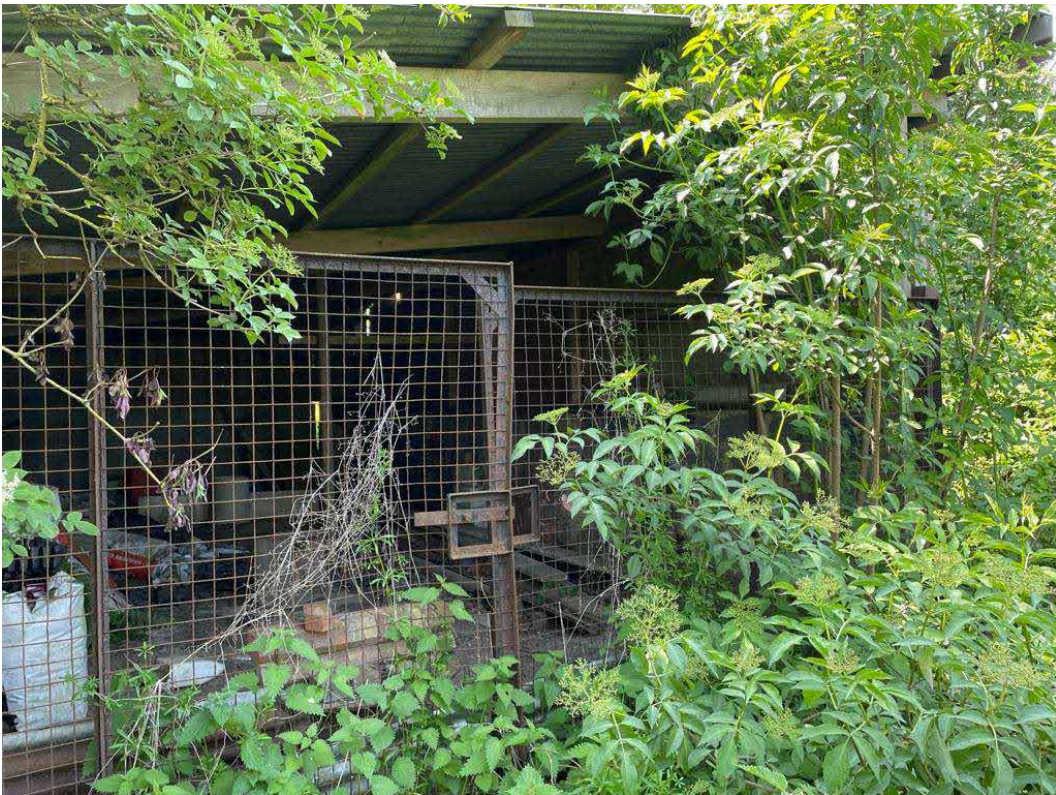
View on north end of building showing open side, roof structure and undergrowth

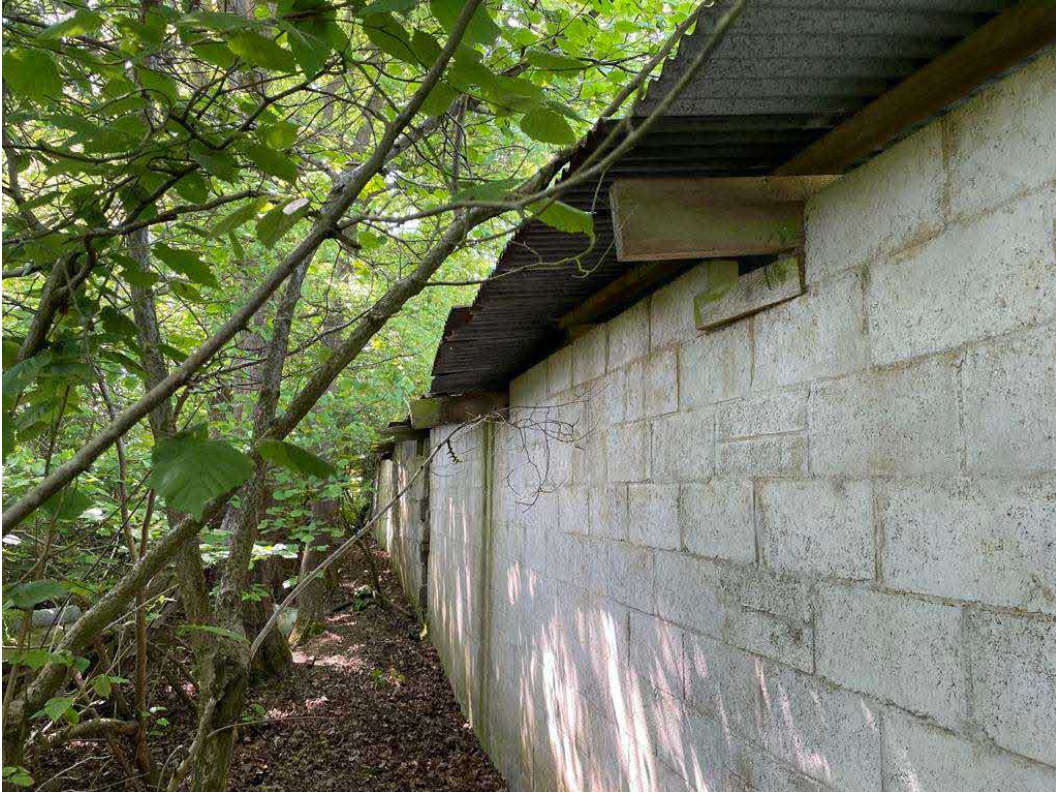
View along rear elevation of building looking south

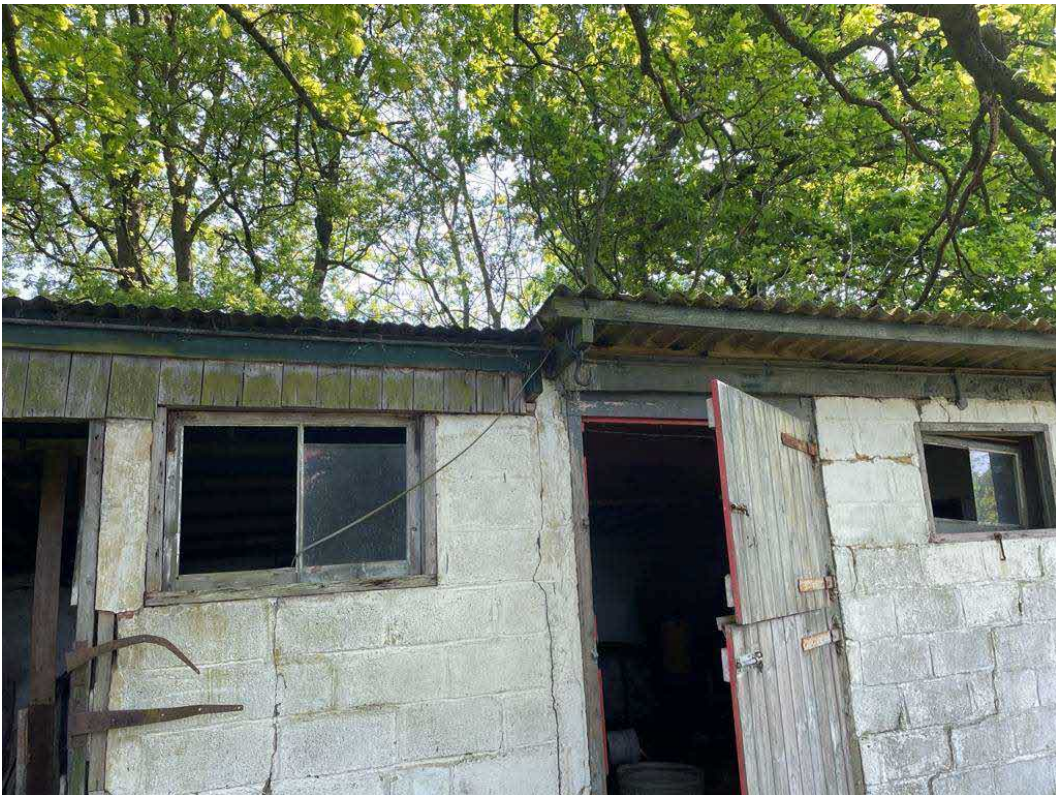
View on connection between northern and southern ends of the barn with step in roof height shown

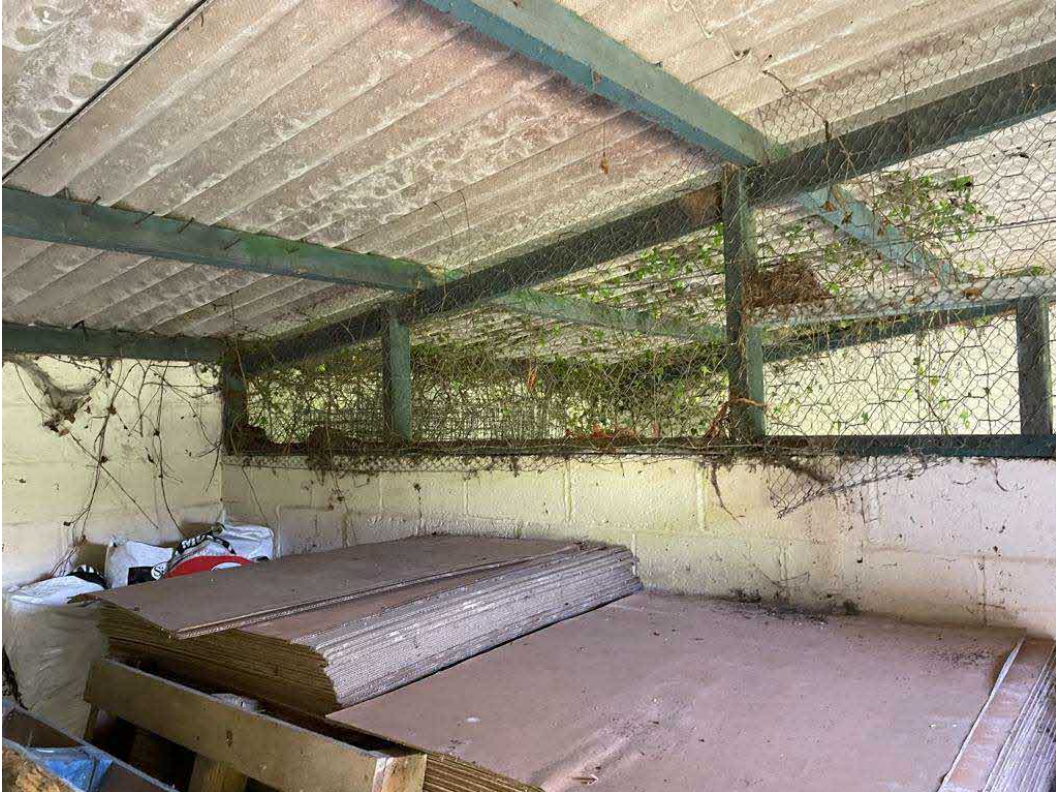
View of interior of stables showing timber purlin roof over stored materials
