JF/L469-001

29th February 2024

**RE: NURSERY BARN, FORMER NURSERY SITE, STAPLEHURST ROAD,
MARDEN, TONBRIDGE TN12 9BS - STRUCTURAL REPORT FOLLOWING
INSPECTION OF BUILDING**

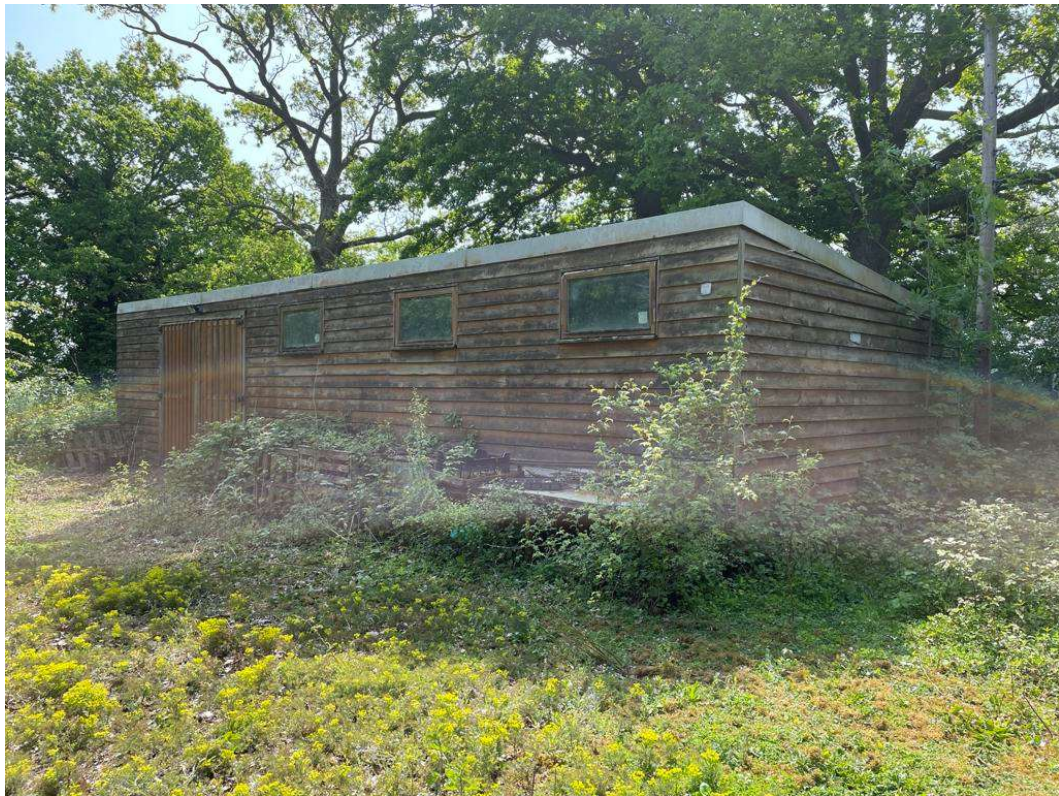
View on front of Nursery Barn from north

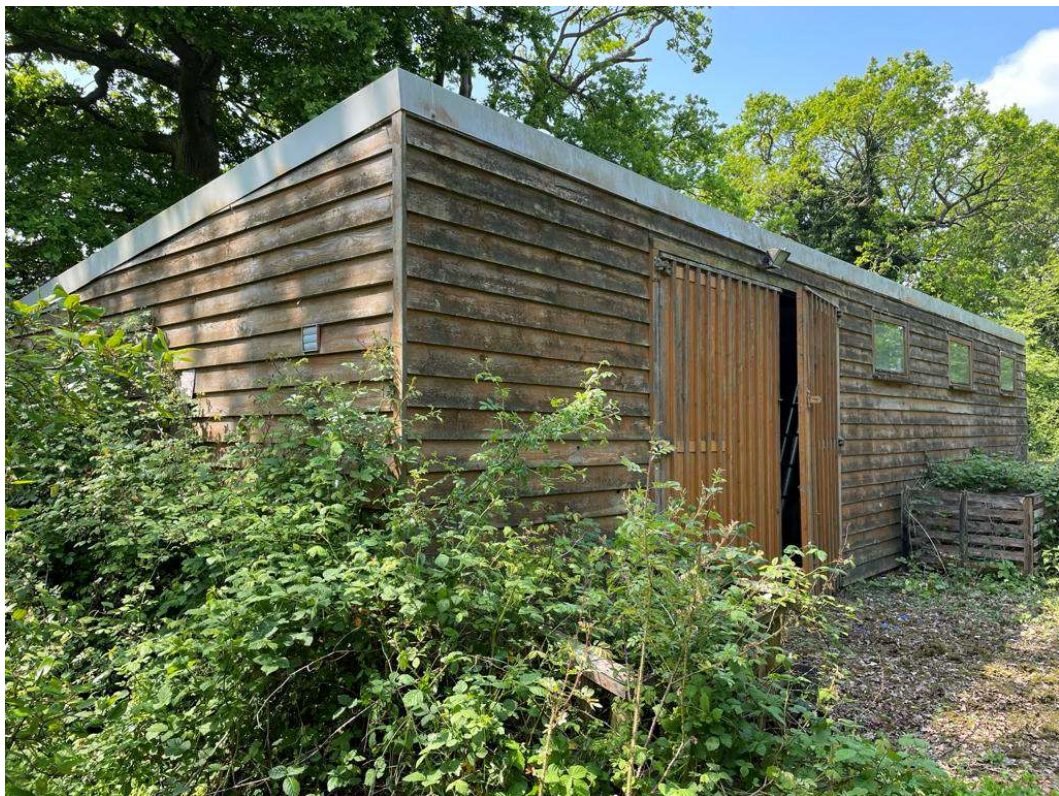
View on front of barn from east

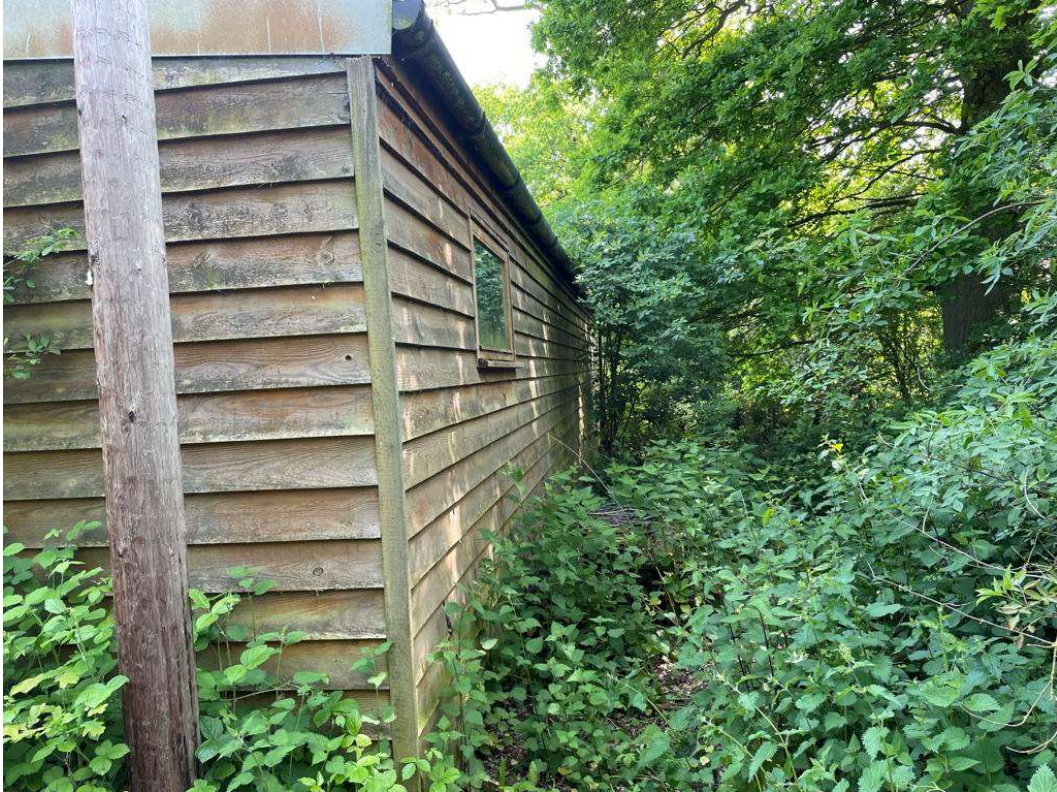
View along rear elevation of barn showing trees and foliage

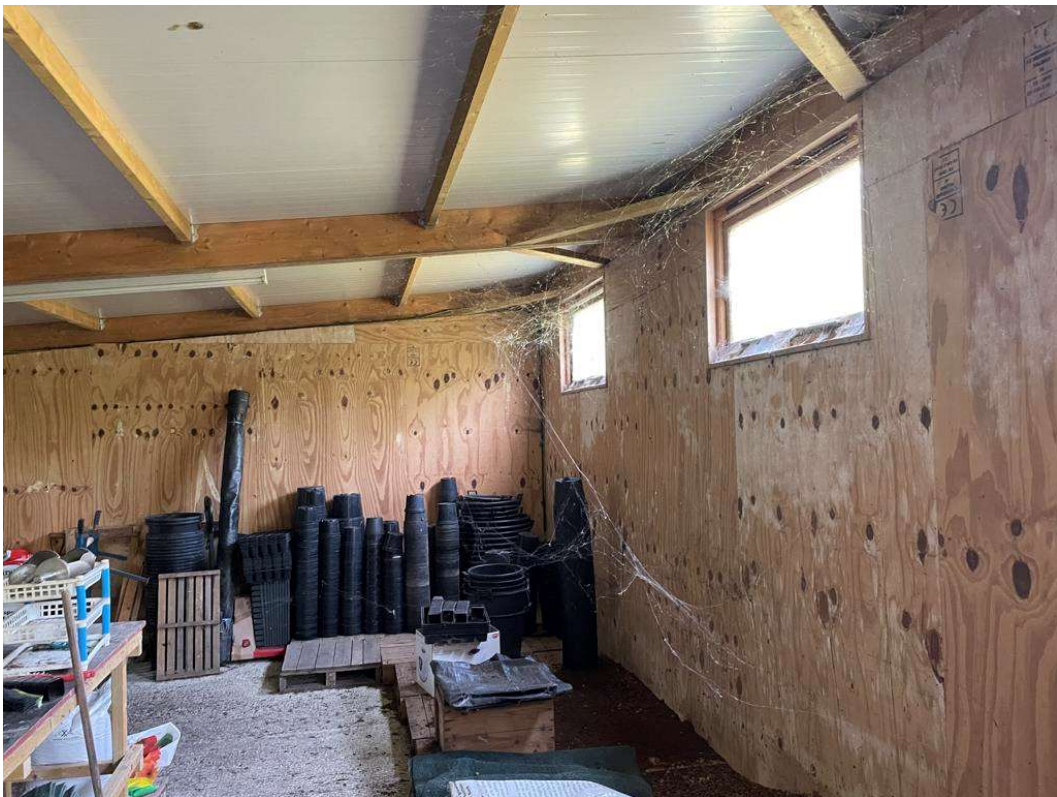
View inside of barn looking to west showing wall lining and roof construction

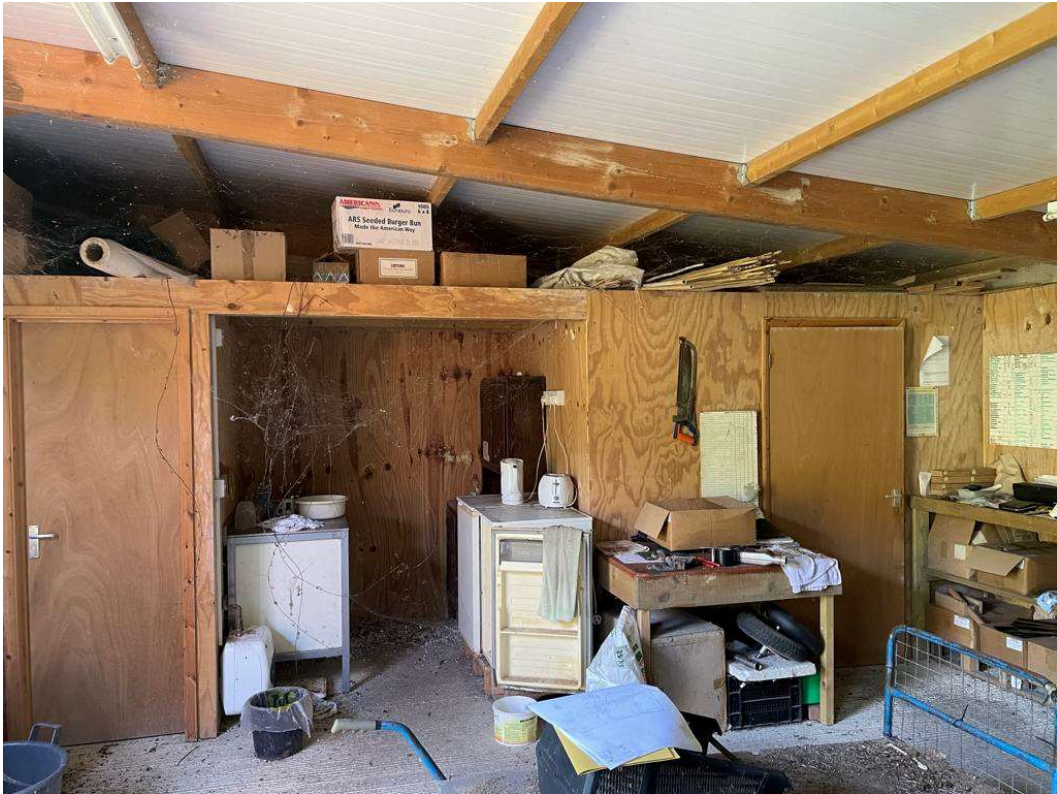
View inside of barn to east
