Arboricultural Impact Assessment Report

June 2024

Land south of Ashford Road

Report No: CSA/4509/14

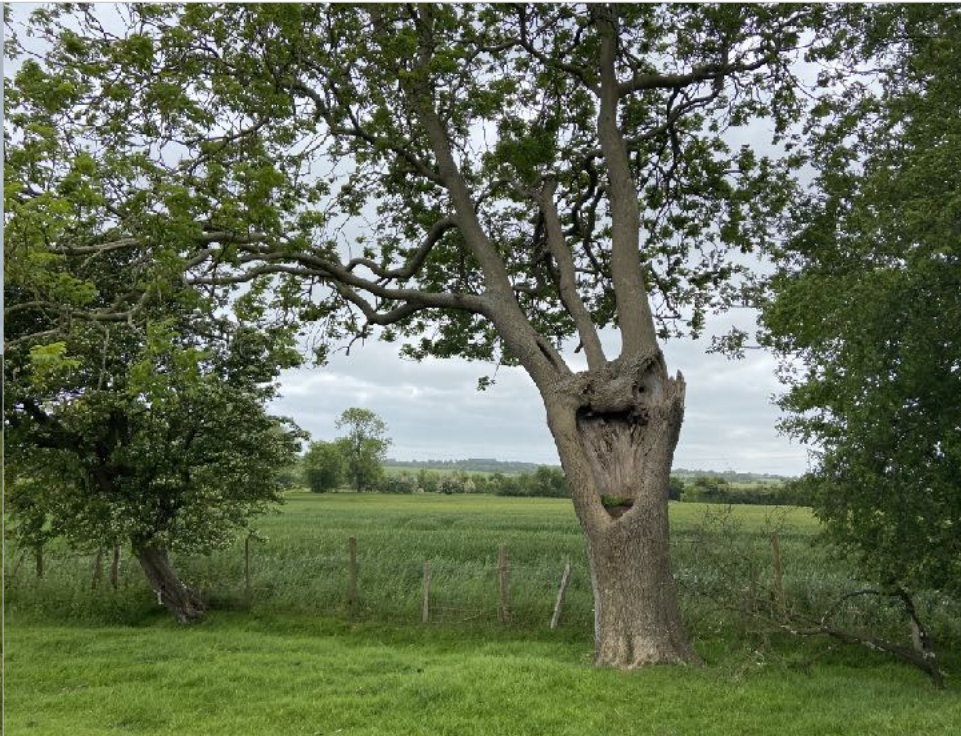
- 5.8. Four of the Site's common ash trees, T59 (B3), T60 (B3), T63 (C1) and T71 (C1), are lapsed pollard trees with decayed and hollowed stems, open cavities, exposed surface roots, dry crevices and other characteristic features found on veteran trees. However, none of the trees have been assessed as ancient/veteran by virtue of their small stem girths (as per Fig. 1.3 in Lonsdale, 2013). Three of the trees, T59, T60 and T71, are 'locally notable' because of their stem size. The structural condition and the presence of some dieback in T59, T60 and T63 suggest a reduced SULE, meaning that they achieve only a B3 quality category. Ash T71 has advanced/extensive crown dieback and a much-reduced SULE, meaning it only achieves quality category C1.

PHOTO 8: Detail of lapsed pollard common ash T59, looking southeast.

| Ref | Species | On / off site | Height (m) | No. of Stems | Est diam? | Calc. / Actual Stem Dia. (mm) | Crown radii (m) N-E-S-W | Avg. Canopy Height (m) | 1st branch ht (m) | 1st branch dir. | Life Stage | Special importance | General Observations | Health & vitality | Struct. cond. | Estimated Remaining Contribution (Years) | BS5837 Category | RPA Radius (m) | RPA m ² | TPO? |
|---|---|---|---|---|---|---|---|---|---|---|---|---|---|---|---|--|---|---|---|---|
| T59 | Common ash | On | 15.0 | 1 | - | 1000 | 7.5-11.5-9.5-4 | 2.5 | 3 | S | M | None | Old 3m pollard with old stem failure wound cavity in pollard head. Strong reaction growth. Stems weighted to south. Dry crevices. Twig dieback. ADB 1 | Good | Fair | 20 | B3 | 12 | 452 | - |

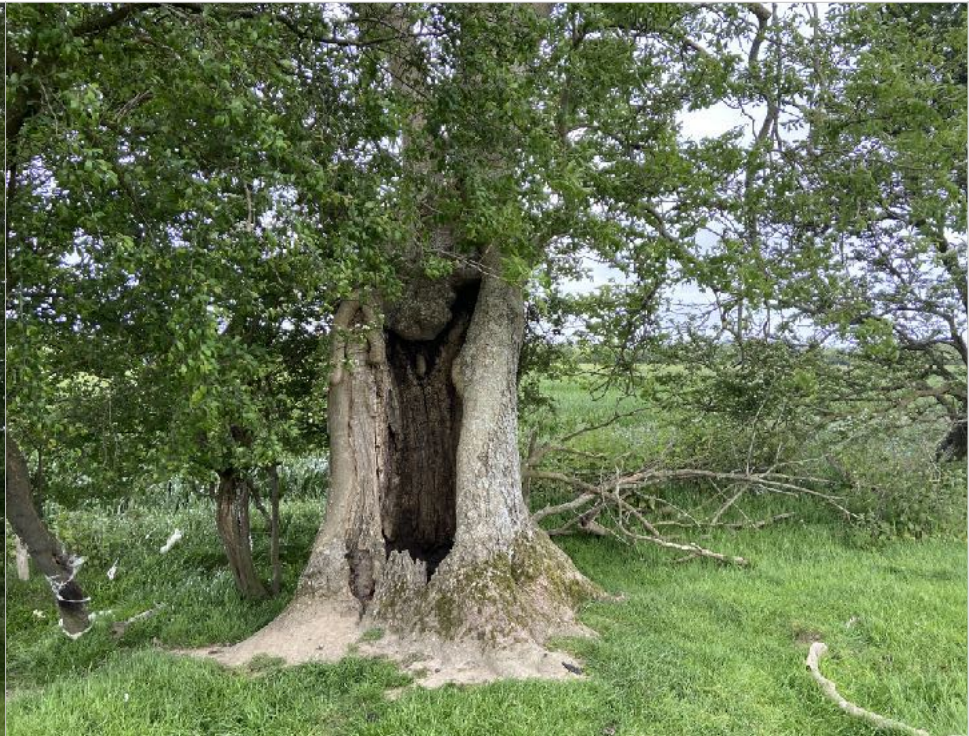
PHOTO 9: Detail of lapsed pollard common ash T60, looking south.

| Ref | Species | On / off site | Height (m) | No. of Stems | Est diam? | Calc. / Actual Stem Dia. (mm) | Crown radii (m) N-E-S-W | Avg. Canopy Height (m) | 1st branch ht (m) | 1st branch dir. | Life Stage | Special importance | General Observations | Health & vitality | Struct. cond. | Estimated Remaining Contribution (Years) | BS5837 Category | RPA Radius (m) | RPA m ² | TPO? |
|---|---|---|---|---|---|---|---|---|---|---|---|---|---|---|---|--|---|---|---|---|
| T60 | Common ash | On | 17.0 | 1 | - | 1170 | 4.5-4.5-9-8.5 | 2.0 | 2.5 | SE | M | None | Old 3m pollard with hollowed bole and open cavity from included bark stem failure. Strong reaction growth. Dry crevices. Woodpecker holes at 5m north. ADB 1 | Good | Fair | 20 | B3 | 14 | 619 | - |

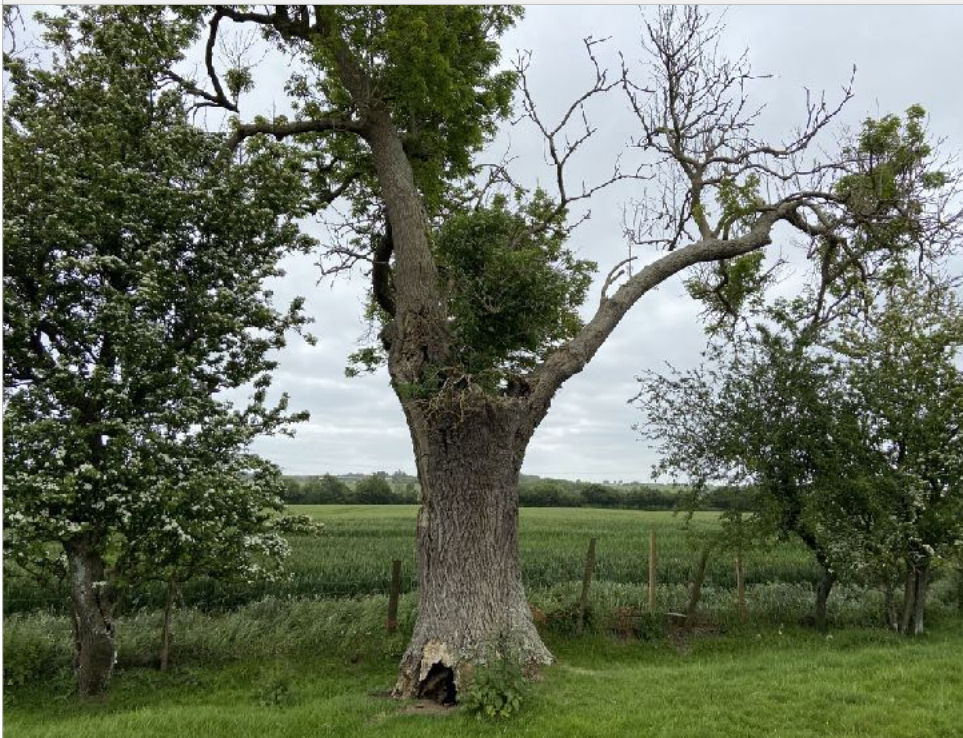
- 5.7. Many of the ash trees within the Site exhibit twig dieback. Examples are T63 and T71. The symptoms are almost certainly a result of the chronic fungal disease Ash Dieback caused by the fungus *Hymenoscyphus fraxineus*. First identified in the UK in 2012, it is estimated that the disease will kill up to 99% of the 90 million ash trees in the UK, and it is the subject of a UK Government strategy. Although Forest Research advise a general presumption against felling living ash trees, whether infected or not (with the exception of felling for public safety), for the purposes of development design it can be reasonably presumed that ash trees at the Site exhibiting twig dieback have a significantly reduced SULE.

PHOTO 10: Detail of lapsed pollard common ash T63, looking southwest.

| Ref | Species | On / off site | Height (m) | No. of Stems | Est diam? | Calc. / Actual Stem Dia. (mm) | Crown radii (m) N-E-S-W | Avg. Canopy Height (m) | 1st branch ht (m) | 1st branch dir. | Life Stage | Special importance | General Observations | Health & vitality | Struct. cond. | Estimated Remaining Contribution (Years) | BS5837 Category | RPA Radius (m) | RPA m ² | TPO? |
|---|---|---|---|---|---|---|---|---|---|---|---|---|---|---|---|---|---|---|---|---|
| T63 | Common ash | On | 13.0 | 1 | - | 1100 | 0.5-6-9-7 | 4.0 | 3 | W | LM | None | Old 3m pollard with hollowed bole to ground and decayed buttresses. Modern stem collapse at pollard head leaving one main stem weighted over field to south and which is cracking away to ground. Poorly attached lower branch to west. Advanced crown dieback with epicormic shoots. | Poor | Poor | 10 | B3 | 13.2 | 547 | - |

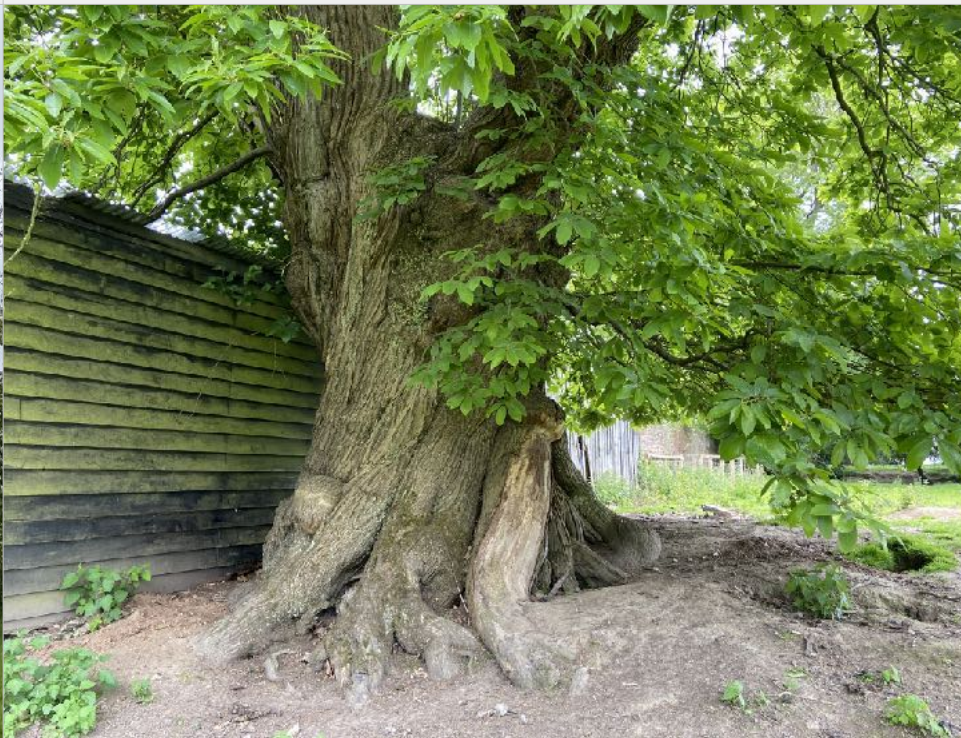
- 5.4. Sweet chestnut T55 is protected and referenced as T10 within TPO 14/2018. The tree has been assessed as an ancient tree by virtue of its 6.3 metre stem girth (as per Fig. 1.3 in Lonsdale, 2013). It has also been assessed as being a veteran tree using the characteristic features found on veteran trees (in para. 2.1.1 in Read, 2000); which in this case include major trunk cavities/progressive hollowing, decay holes, physical damage to the trunk, bark loss/loose bark, crevices in the bark, pollarded form and an 'old look'. It has been assigned Category A3 and therefore of high arboricultural and historical value.

PHOTO 11: Detail of ancient/veteran sweet chestnut T55, looking south.

| Ref | Species | On / off site | Height (m) | No. of Stems | Est diam? | Calc. / Actual Stem Dia. (mm) | Crown radii (m) N-E-S-W | Avg. Canopy Height (m) | 1st branch ht (m) | 1st branch dir. | Life Stage | Special importance | General Observations | Health & vitality | Struct. cond. | Estimated Remaining Contribution (Years) | BS5837 Category | RPA Radius (m) | RPA m ² | TPO? |
|---|---|---|---|---|---|---|---|---|---|---|---|---|---|---|---|--|---|---|---|---|
| T55 | Sweet chestnut | On | 10.0 | 1 | - | 2000 | 7.5-5.5-6-6.5 | 1.0 | 3 | N | M | Ancient & veteran | Basal decay cavities and bark loss on buttresses. Pollarded tree with large natural stem fractures showing hollowed stems. Branch bark loss. 'Old look'. Tree girth qualifies tree as ancient according to Fig.1.3 of Lonsdale (2103). Tree has sufficient veteran characteristics to be assessed as a Veteran tree (in para. 2.1.1 in Read, 2000). | Good | Good | 40 | A3 | 15.0 | 707 | TPO 14/2018 T10 |

- 5.18. Detrimental impacts on the ancient and veteran sweet chestnut tree T55 from development might include but are not limited to, damage to roots and understorey, damage to or compaction of soil around the tree roots, changes to the water table or drainage within the tree's soil and increased pollution (such as from de-icing salt).

- 6.9. The SuDS basin in the north of the Site has been designed so that it is located outside of the ancient tree buffer of sweet chestnut T55. The area within the ancient tree buffer will be retained and enhanced as semi-natural habitat. Additional drainage scheme elements can be designed so that they are outside of the buffer. This means that there would be no loss or deterioration of the tree's irreplaceable habitat. The physical protection of the buffer and soft landscaping treatment within it will be detailed within an Arboricultural Method Statement (AMS) to ensure that direct and indirect impacts are avoided throughout construction.

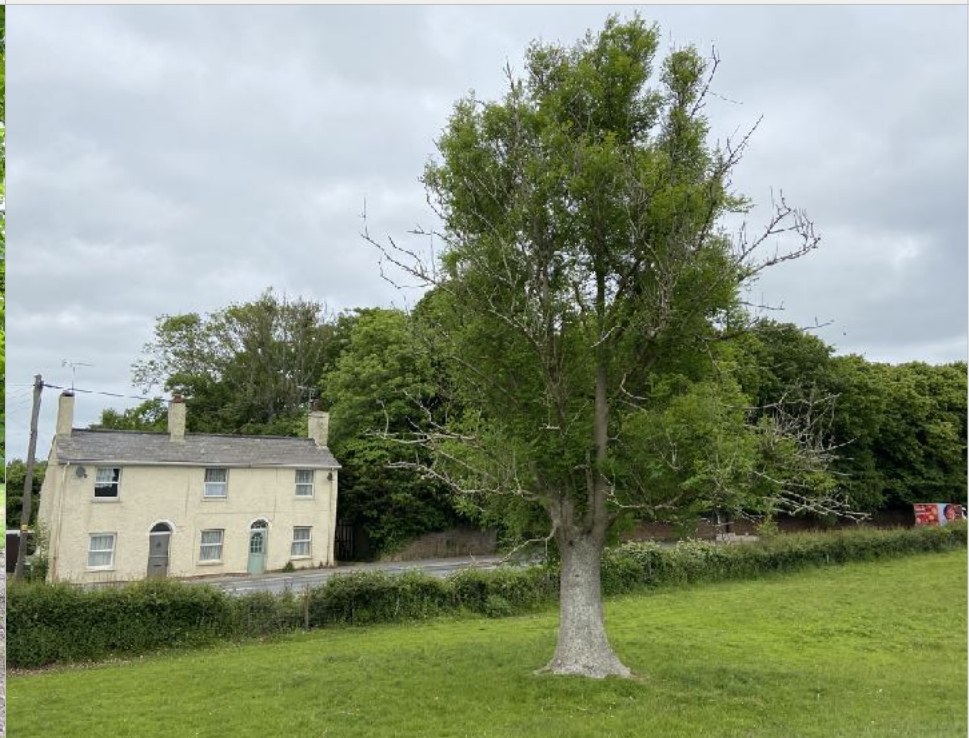
PHOTO 12: Lapsed pollard ash T71, looking northeast towards Ashford Road.
