Bat Ground Level Tree Assessment Report

Land adjoining to Hawthorns

**Maidstone Road
Borden
Kent
ME9 7QA**

**24-027
October 2024**

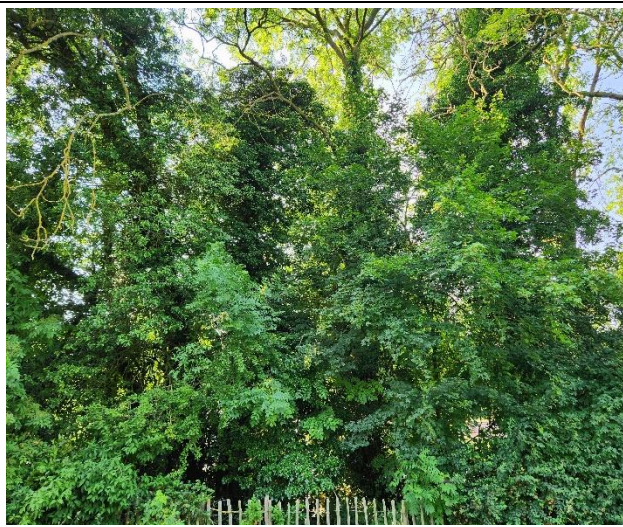
Photograph 1: Trees proposed for removal on the site boundary.

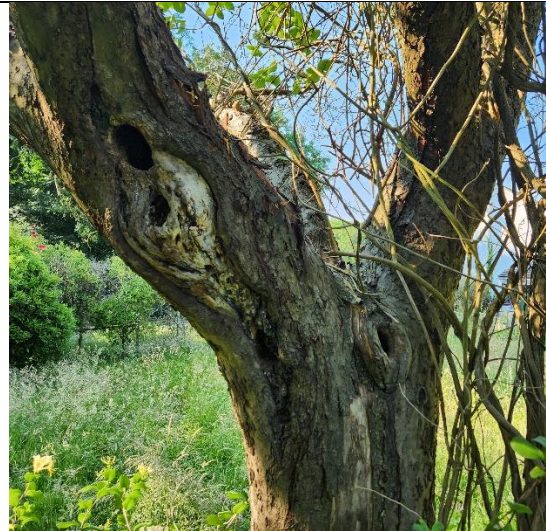
T19	Apple, mature	PRF-I	Small tree with several rot holes. On inspection the rot holes were very shallow (<3 inches deep) and did not provide a suitable roosting space, they were also very damp. There is potential for rot holes to develop into potential roosting features in the future with further decay.
T20	Apple, mature	PRF-I	Small tree with several rot holes. On inspection the rot holes were very shallow (<3 inches deep) and did not provide a suitable roosting space, they were also very damp. There is potential for rot holes to develop into potential roosting features in the future with further decay. A dead branch within the crown provides a small cavity space, however the hole is upward facing so would be subject to considerable water ingress making it highly unappealing for roosting. Inspection revealed considerable cobwebbing and no signs of use by bats.
T21	Apple, over-mature	PRF-I	Small tree with a largely hollow trunk and several holes leading into large cavity spaces. All holes were inspected using an endoscope and no signs of use by bats was identified. Due to the tree's state of deterioration and decay, there is significant water ingress within the cavity spaces. The spaces were found to be extremely damp and full of woodlice. Whilst there is a sufficient space within the cavities for a higher number of bats, these cavities are considered to be highly unlikely to support a maternity roost due to the level of water ingress/

damp. The cavities are also large due to the trunk being predominantly hollow with several entrance holes, which could result in poor temperature regulation within the roost and a lack of tighter spaces for bats to tuck into as is typically preferred for roosting. As such, it is considered that the tree meets 'PRF-I' roost suitability.
T22	Walnut, mature	Negligible	Small tree with a slender stem in good condition, no potential roosting features present.
T23	Myrobalan plum, mature	Negligible	Small tree with slender stems in good condition, no potential roosting features present.

Photograph 2: Tree T21 with several holes leading into the hollow trunk.

- 6.1 Prior to works commencing, trees T9, T11, T12, T13, T19, T20, and T21 must be fully inspected by a licensed bat ecologist to check for roosting features, signs of use and/or the presence of bats. Trees T13, T20, and T21 must be inspected using an endoscope immediately prior to felling due to the presence of crevice and cavity features.

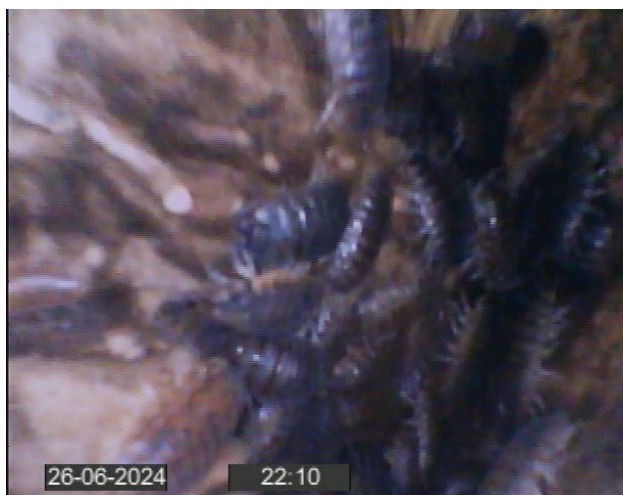
Photograph 3: Endoscope image showing accumulations of woodlice in T21.

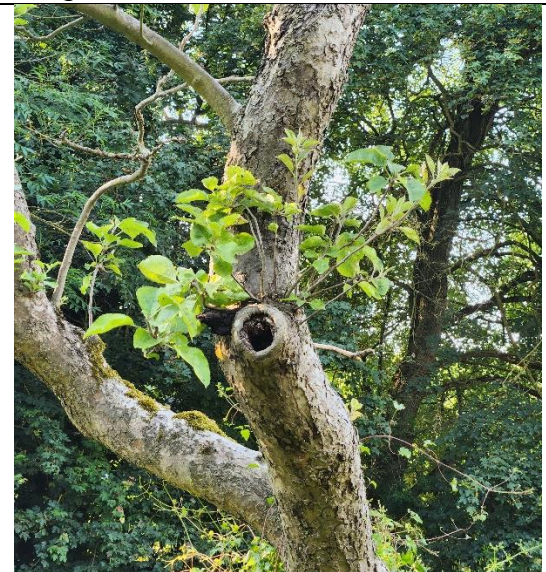
Photograph 4: Rot hole on T20, found to be too shallow for bat roosting at present.

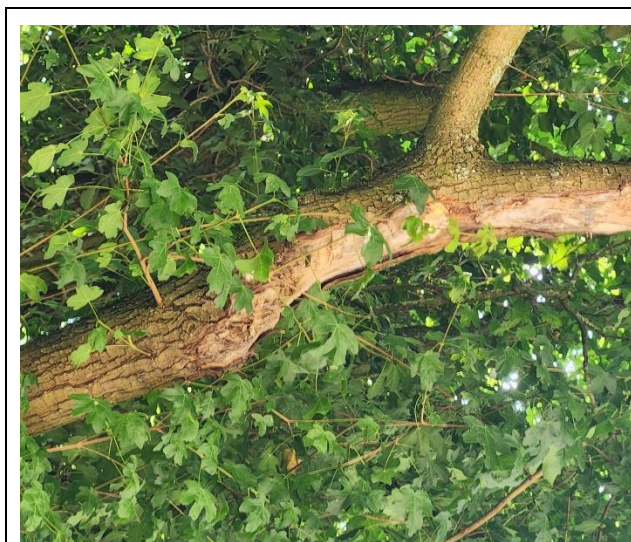
Photograph 5: Flaking bark on T12, found not to create a suitable crevice for bat roosting.

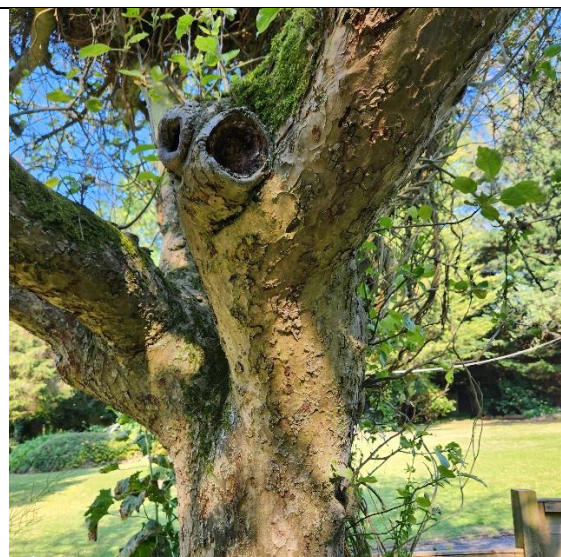
Photograph 6: T19 with shallow rot holes.

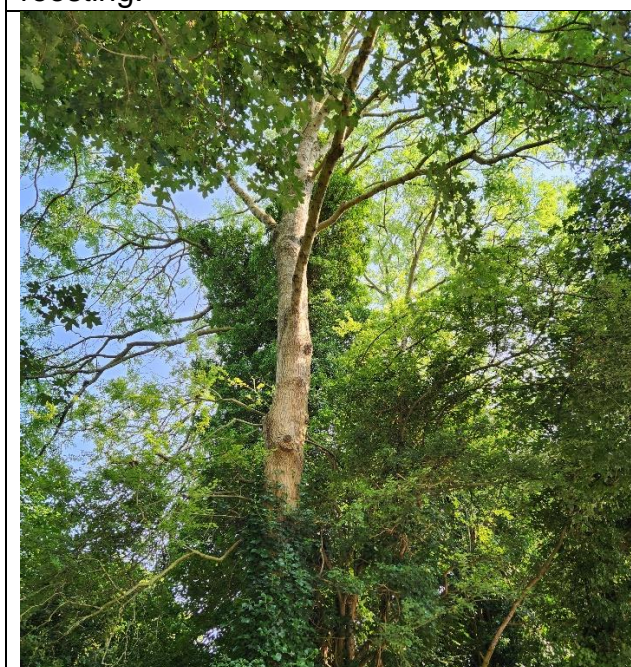
Photograph 7: T10 with negligible roost suitability.

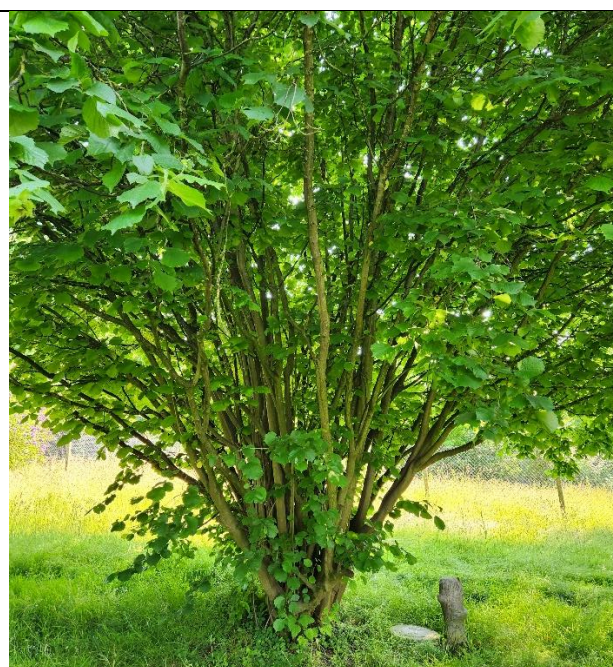
Photograph 8: T18 with negligible roost suitability.
