JF/L469-002

14<sup>th</sup> May 2024

#### <u>RE: THE BARN, FORMER NURSERY SITE, STAPLEHURST ROAD, MARDEN,</u> <u>TONBRIDGE TN12 9BS - STRUCTURAL REPORT FOLLOWING INSPECTION OF</u> <u>BUILDING</u>

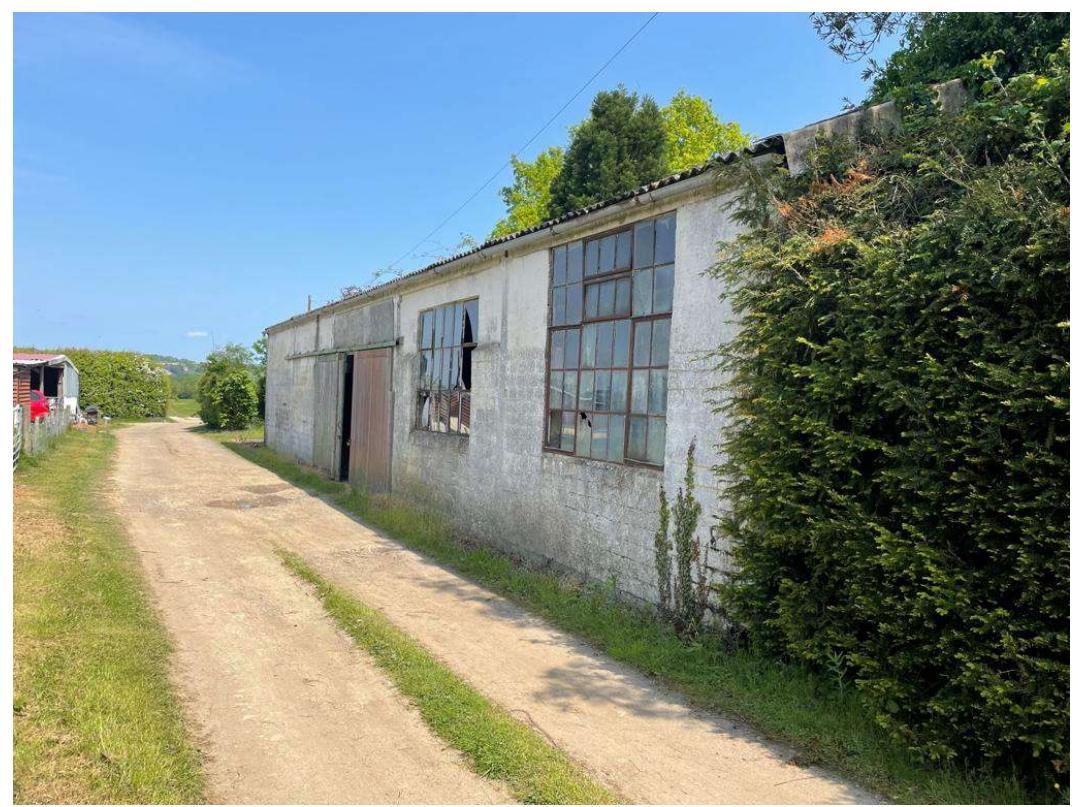
View of front of The Barn from south west

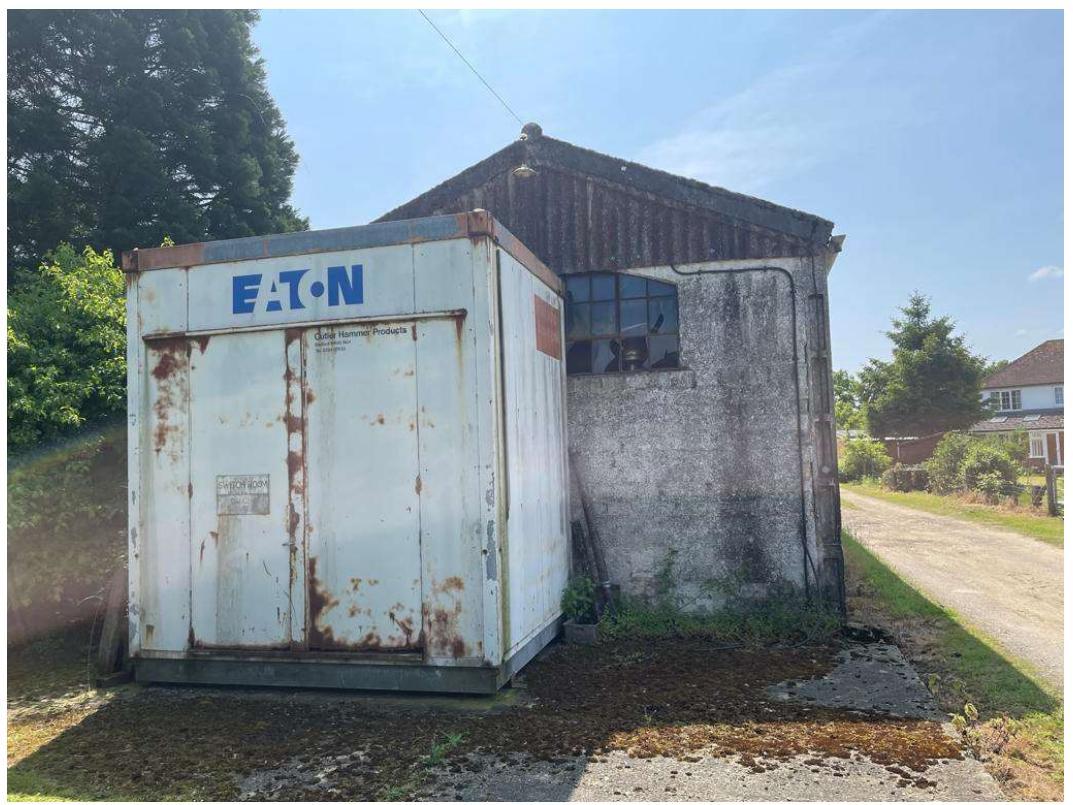
View on north end of building showing gable end and storage unit

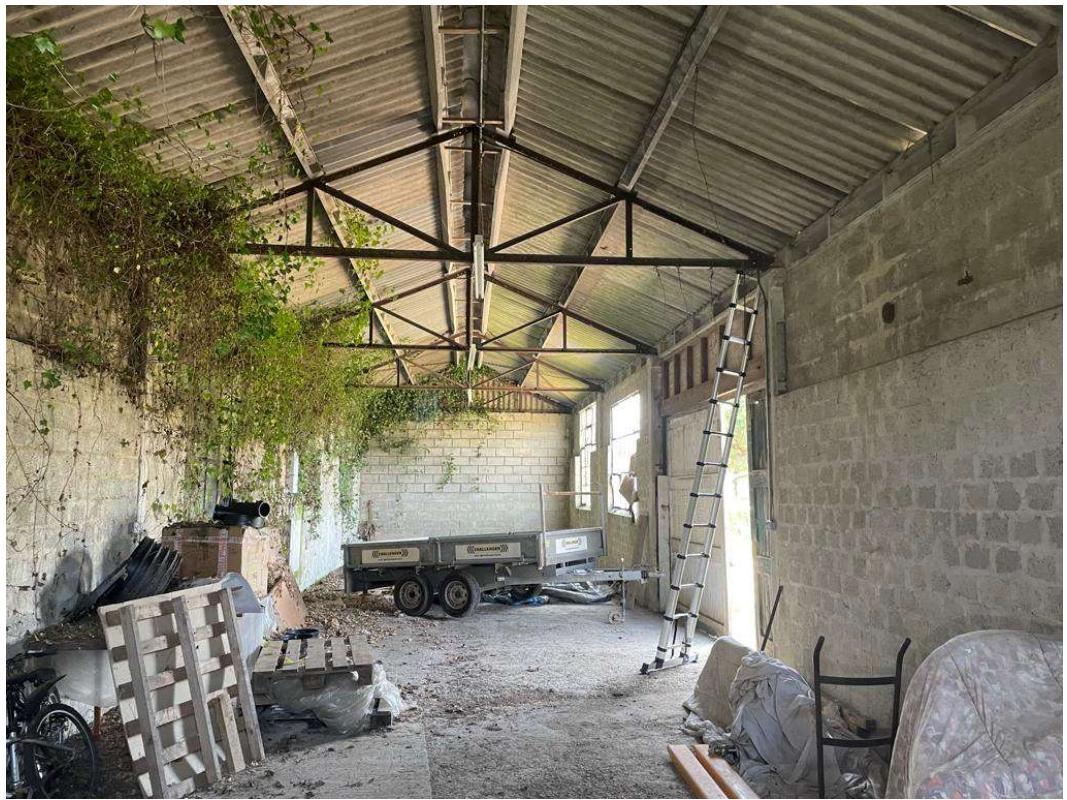
- 12) The fibre cement roof sheets appeared to be weathered with some lichen growth to the external surface but otherwise was found to be complete and weather-tight. Some minor cracking was noted to the blockwork wall but was thought to be due to thermal movement. The steel roof trusses were observed to have some surface rusting but no extensive or damaging corrosion was viewed to the truss members or bolts.

View inside of barn looking south, showing walls, posts and steel roof trusses

- 16) Some minor work may be required to increase the structural capacity of the roof, to support the additional weight of required insulation and internal finishes. We suggest that the internal lining walls and any cross-walls could be employed to provide necessary support without replacement or major works to the existing roof structure.

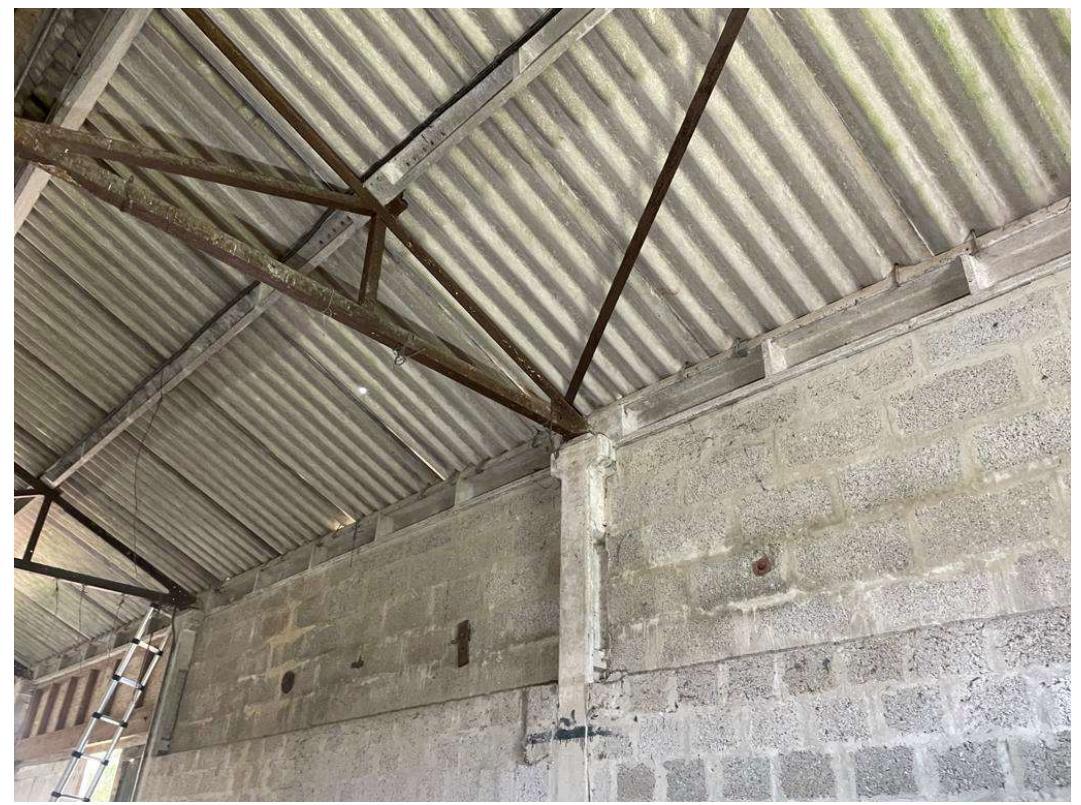
View inside of barn close-up showing roof truss bearing on concrete posts

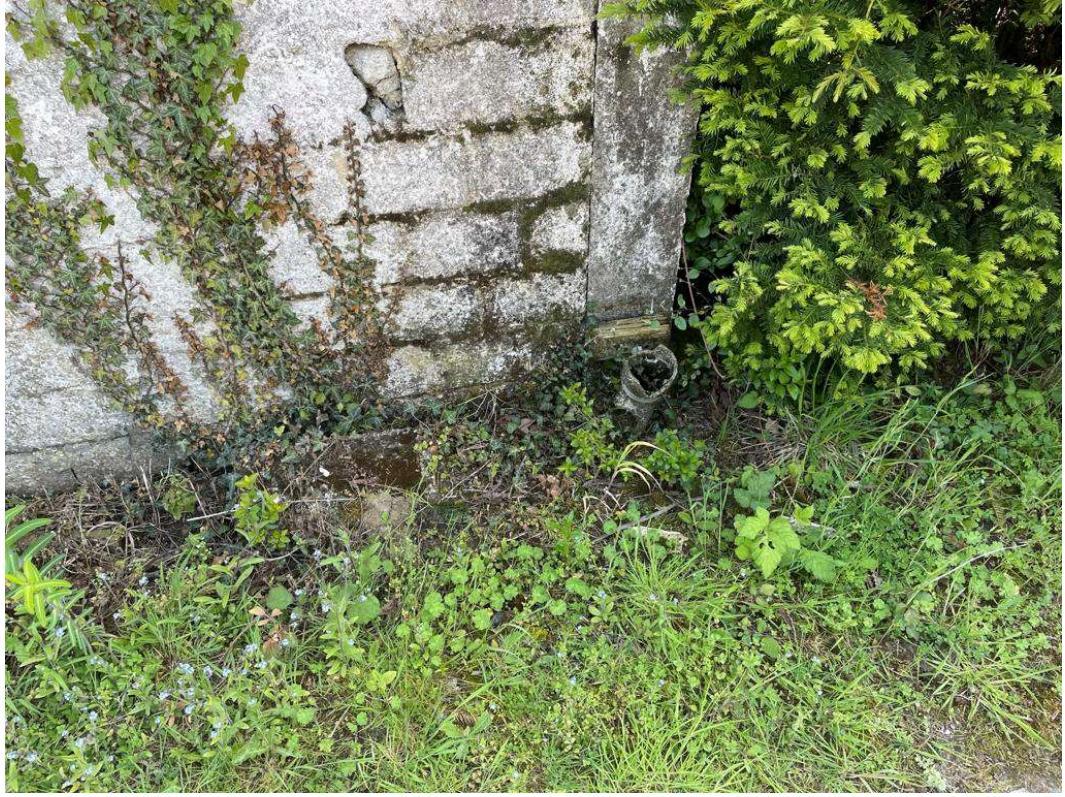
- 13) A concrete floor slab extends to the full area of the barn internally and was found to be in good condition with limited cracking and no significant falls measured. Externally, the rainwater downpipes were noted to be damaged and/or missing and discharging directly on to the ground adjacent to the barn. No mains water or foul drainage was found serving the barn. Three-phase mains electricity was noted but not currently connected.
- 14) As noted above, the plot boundary appears to be at the unmade road which runs to the front of The Barn, over which we understand the owners has full rights of access. The plot extends north, east, and south from the barn itself. The road provides private access to a domestic property and a barn 50m or so to the north and is not a public footpath or bridleway.

View on rainwater pipe shoe at front right corner showing missing downpipe and pipe was discharging on to the ground

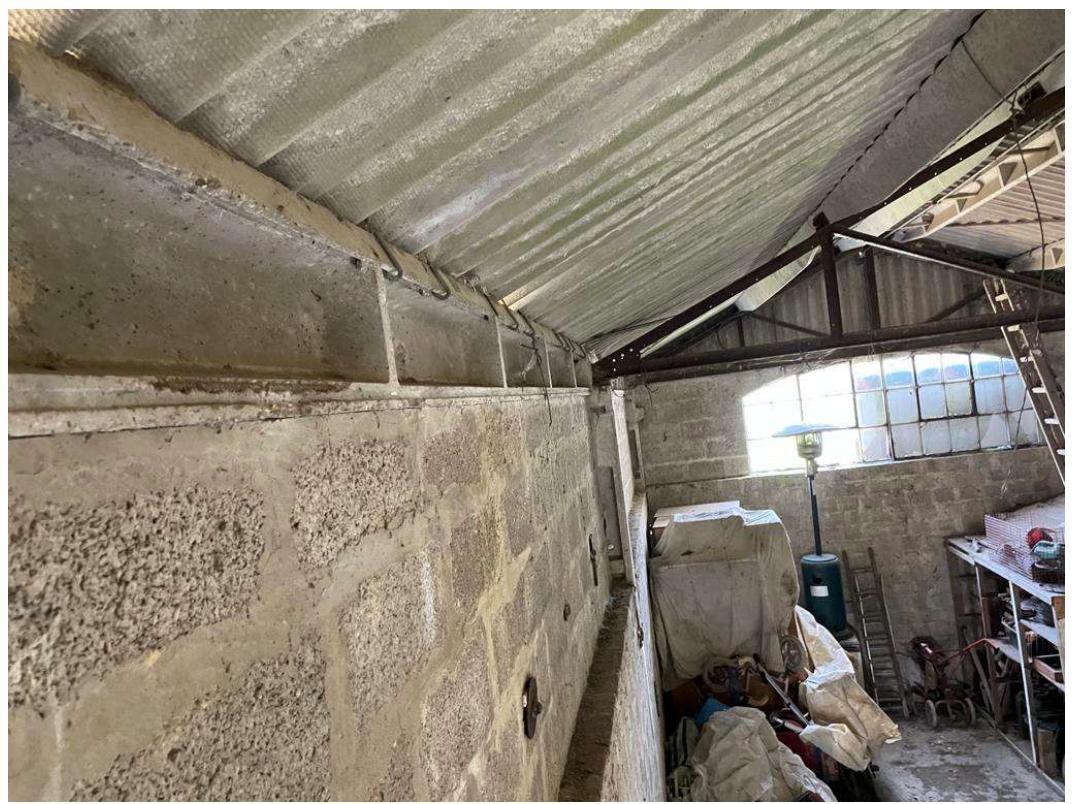
Internal view at high level showing concrete eaves beam and wall reducing in thickness at underside of window level

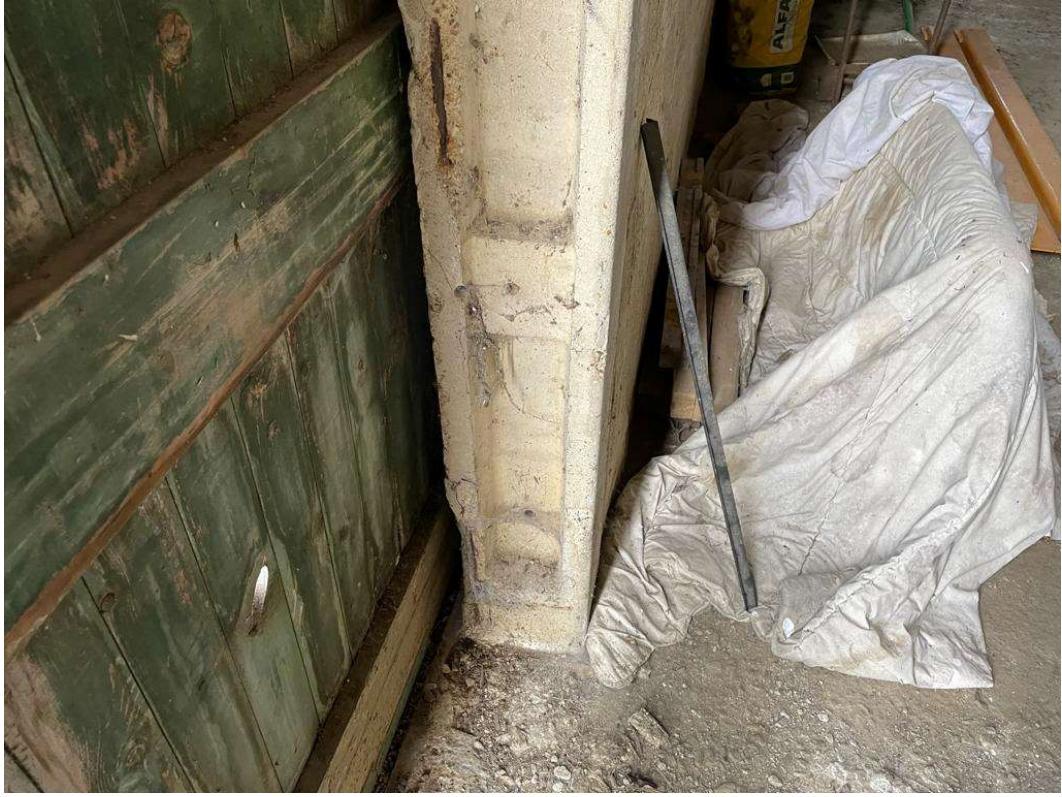
- 11) The building was seen to be in generally good condition with flat even walls and straight, level roof and eaves lines. The barn appears to have been constructed in the 1950's or possibly slightly earlier and used for low level storage. The primary concrete structural posts were seen to be in fair condition with some small areas of spalling and section loss where reinforcement could be seen. The damage appeared to be isolated to the posts adjacent to the doorway and may have been caused by vehicle impacts some time ago.

View of concrete post next to doorway showing damage with reinforcement exposed

- 18) The existing floor slab appears to be suitable for continued use with the application of insulation and finishes over, as required to comply with insulation requirements. Local repair to the concrete columns, where they have been damaged, should be made using proprietary concrete repair products to ensure their integrity and continued ability to support the roof structure.
