Results of Tree Surveys for Bats

Land South of Ashford Road, Sellindge

September 2024

Tree T59, T60 & T63 Inspection Results

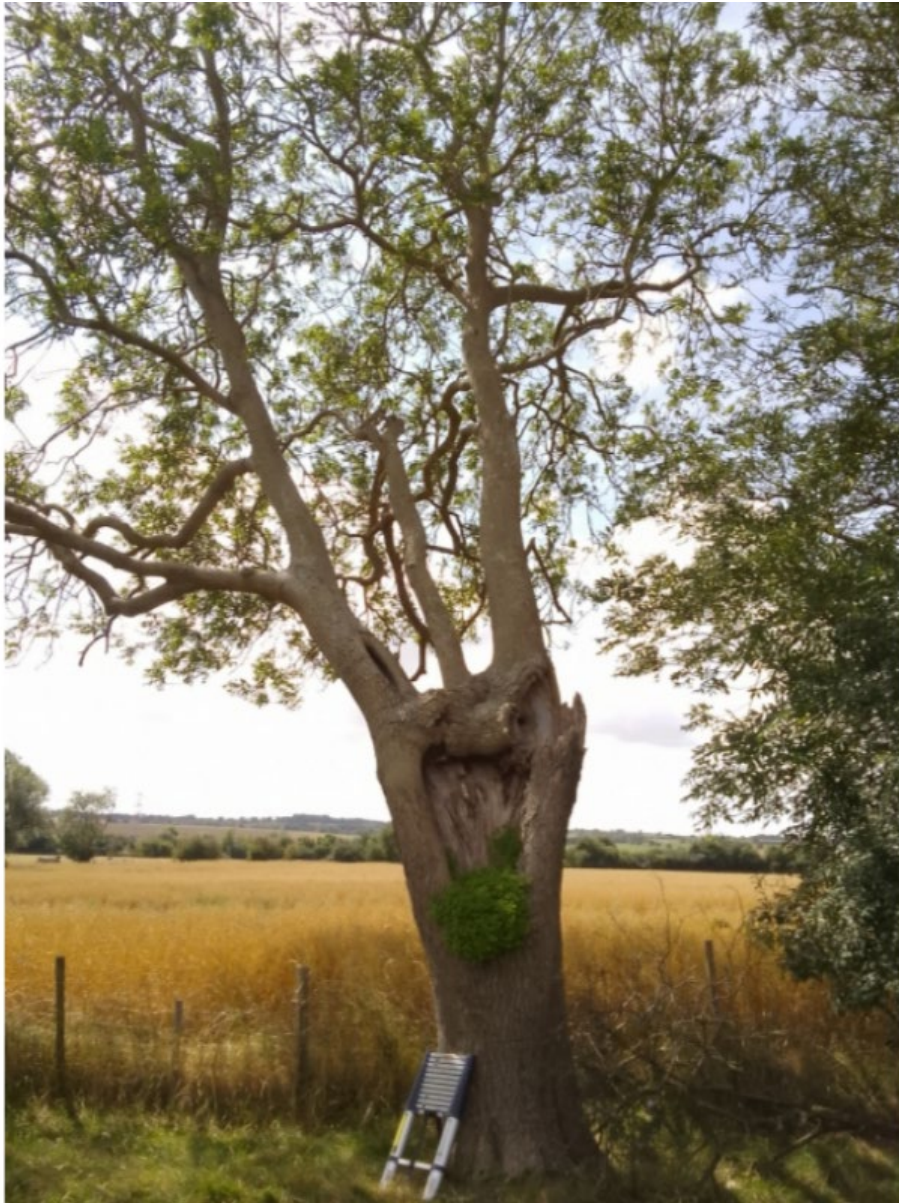
T59 viewed from the north

Tree ref.	59	Species	Ash	Location (w3w)	Quicker.obstruction.butchers	Tree Height (m)	15	Tree Alive or Dead	Alive	Single or Multi-stem	Single	Initial Suitability Category	PRF
Central, wide open cavity has cracks and crevices, but these are exposed to light and weather. There is a central bulge beneath primary branches which does form some crevices but these are exposed to light and weather.													
Further surveys required?							Yes, aerial PRF inspections (ladder). Tree PRF-M.

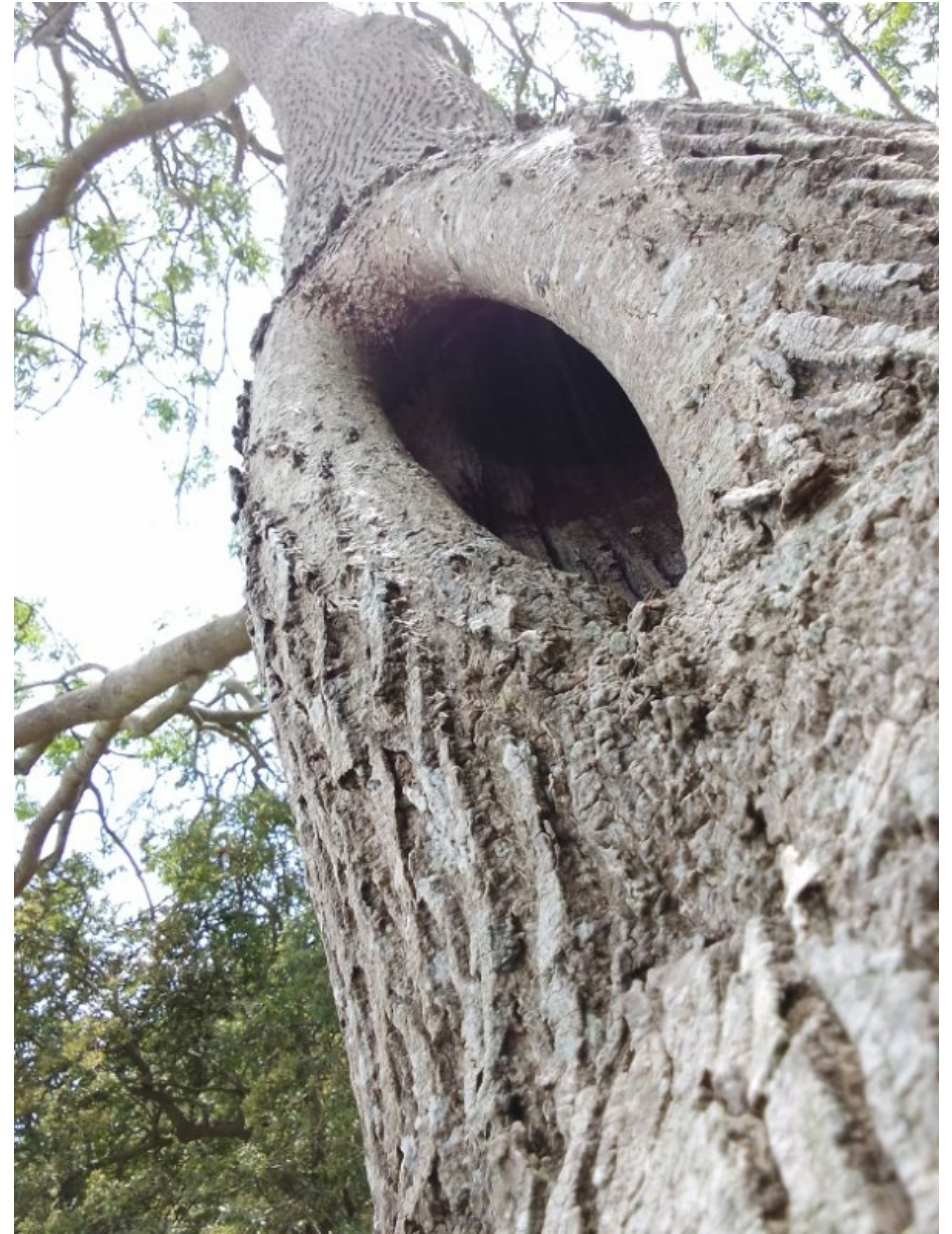
T59 PRF 1

PRF Ref.	PRF Type	PRF Height (m)	PRF Loc.	Aspect of PRF Entrance	PRF Suitability	Description of Suitability	Hibernation Suitability	Hibernation - Further Survey	26.7.24 Inspection Notes	16.8.24 Inspection Notes	6.09.24 Inspection Notes
1	Rot hollow	3	Top of main stem viewed from the north. Easternmost branch leading off of wide open cavity.	North	PRF-M	Cavity extends 2m up the stem, a depth and width of c. 20cm throughout the cavity. Base of cavity wet/sludgy.	No	No	No bats or evidence present.	No bats or evidence present.	No bats or evidence present.
2	Rot hollow	3	Top of main stem, westernmost primary branch, goes directly up	North-west	PRF-I	60cm depth, approx. 20cm in diameter, smooth and dry, quite open and exposed, quite a bright cavity	No	No	Cavity full of cobwebs c. 50cm up. No bats or evidence present.	As before. No bats or evidence present.	As before. No bats or evidence present.
3	Knot hole	5	South side of western-most primary branch	South	PRF-I	10x6cm knot hole, extends c. 8cm. 1cm recurve on callus roll.	No	No	No bats or evidence present.	No bats or evidence present.	No bats or evidence present.

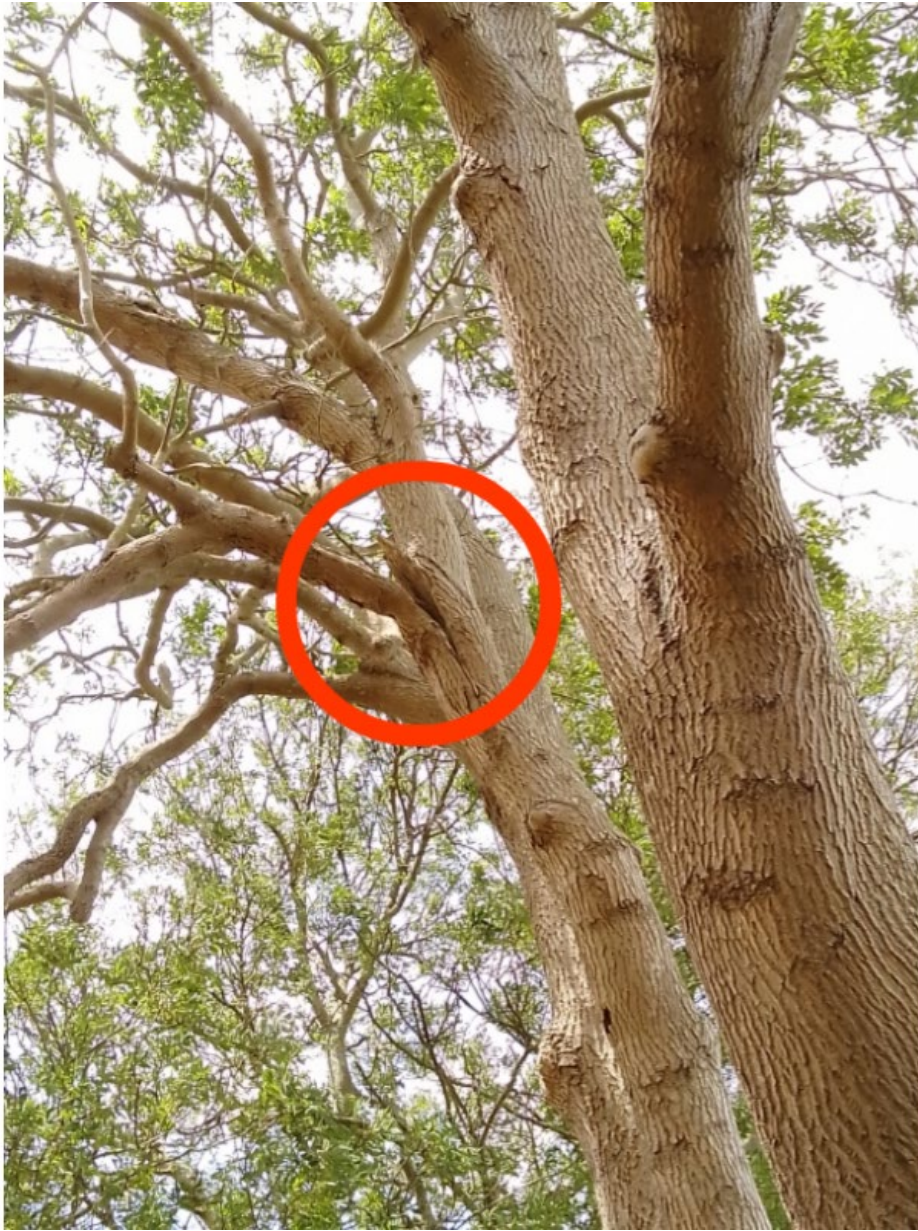
T59 PRF 4

4	Crack	6	Central primary branch, pointing straight up, located at join of first secondary branch.	East	PRF-I	30cm long, 8cm at widest point. Feature faces upward, no pockets of further internal crevices that would offer shelter. No bat potential.	No	No	Not suitable	Not suitable	Not suitable

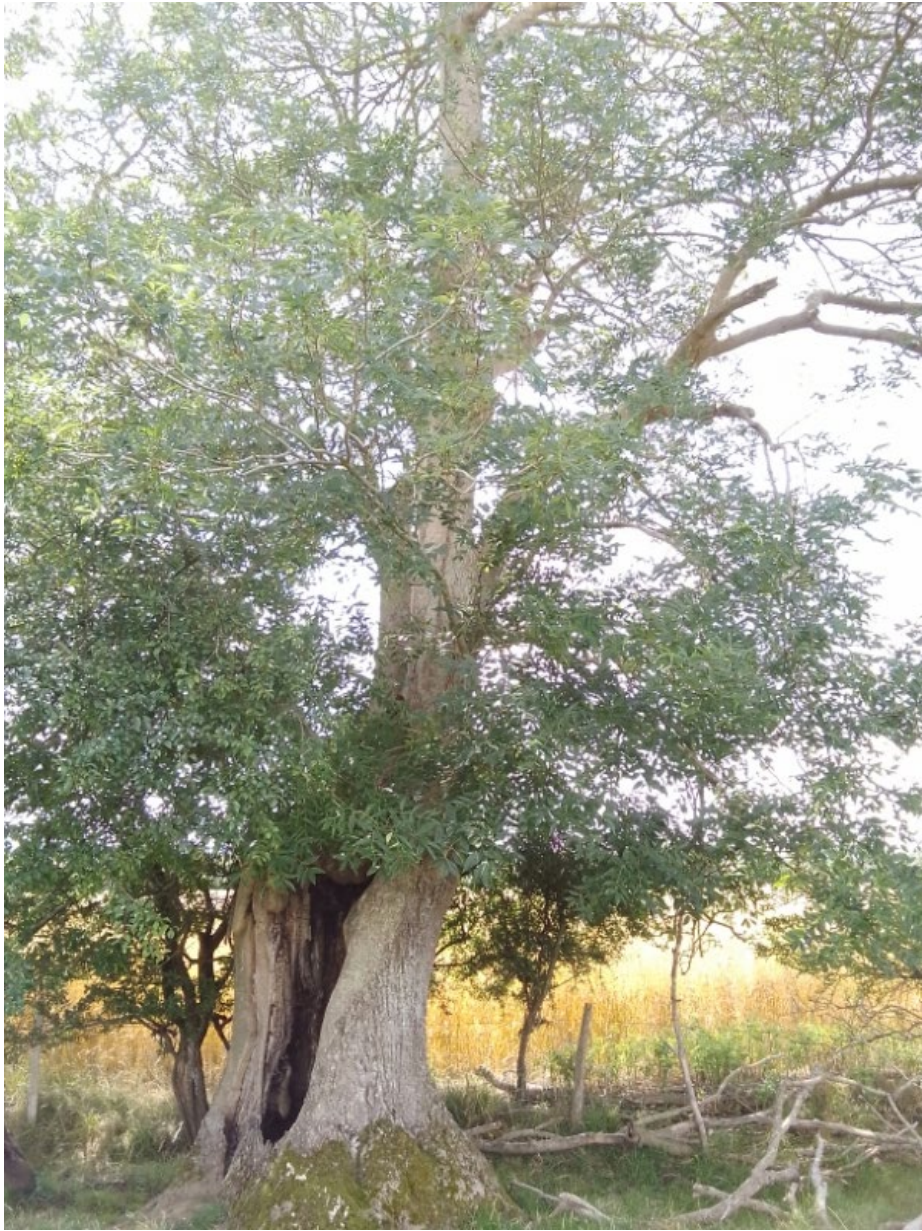
T60 viewed from the north

Tree ref.	60	Species	Ash	Location (w3w)	whiplash.armed.winners	Tree Height (m)	17	Tree Alive or Dead	Alive	Single or Multi-stem	Single	Initial Suitability Category	PRF
There are crevices in the exposed heartwood on the central main stem that would be suitable if these were not so exposed.													
Further surveys required?							Yes, aerial PRF inspections (ladder). Tree PRF-M.

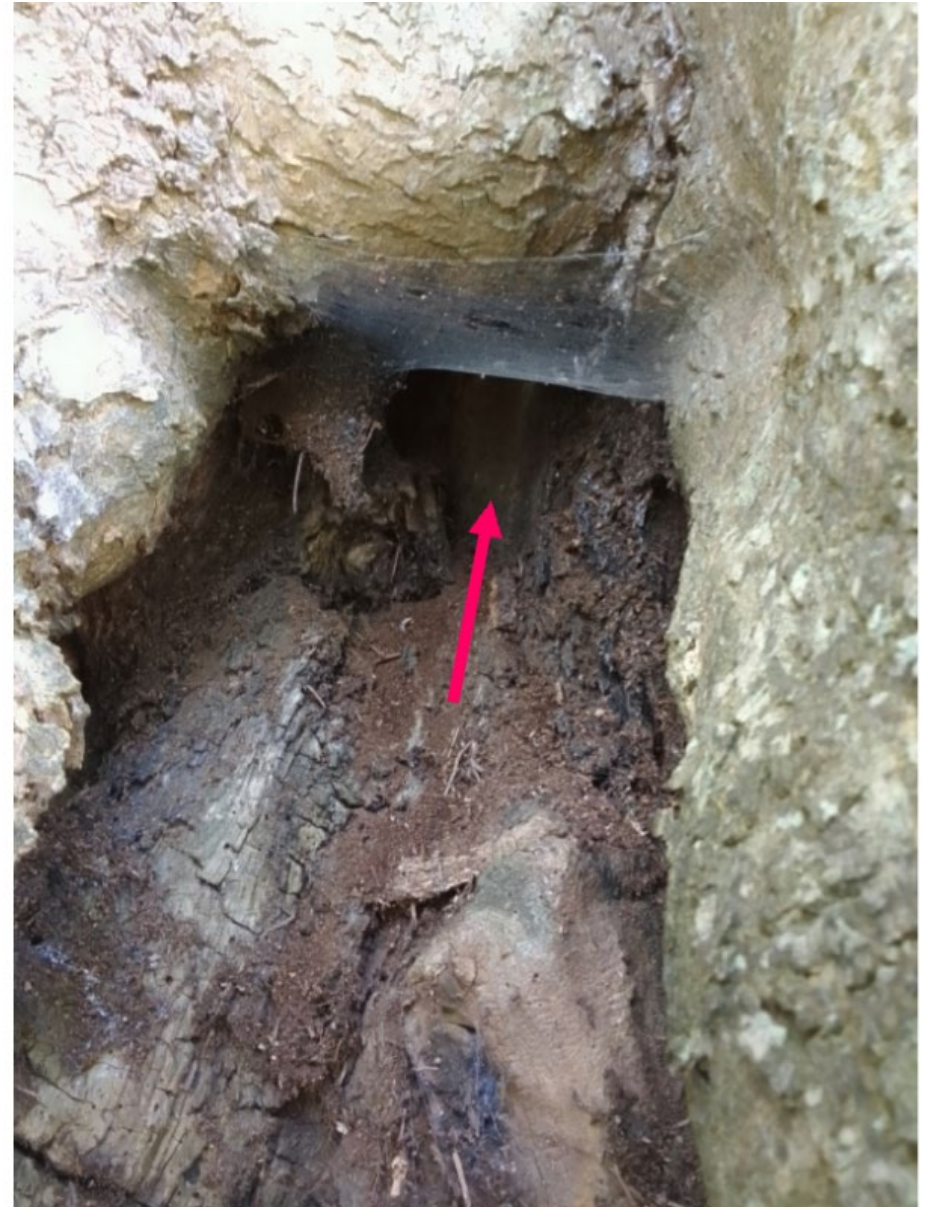
T60 PRF 1

PRF Ref.	PRF Type	PRF Height (m)	PRF Loc.	Aspect of PRF Entrance	PRF Suitability	Description of Suitability	Hibernation Suitability	Hibernation - Further Survey	26.7.24 Inspection Notes	16.8.24 Inspection Notes	6.09.24 Inspection Notes
1	Rot hollow	2	Main stem at top of large open cavity.	North-east	PRF-M	70cm depth, 20cm diameter, dry with smooth sides, full of slugs, dark and sheltered.	No	No	No bats or evidence present.	No bats or evidence present.	No bats or evidence present.
2	Rot hollow	3	Outside of central cavity, between eastern-most and central primary branches.	North-east	PRF-M	Entrance hole 5x5cm, opening into cavity that is at least 60cm deep by 20cm wide, but narrow, travels down and open at the bottom, not as dry and smooth as other cavities. Some slugs.	No	No	No bats or evidence present.	No bats or evidence present.	No bats or evidence present.

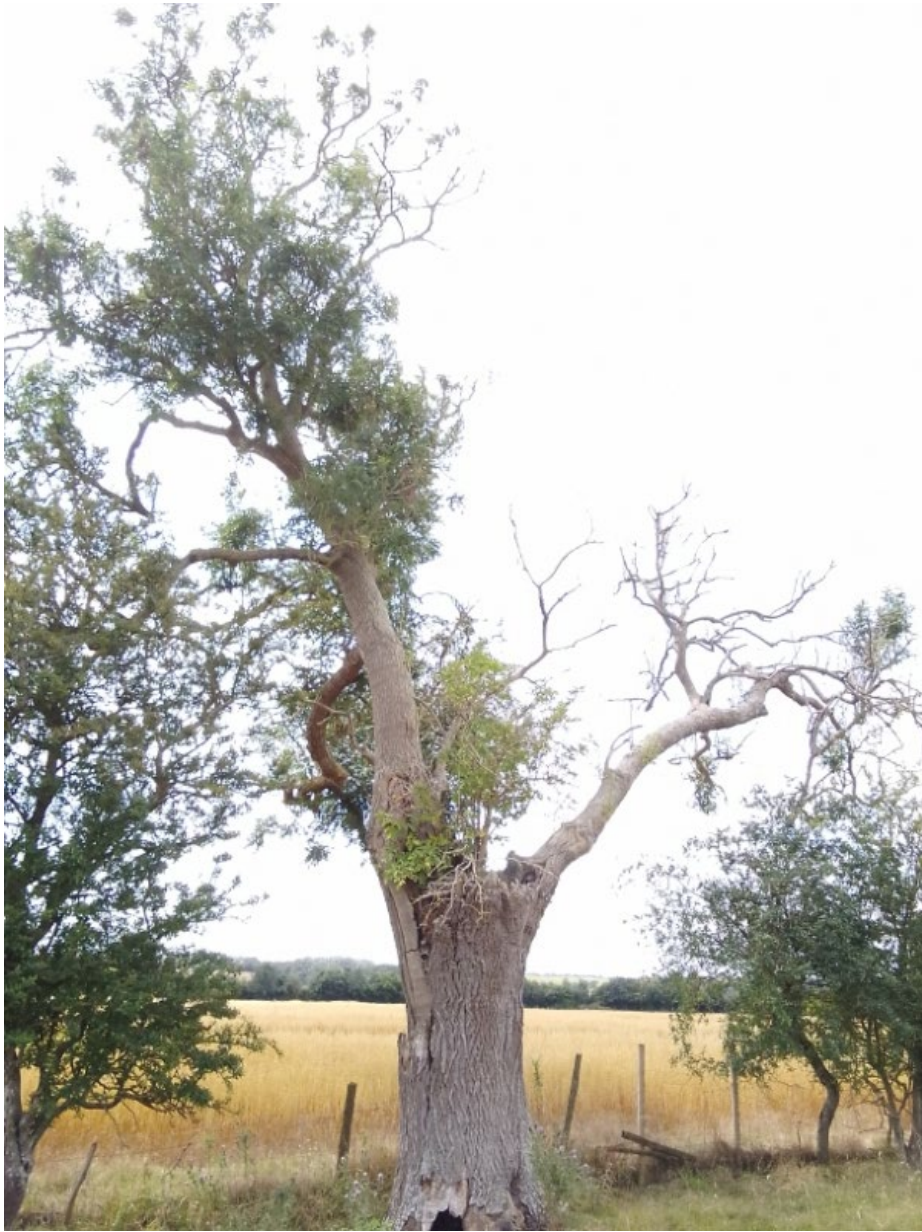
T63 viewed from the north

Tree ref.	63	Species	Ash	Location (w3w)	outhouse.branded.husband.	Tree Height (m)	13	Tree Alive or Dead	Alive	Single or Multi-stem	Single	Initial Suitability Category	PRF
Epiphytic elder obstructs some of the PRF entrances, especially on the easternmost primary limb.													
Further surveys required?							Yes, aerial PRF inspections (ladder). Tree PRF-M.

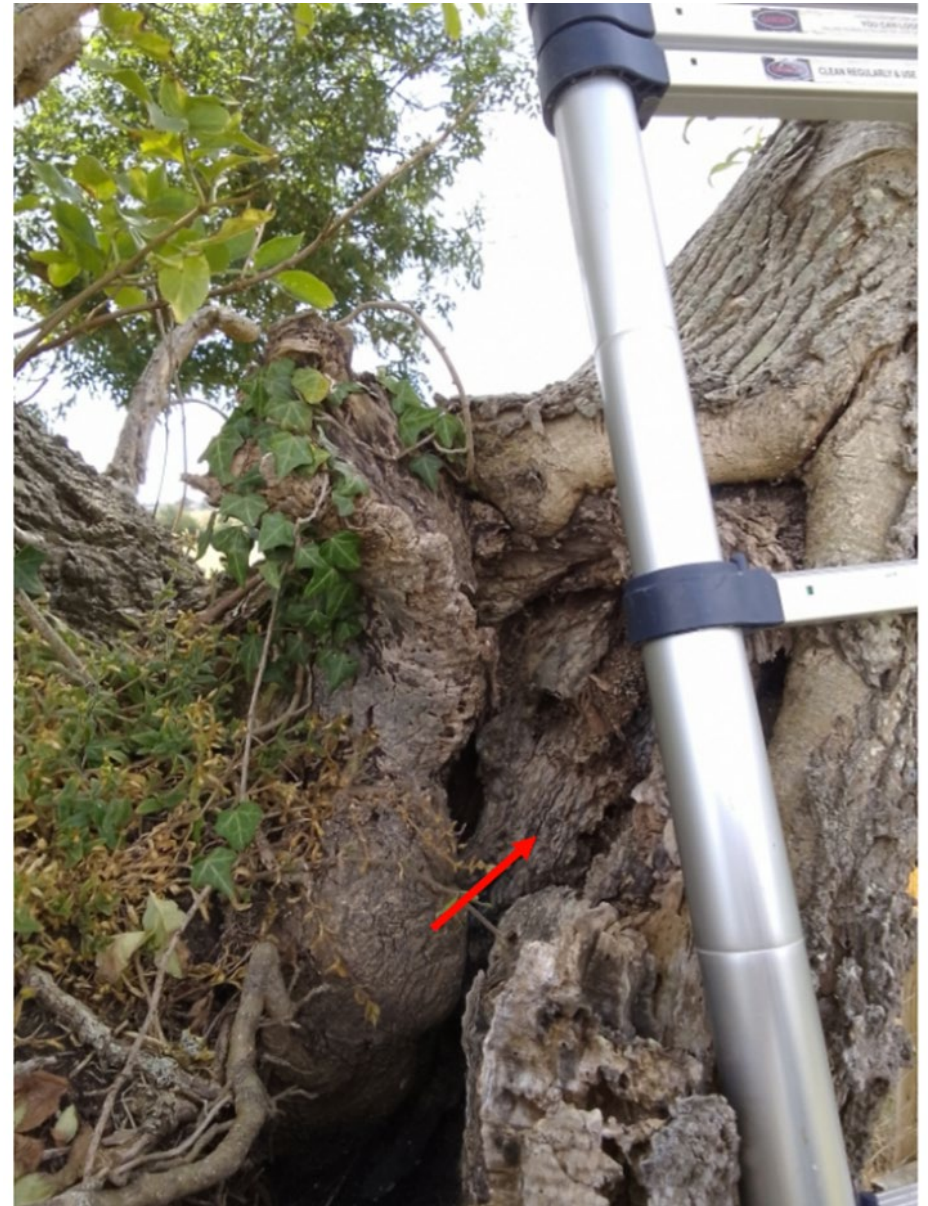
T63 PRF 1

PRF Ref.	PRF Type	PRF Height (m)	PRF Loc.	Aspect of PRF Entrance	PRF Suitability	Description of Suitability	Hibernation Suitability	Hibernation - Further Survey	26.7.24 Inspection Notes	16.8.24 Inspection Notes	6.09.24 Inspection Notes
1	Rot hollow	3	At base of western-most primary branch.	North-east	PRF-I	Entrance 3cm wide, 20cm depth, dry crevice.	No	No	No bats or evidence present.	No bats or evidence present.	No bats or evidence present.
2	Rot hollow	4	Eastern-most primary branch, at base of cavity within that branch.	North	PRF-I	20cm depth, approx. 10cm diameter with smooth bark and suitable for transitional/ opportunistic use.	No	No	No bats or evidence present.	No bats or evidence present.	No bats or evidence present.
3	Rot hollow	4	Directly above PRF 2.	North	PRF-I	20cm depth, approx. 3cm diameter, lots of woodlice, upward positioned dry crevice. Lots of slugs.	No	No	No bats or evidence present.	No bats or evidence present.	No bats or evidence present.

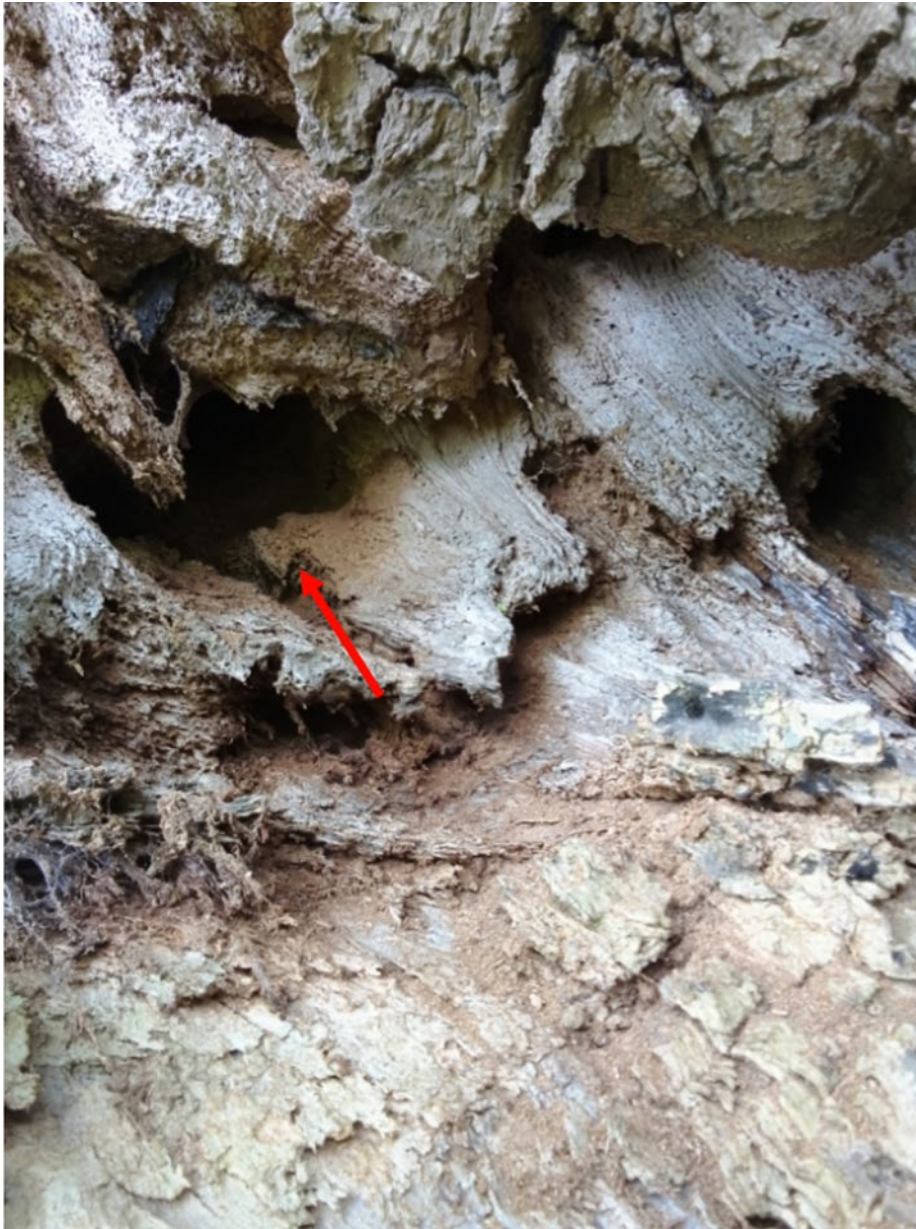
T63 PRF 4

4	Rot hollow	4	Directly adjacent (east) to PRF 3	North	PRF-I	25cm depth, approx. 10 diameter but widens inside, dry, only semi-dark, although spacious not likely to be a	No	No	Lots of cobwebs. No bats or evidence present.	As before. No bats or evidence present.	As before. No bats or evidence present.

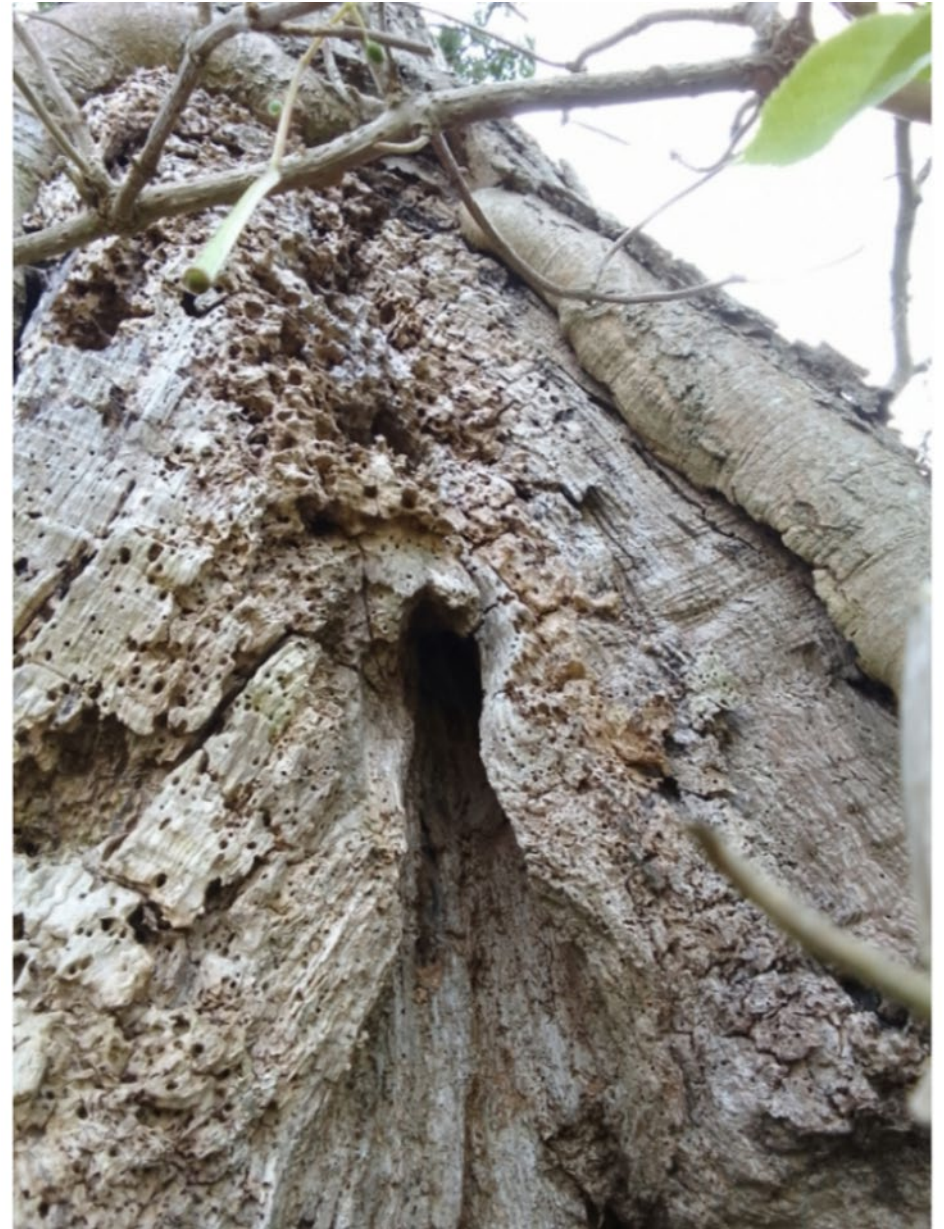
T63 PRF 5

PRF Ref.	PRF Type	PRF Height (m)	PRF Loc.	Aspect of PRF Entrance	PRF Suitability	Description of Suitability	Hibernation Suitability	Hibernation - Further Survey	26.7.24 Inspection Notes	16.8.24 Inspection Notes	6.09.24 Inspection Notes
						favourable feature for maternity roost.					
5	Rot hollow	4.5	Top of cavity at the base of eastern-most primary branch, among spongy heartwood.	North	PRF-M	50cm depth, 10cm diameter, dry with smooth sides, some slugs, travels directly up.	No	No	No bats or evidence present.	No bats or evidence present.	No bats or evidence present.
