## Phase I Geo-Environmental Report

Land off Old Ashford Road, Lenham

**Dean Lewis Estates Ltd.**

SHF.1528.004.GE.R.001

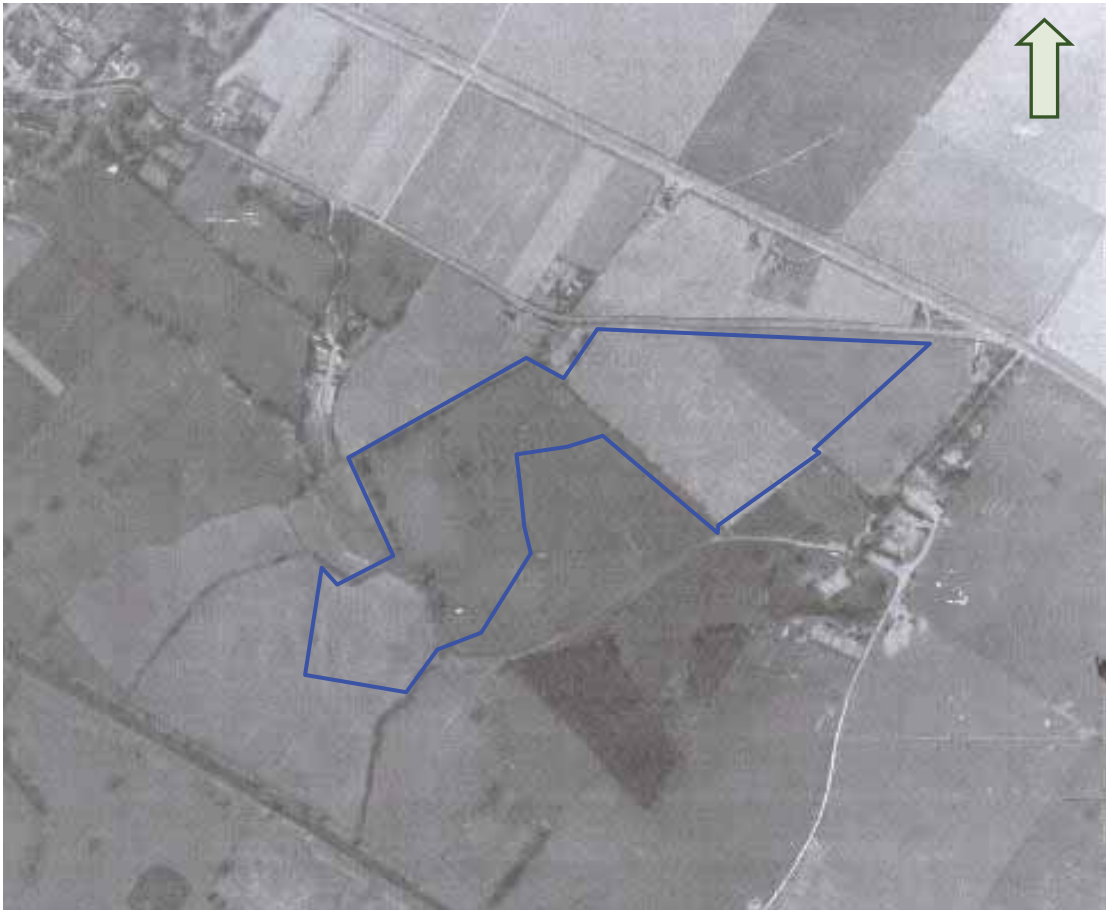
<b>Plate 4</b>	Aerial photograph, 10 <sup>th</sup> April 1946

Source: Historic England <span style="float: right;">Not to Scale</span>	
<b>Legend</b>	Site boundary —
<b>Potential UXO Hazard</b>	
<p>Records indicate that 3No. HE bombs fell on the southern part of the Site and exploded. 1No. additional HE bomb fell adjacent to the north-western boundary of the Site. This was recorded as UXB and removed.</p> <p>No further records of bombing on the Site have been found and no bomb damage or cratering has been identified on the Site on historical aerial photography.</p> <p>Given this, and the lack of heavy air raids in the vicinity, it is considered unlikely that a UXB would have fallen unnoticed on the Site.</p> <p>WWII bombing is not considered to provide a source of UXO hazard to the Site.</p>	
<b>3.4 Geology and Bomb Penetration Depths</b>	
<p>It is important to consider the geological materials present on the Site at the time that a bomb was dropped in order to establish its maximum penetration depth. British Geological Survey (BGS) 1:50,000 Sheet 288, Maidstone (Solid and Drift) and BGS borehole records were consulted.</p>

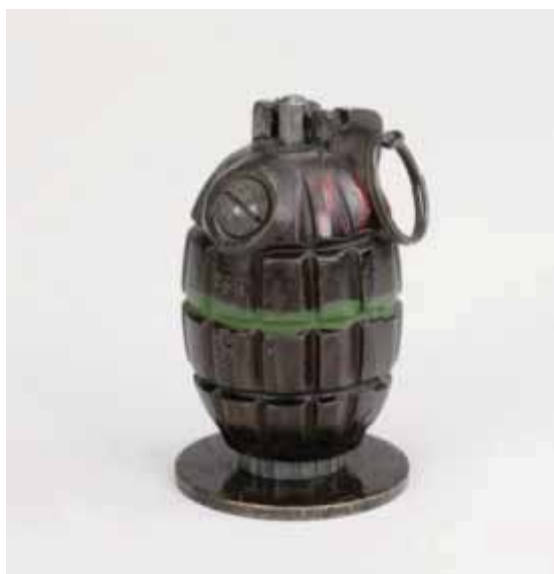
<b>Plate</b>	Photographs of a typical and an excavated WWII No. 36 hand grenade
--------------	--

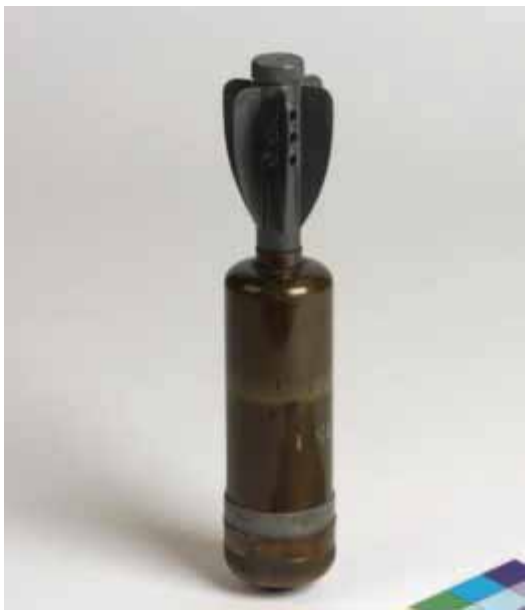
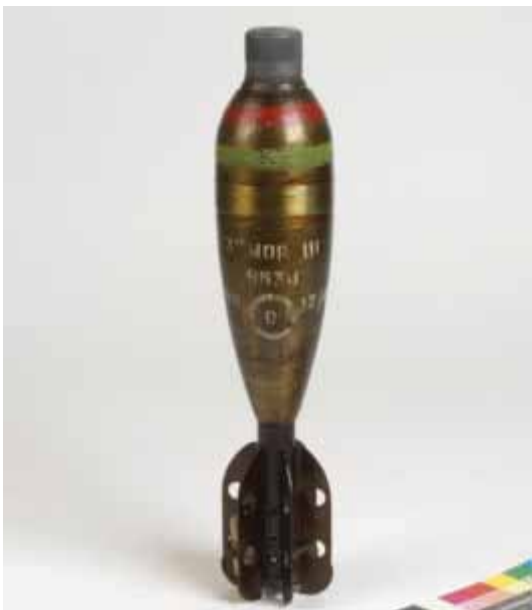
<b>Plate</b>	Photographs of WWII 2-inch and 3-inch mortars
<div style="display: flex; justify-content: space-around;">

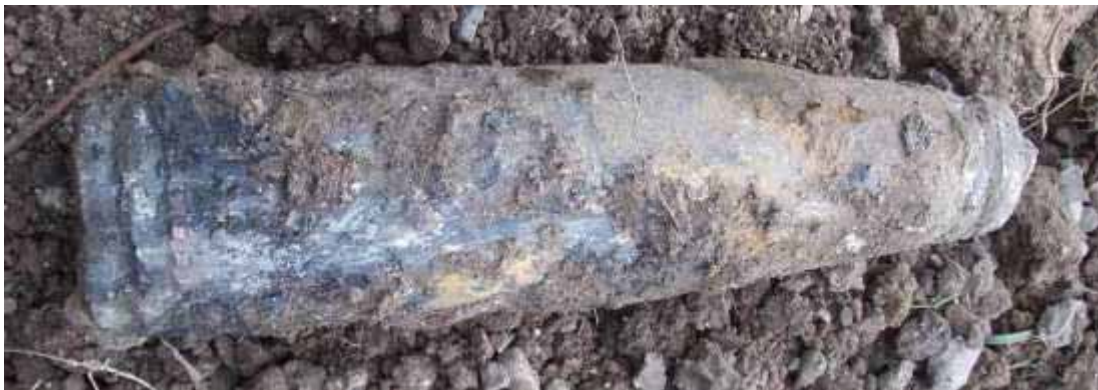
<b>Plate</b>	Photograph of a recently excavated 3.7" AA shell

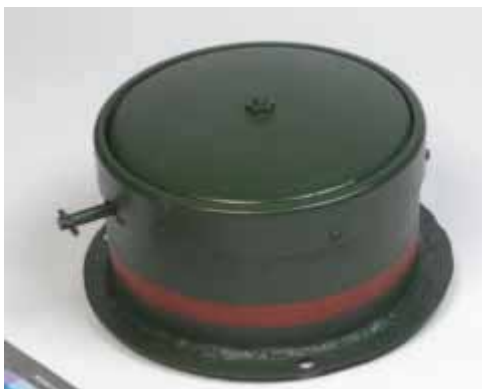
Plate	Photographs of original and recently excavated WWII land mines
-------	--

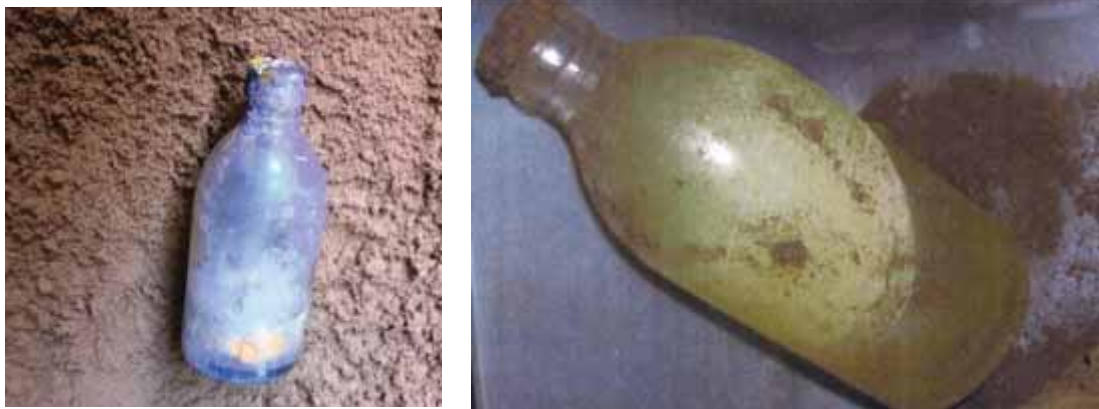
Plate	Photograph of No. 76 SIP grenades

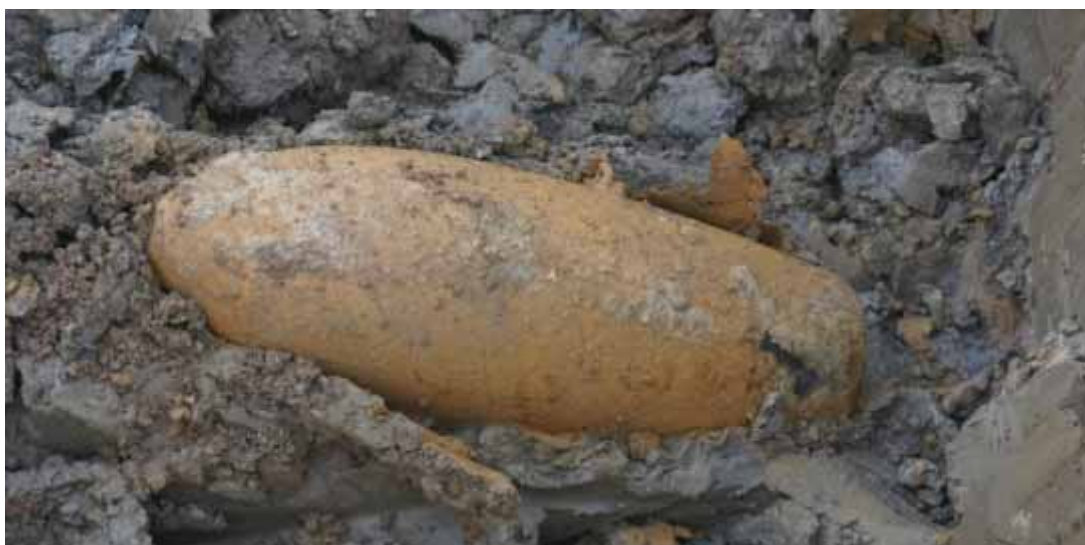
Photograph of a recently excavated WWII British 500lb GP bomb
