**PROPOSED RESIDENTIAL DEVELOPMENT
ON LAND ADJACENT TO ROMNEY AVENUE
FOLKESTONE
KENT, CT20 3QJ**

CONSTRUCTION STABILITY ASSESSMENT

**FOR
VILLAGE HOMES FOLKESTONE LTD**

Report no: 3066 Stability

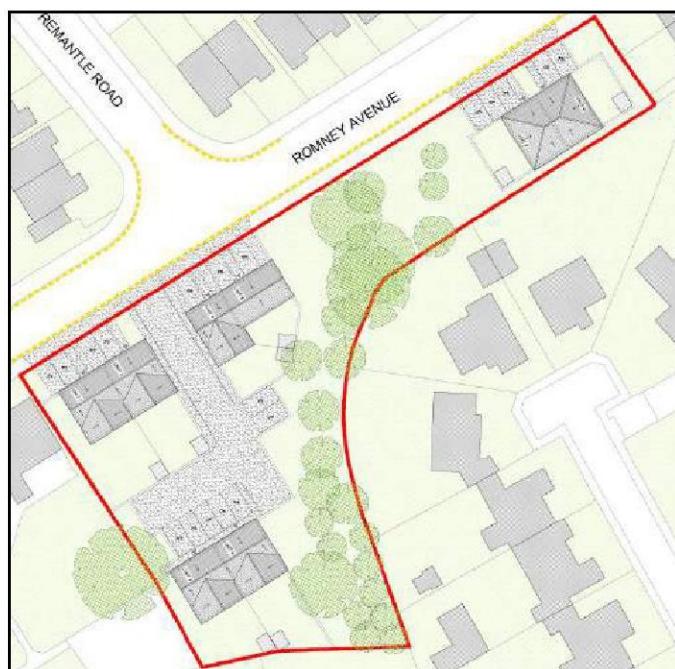
Figure 1.1 – Development Proposals – full drawing within Appendix 1

The proposal is to construct 8 dwellings with associated access road and parking.

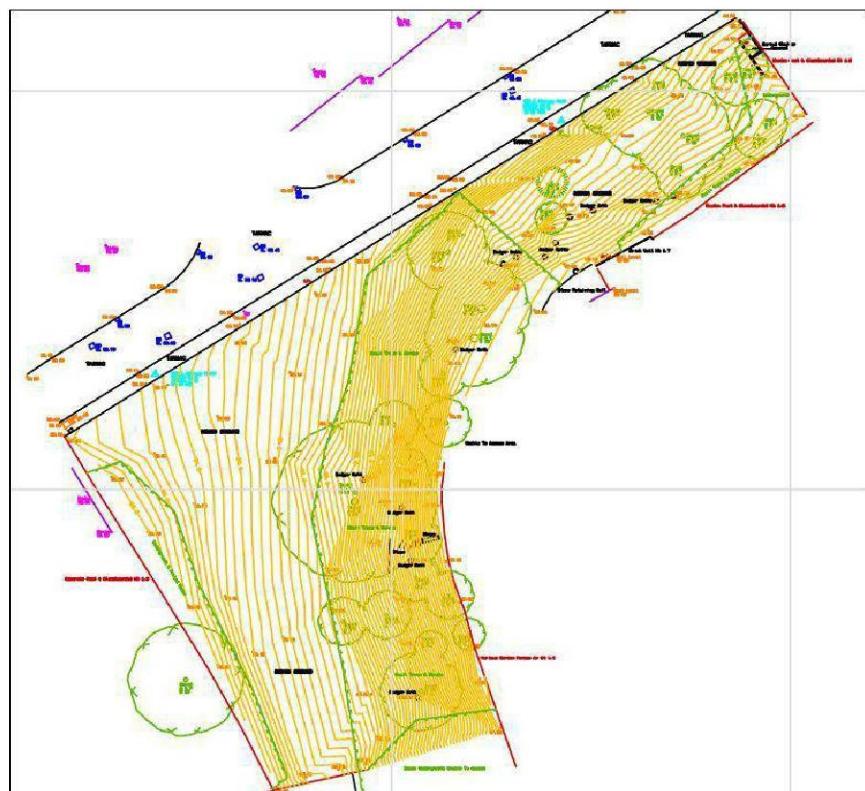
A review of the topographical survey indicates that the site generally falls from the east to west. Overall, there is a fall of approximately 17m as can be seen from the extract of the survey below.

Figure 2.4 – extract of Topographic Survey

It can be seen that there are significant trees planted within the higher levels of the site and these are coincidentally the steeper parts of the site.

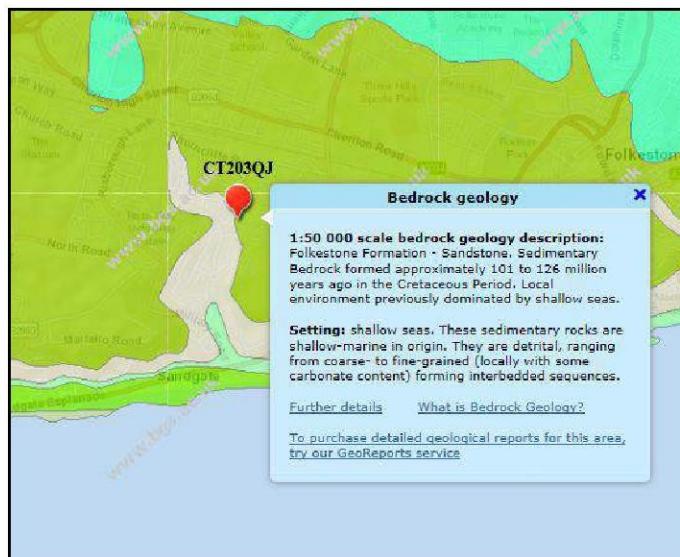
A review of the BGSonline bedrock mapping tool has identified that the development site is likely underlain by the Folkestone Formation (Sandstone). These sedimentary rocks are defined by the BGS as 'detrital, ranging from coarse to fine grained forming interbedded sequences'.

The site is also noted to be within the vicinity of the Sandgate Formation (Sandstone, Siltstone and Mudstone). These sedimentary rocks are defined by the BGS as 'detrital, ranging from coarse to fine grained forming interbedded sequences'.

Figure 2.5 – BGS Extracts: Bedrock Geology © BGS

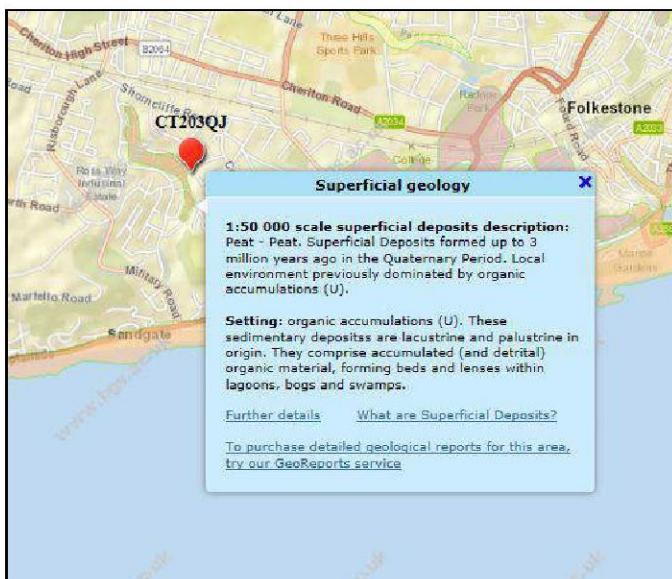
A review of the BGS online superficial deposits mapping tool has identified that the development site is not likely underlain by a superficial deposit. There are, however, superficial deposits within the area, comprising Peat. Peat is a partially decomposed mass of semi-carbonised vegetation which has grown under waterlogged, anaerobic conditions, usually in bogs or swamps.

Figure 2.6 – BGS Extracts: Superficial Geology © BGS

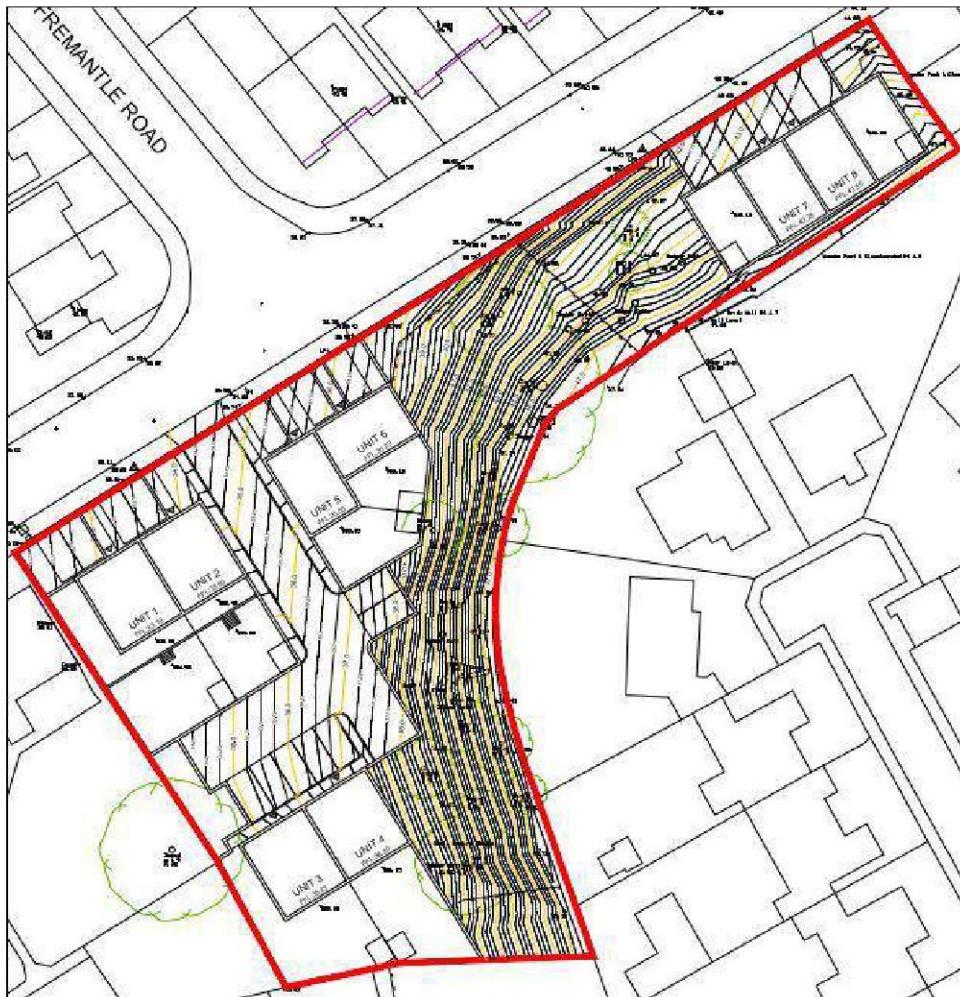
The proposal is to construct 8 dwellings with associated access road and parking. The figure below shows the Architect's current proposals with design contour levels shown.

Figure 3.1 – Proposed Site Plan with Proposed Levels – full drawing within Appendix 1.

The proposed development retains the steeper parts of the site as evidenced by the closely banded contours on the above extract. The plan also confirms that the extensive tree and shrub covering on that part of the site will be retained which will provide significant defence against the predicted shallow slope failures as modelled when the trees were removed. It is noteworthy that Network Rail and Highways England both use tree and shrub planting as accepted methods of ensuring slope stability is retained on steep cuttings and embankments so the Contractor must be made aware that the planting must be preserved.

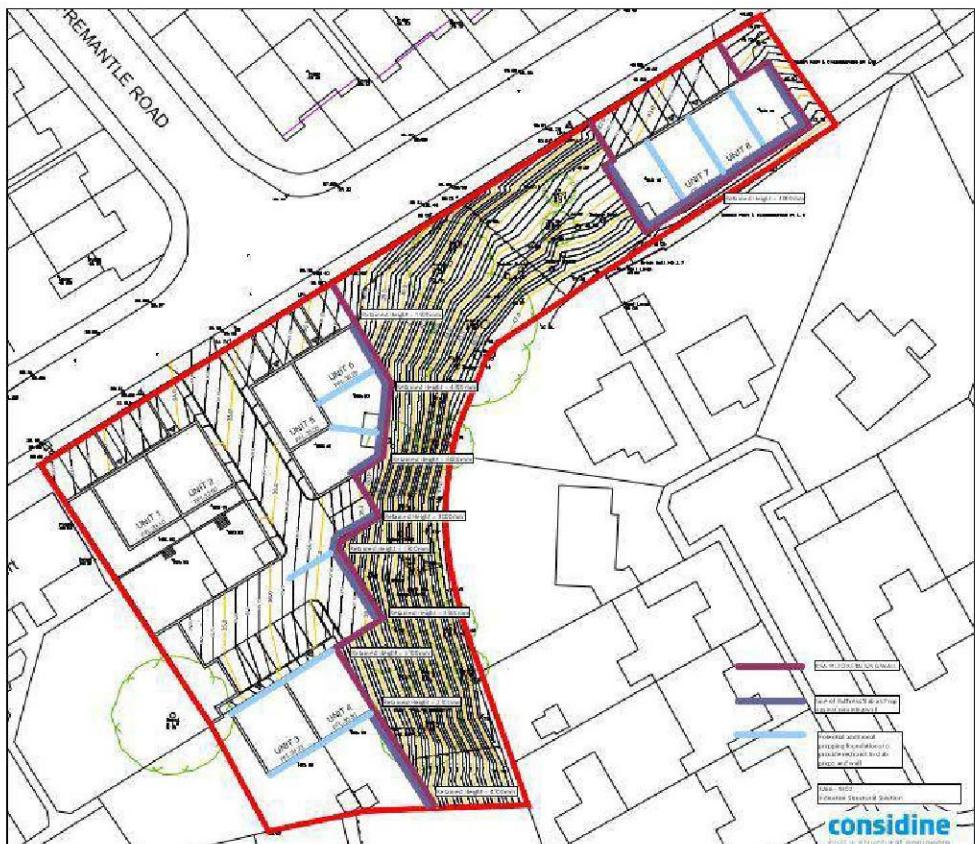
An example of a suitable foundation layout is shown at SK02 at appendix 3 and as below.

Figure 3.2 – Example of a retaining wall solution - Layout

The use of piles as a retaining solution would require the use of building foundations as props in order to ensure deflection was within acceptable limits. This has been used on other projects in these ground conditions successfully. The layout of the walls – shown by the purple lines above – lends itself to this solution. Specifically Units 1 and 2 would be normal construction; Units 3 and 4 would incorporate the retaining solution within their structure including floor slabs acting as props to the wall; Units 5 and 6 would similarly incorporate retaining walls within their structure including elements of propping and Units 7 and 8 would be a simple 'box' arrangement with floor slab acting as internal props.

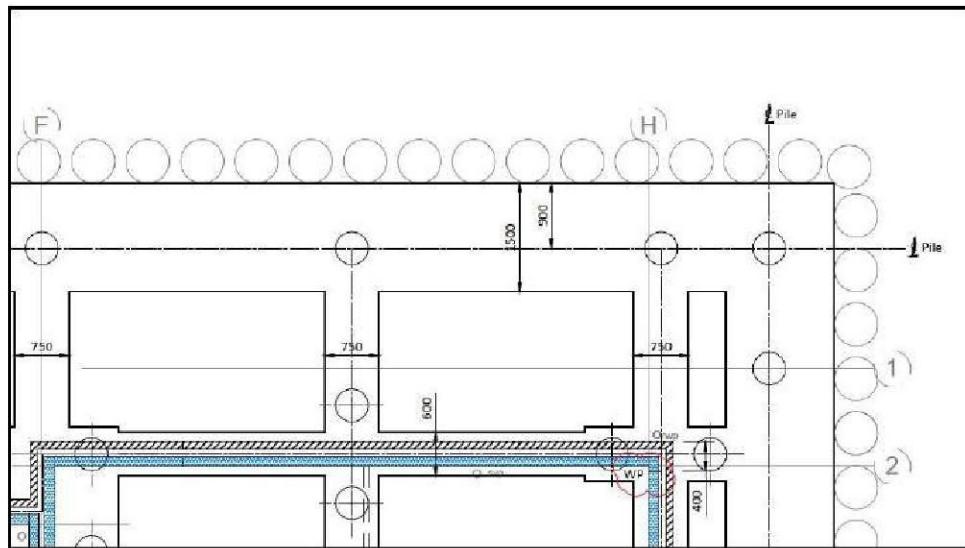
The extract of a similar scheme drawing shows how a piled retaining wall was propped by ground beams into the foundations of the associated dwellings as an example of how this has been done in the area previously.

Figure 3.3 – shows extract of similar scheme where ground beams act as props to a piled retaining wall and brace the wall into the main structure to ensure deflections within limits.

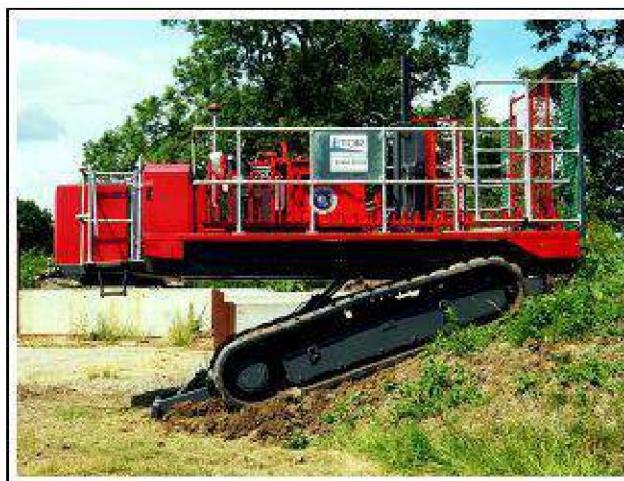
Specialist piling plant is available from specialist contractors that are designed specifically to access steep slopes – as steep as 1 in 1 in some instances. This plant has very wide tracks to ensure imposed loads generated are within the tolerance of the site soil conditions and as soon as piles are commenced then stability improves. An example is shown below.

Figure 3.4 – specialist piling rig for steep slopes © TOR Drilling

By use of a specialist rig it will be possible to install the initial run of piles. That will in effect provide the Temporary Works support to allow excavations down to foundation level for the new buildings and the casting in of ground beams and additional propping support for the piled wall to thus ensure long term stability. All of this would require extensive detailed design by the specialist piling contractors taking full account of the findings of the Site Investigation and Slope Stability calculations therein, but it is entirely possible even on a site as constrained as this one. Once the main wall and supporting building foundations are in place then the remainder of the site can be built out using normal construction techniques. As the slope above the site would be unchanged, and all planting left intact the stability of that would also be ensured.

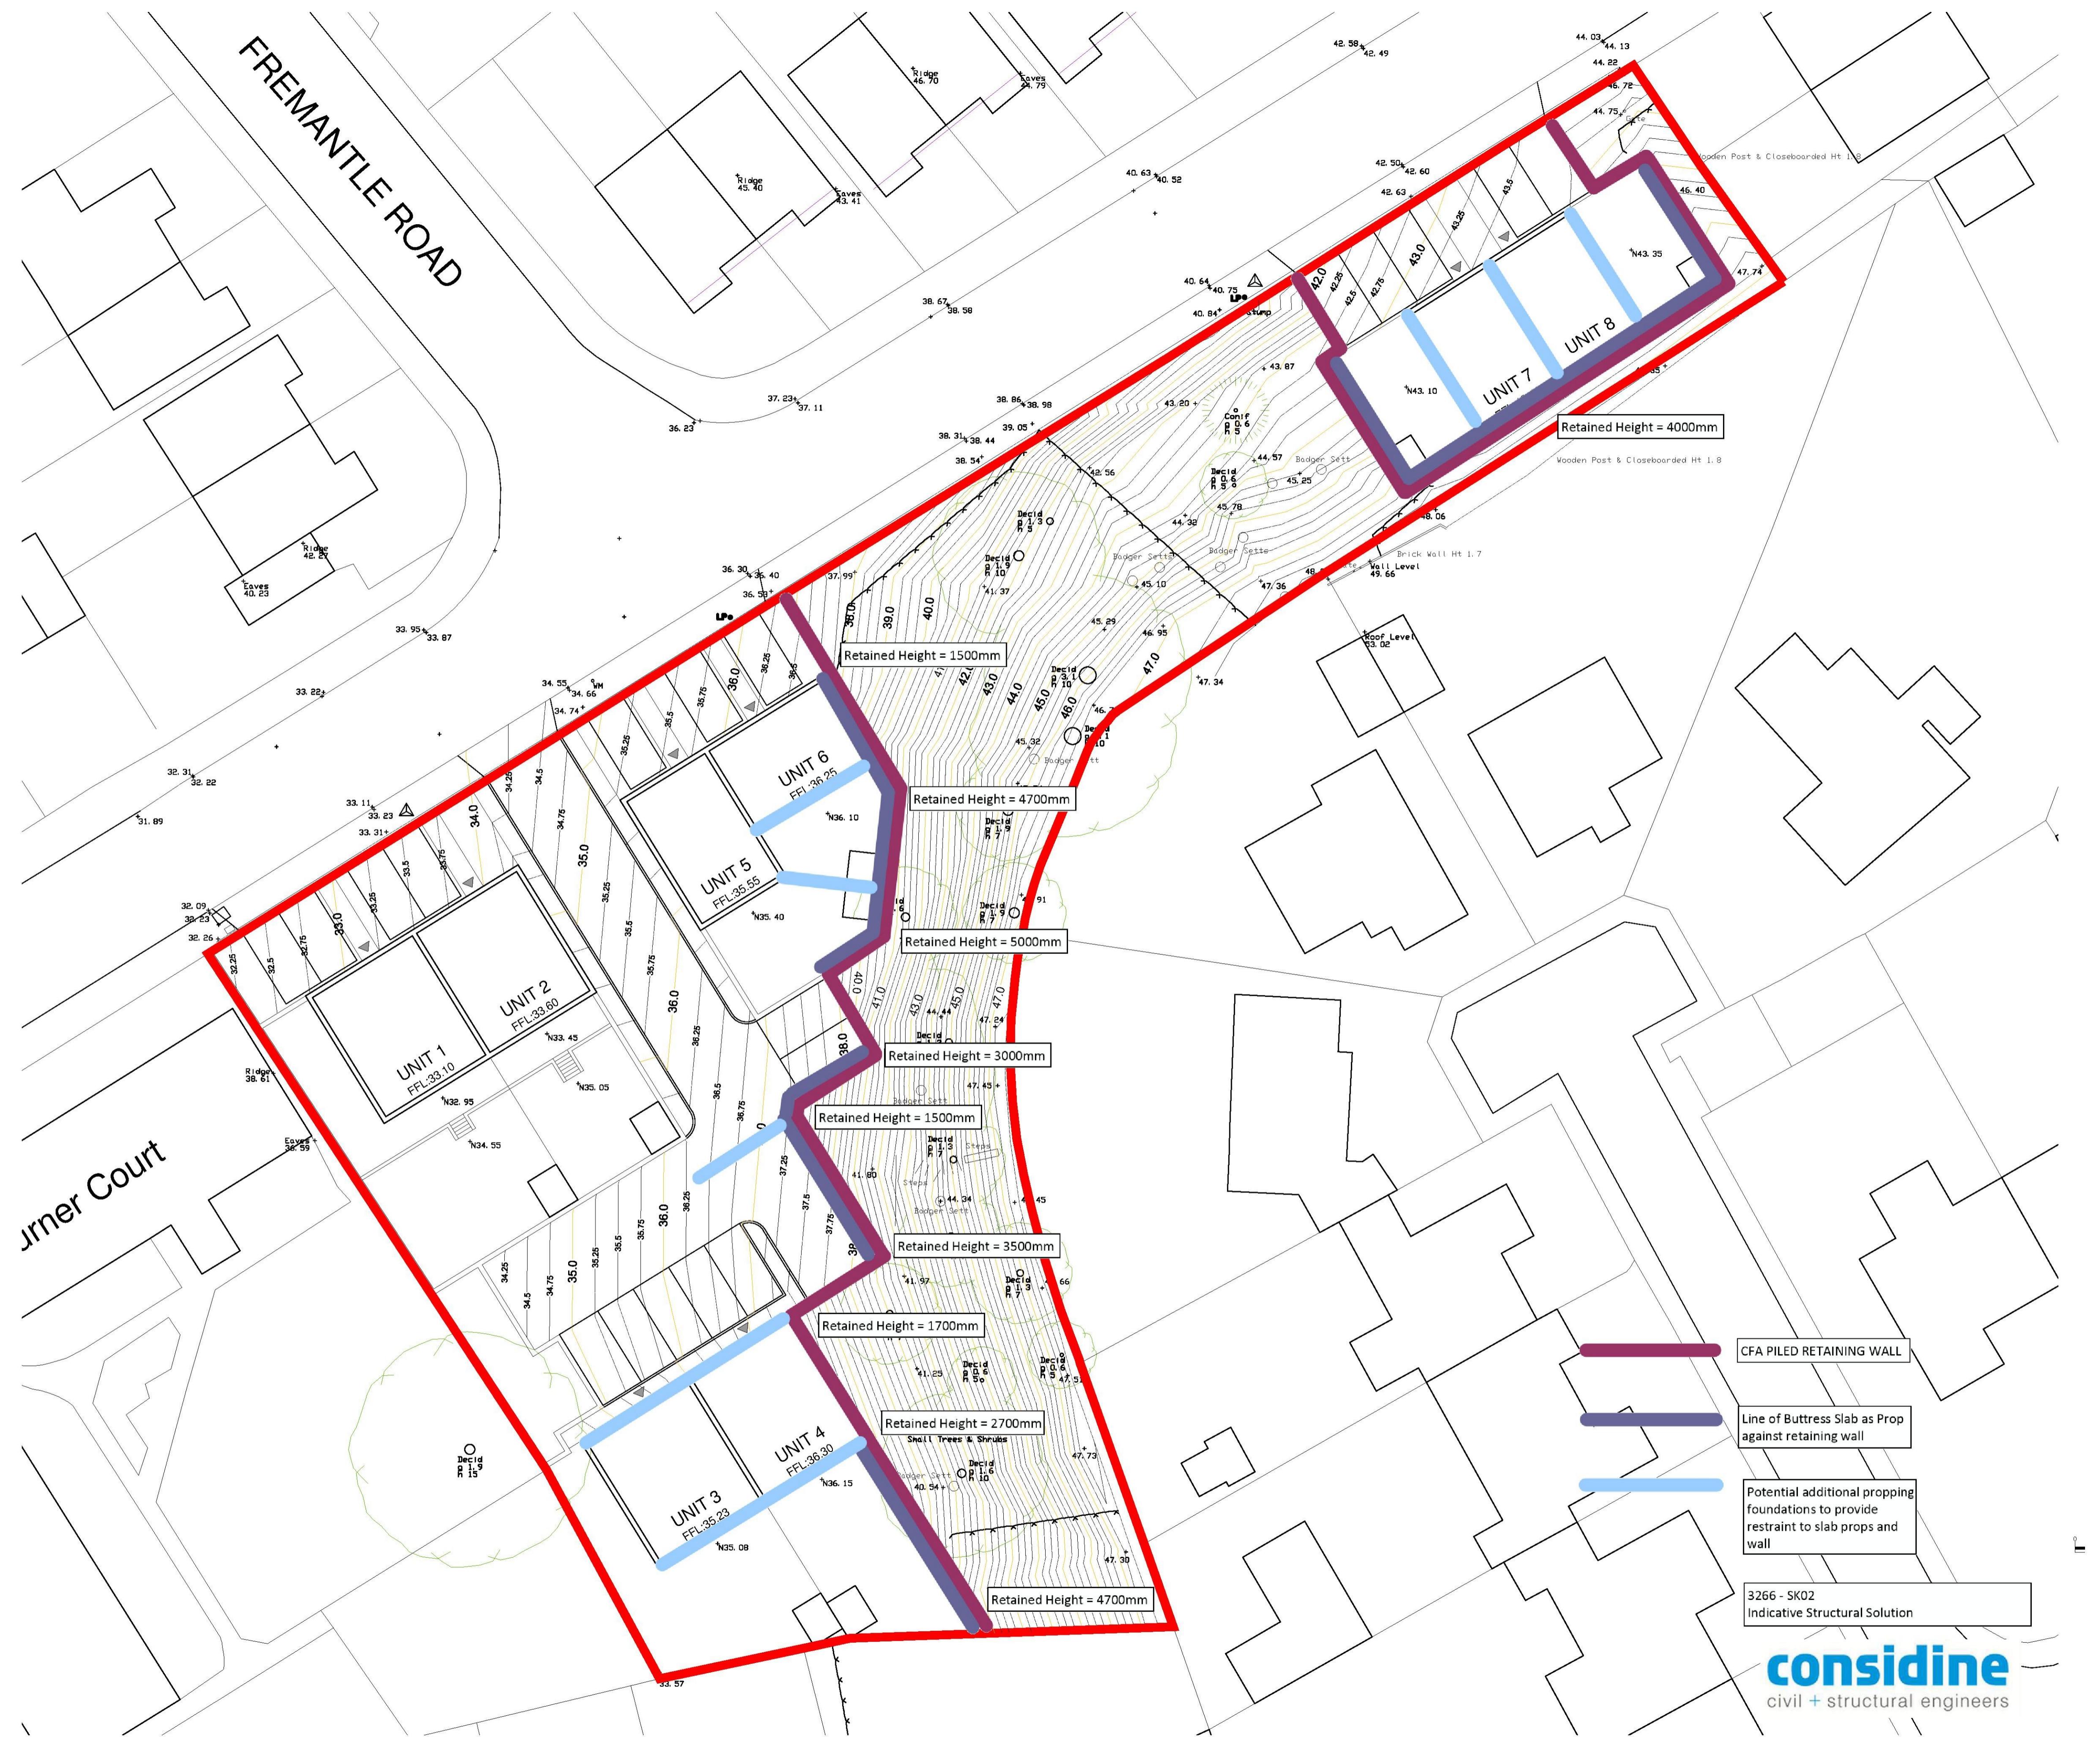
Sketch showing Retained Heights around the site

The cuttings to form the new dwellings will require significant retaining solutions up to 5.00m in height as shown on sketch SK01 at Appendix 2.
