DETAILED UXO RISK ASSESSMENT

STAGE 2 DETAILED UXO RISK ASSESSMENT

Client: IDOM
Project Ref: IDOM95R
Site: Swanstree Avenue, Sittingbourne
Report Ref: DRA-23-1577-IDOM95R-SwanstreeAvenue,Sittingbourne
Revision: 0
Status: Final
Release Date: 26th July 2023

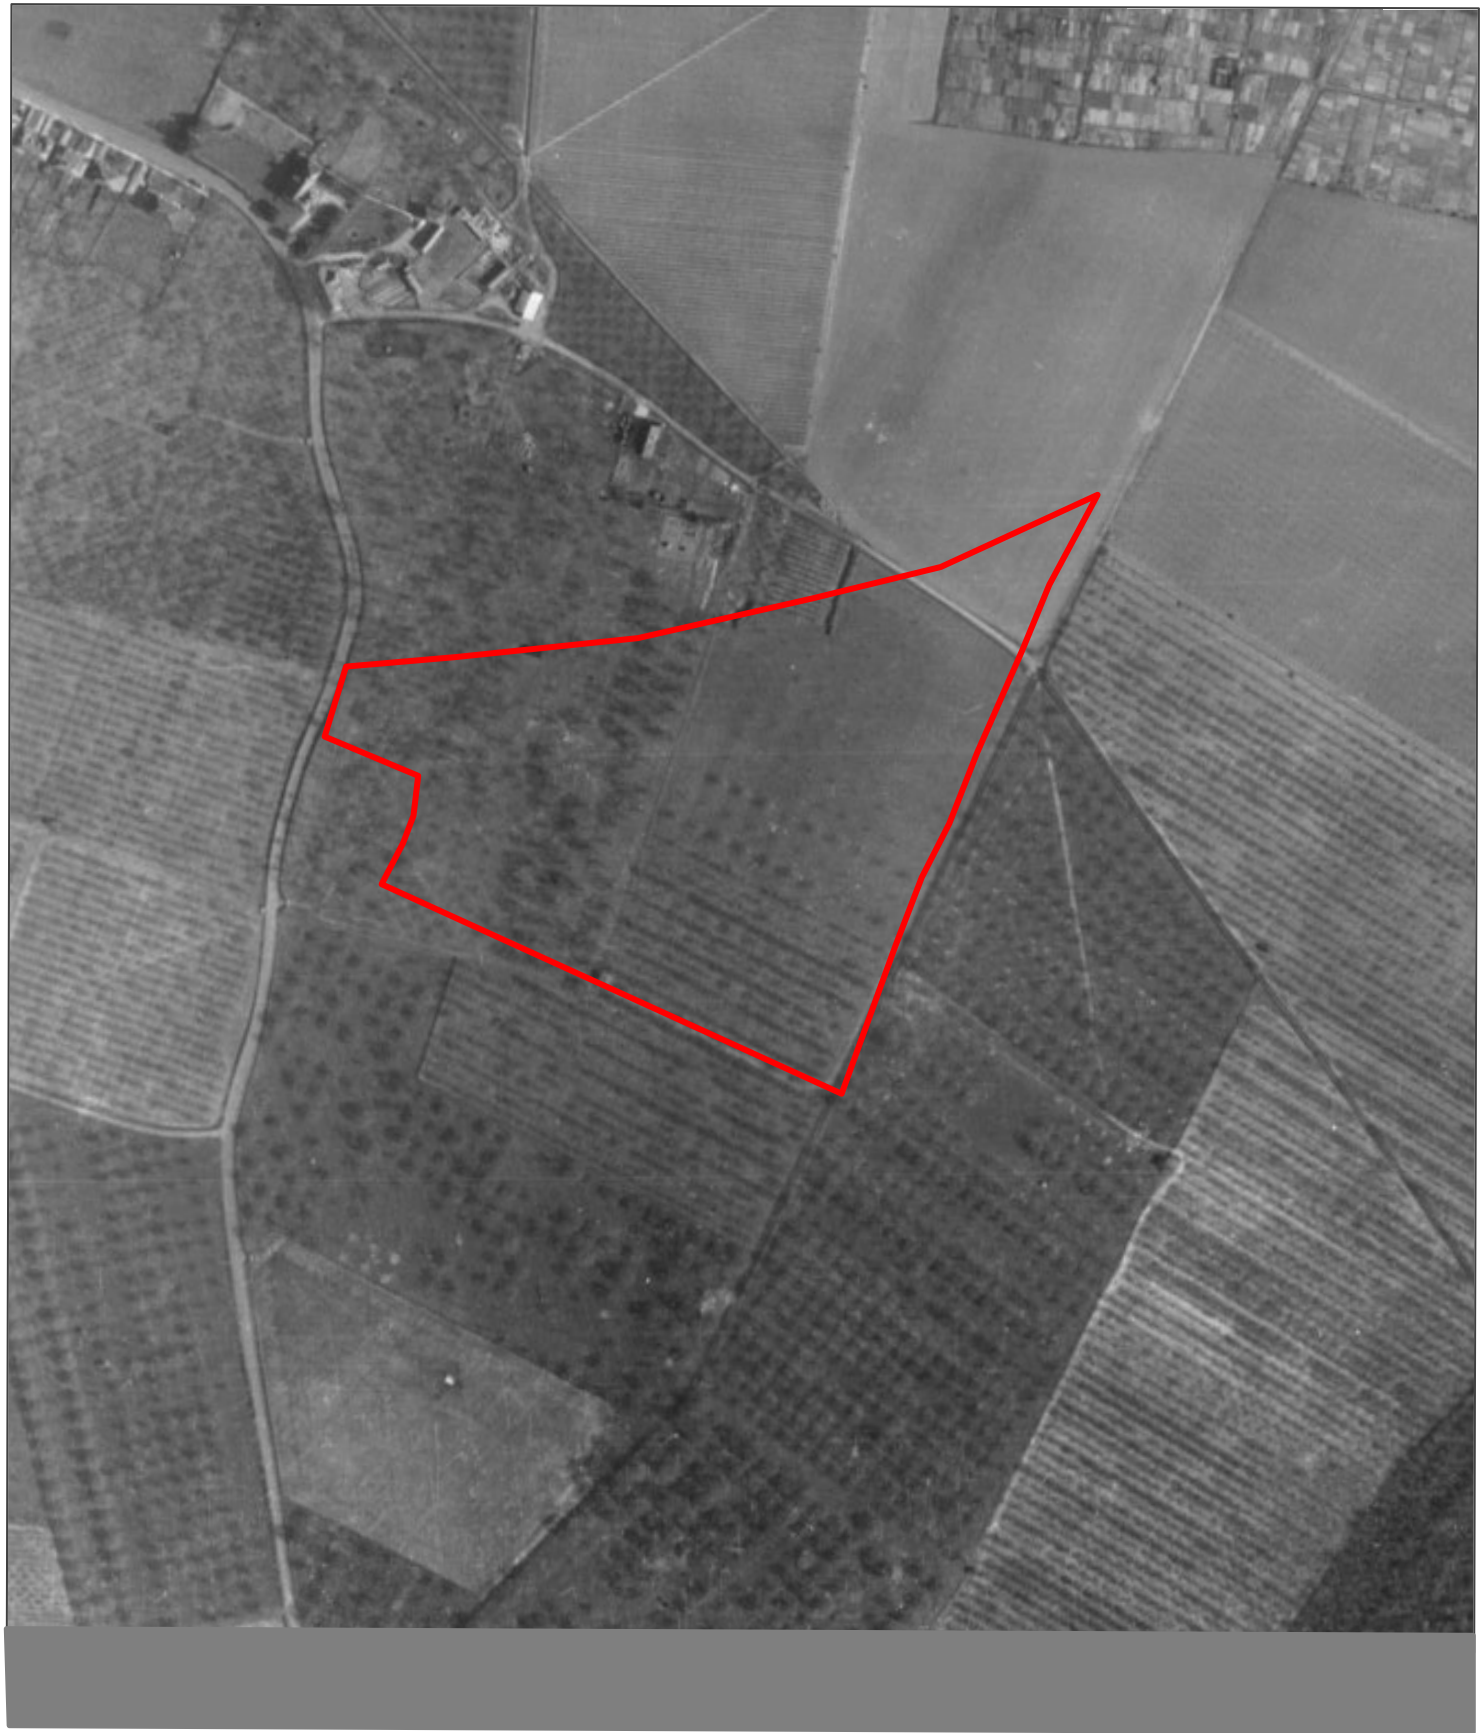
FIGURE: 4.3

FIGURE 4.3: The full Site is visible within this aerial image. The Site comprises orchards in the east and south, with open ground in the north-east. A section of a wall/pit associated with the structure to the north encroaches within the northern Site boundary. A small hut structure appears to be visible along the southern boundary. There does not appear to be any evidence of bombing on Site or its immediate surrounds.

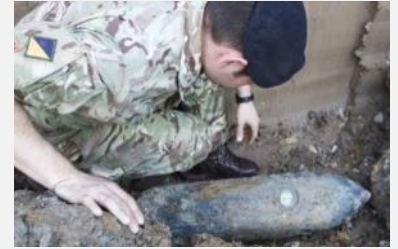
SC 50

Bomb Weight: 40-54kg (110-119lb)
Explosive Weight: 25kg (55lb)
Filling: TNT, Amatol or Trialen
Charge/Weight Ratio: 46%
Fuse Type: Electrical impact fuse or mechanical delayed action fuse
Body Dimensions: 1,100mm length x 200mm diameter
Appearance: Bomb body and tail painted grey/green with a yellow stripe on the tail unit. Steel construction.
Variants: 8 x variants. Additional fittings: Kopfring nose for limited penetration and Stabbo nose for dive-bombing.

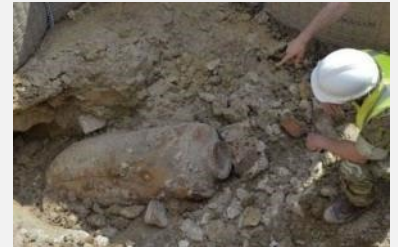
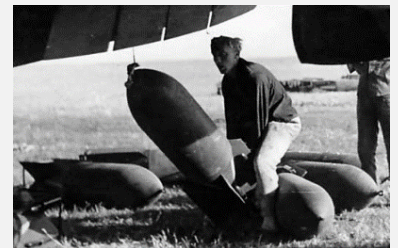
SC 250

Bomb Weight: 245-256kg (540-564lb)
Explosive Weight: 125-130kg (276-287lb)
Filling: TNT, Amatol and Trialen mix
Charge/Weight Ratio: 44%
Fuse Type: 1 or 2 electrical impact fuse(s) or mechanical delayed action fuse(s)
Body Dimensions: 1,173mm length x 368mm diameter
Appearance: Bomb body and tail painted grey/green with a yellow stripe on the tail unit. Steel construction.
Variants: 8 x variants. Kopfring nose for limited penetration. Stabbo nose for dive-bombing.

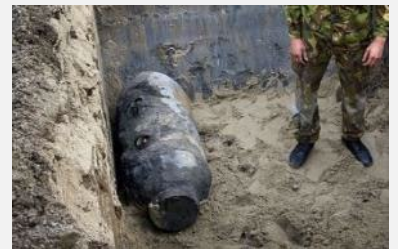
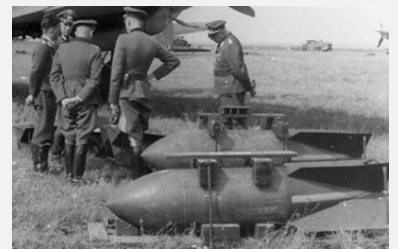
SC 500

Bomb Weight: 480-520kg (1,058-1,146lb)
Explosive Weight: 220kg (485lb)
Filling: TNT, Amatol and Trialen mix
Charge/Weight Ratio: 44%
Fuse Type: 2 electrical impact fuses or mechanical delayed action fuses
Body Dimensions: 1,423mm length x 470mm diameter
Appearance: Bomb body and tail painted grey/green or buff with a yellow stripe on the tail unit. Steel construction.
Variants: 3 x variants. Kopfring nose for limited penetration.

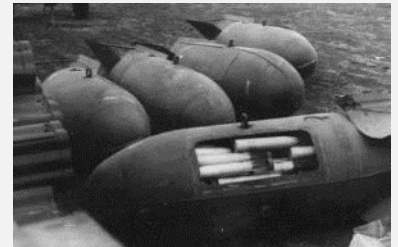
B-1E Sub-Munition

Bomb Weight:	1-1.3kg (2.2-2.87lb)
Incendiary Weight:	680g (1.4lb)
Filling:	Thermite
Fuse Type:	Simple impact fuse
Body Dimensions:	247mm length x 50mm diameter
Appearance:	Grey body and dark green painted tail unit. Magnesium alloy case.
Operation:	Small percussion charge ignites Thermite (>1,000°C burn).
Variants:	Most common variant: B 2EZ (2kg) included a small HE charge
Remarks:	Drop containers varied in size. The smallest cluster bomb held 36 x B-1Es and the largest 620 x B-1Es.

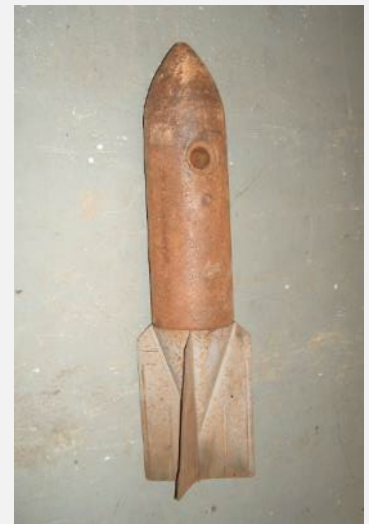
Brand C50

Bomb Weight:	41kg (90.4lb)
Incendiary Weight:	13kg (30lb)
Filling:	Main fill (86% Benzine, 10% Rubber) plus 4% Phosphorus in glass bottles
Fuse Type:	1 x electrical impact fuse
Bomb Dimensions:	762mm length x 203mm diameter
Appearance:	bomb body and tail painted grey or green with the rear of the bomb painted red and a red band around the centre of the body.
Variants:	C 50 B: 77% White Phos fill C 250 A: 87.7% Petroleum, 11.7% Polystyrene, 0.5% White Phos (185kg version)

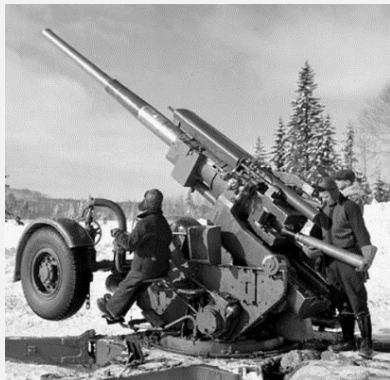
LAA Battery - 40mm Bofors Shell

Shell Weight: 0.84kg

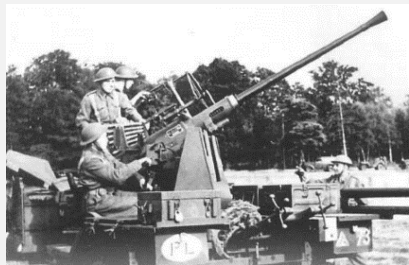
Variants: HE or AP shells. Both with rear tracer compartment

SHELL, Q.F. HIGH EXPLOSIVE, 40 MM.

The 40mm Bofors gun could fire 120 x HE shells / minute to a ceiling of 1,800m. Each shell was designed to self-destruct if it didn't strike an aircraft, however, inevitably some failed and fell back to earth.

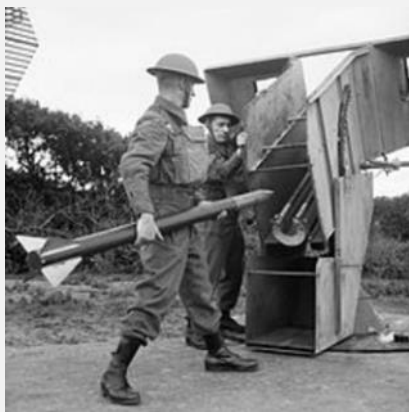
Z Battery - 3" U.P Rocket

Rocket Weight: 24.5kg

Ceiling: 6,770m

Operation: Fired from single, tandem and (later) 36 x rail launchers (Z Batteries). Limited use throughout the UK.
