**VILLAGE HOMES FOLKESTONE LTD**

**SITE AT ROMNEY AVENUE, FOLKESTONE CT20 3AJ**

**GEOENVIRONMENTAL SITE INVESTIGATION AND  
SLOPE STABILITY REPORT**

**Reference: 1145/SI 2.0**

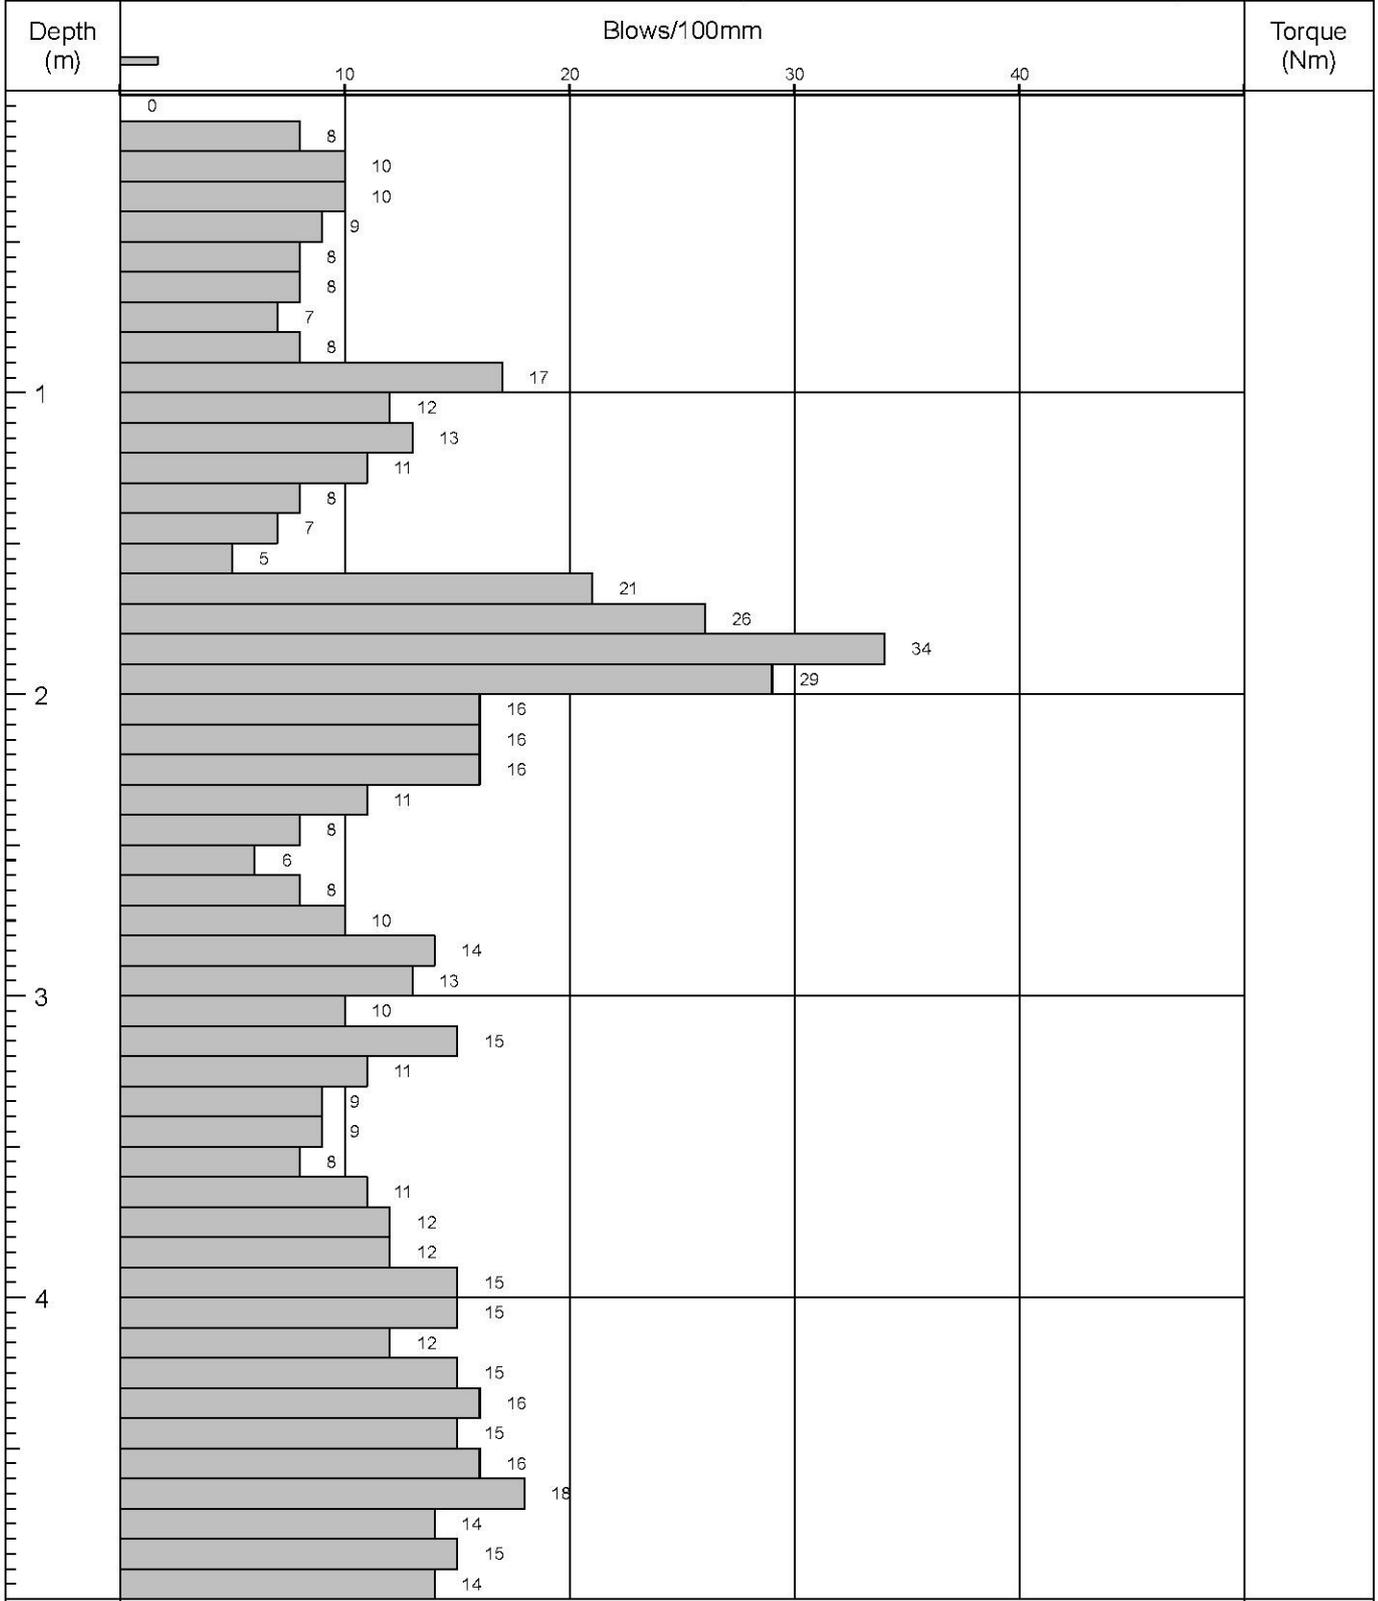
Remarks:	Fall Height	300	Cone Base Diameter	
	Hammer Wt	63	Final Depth	7.00
	Probe Type	DPH

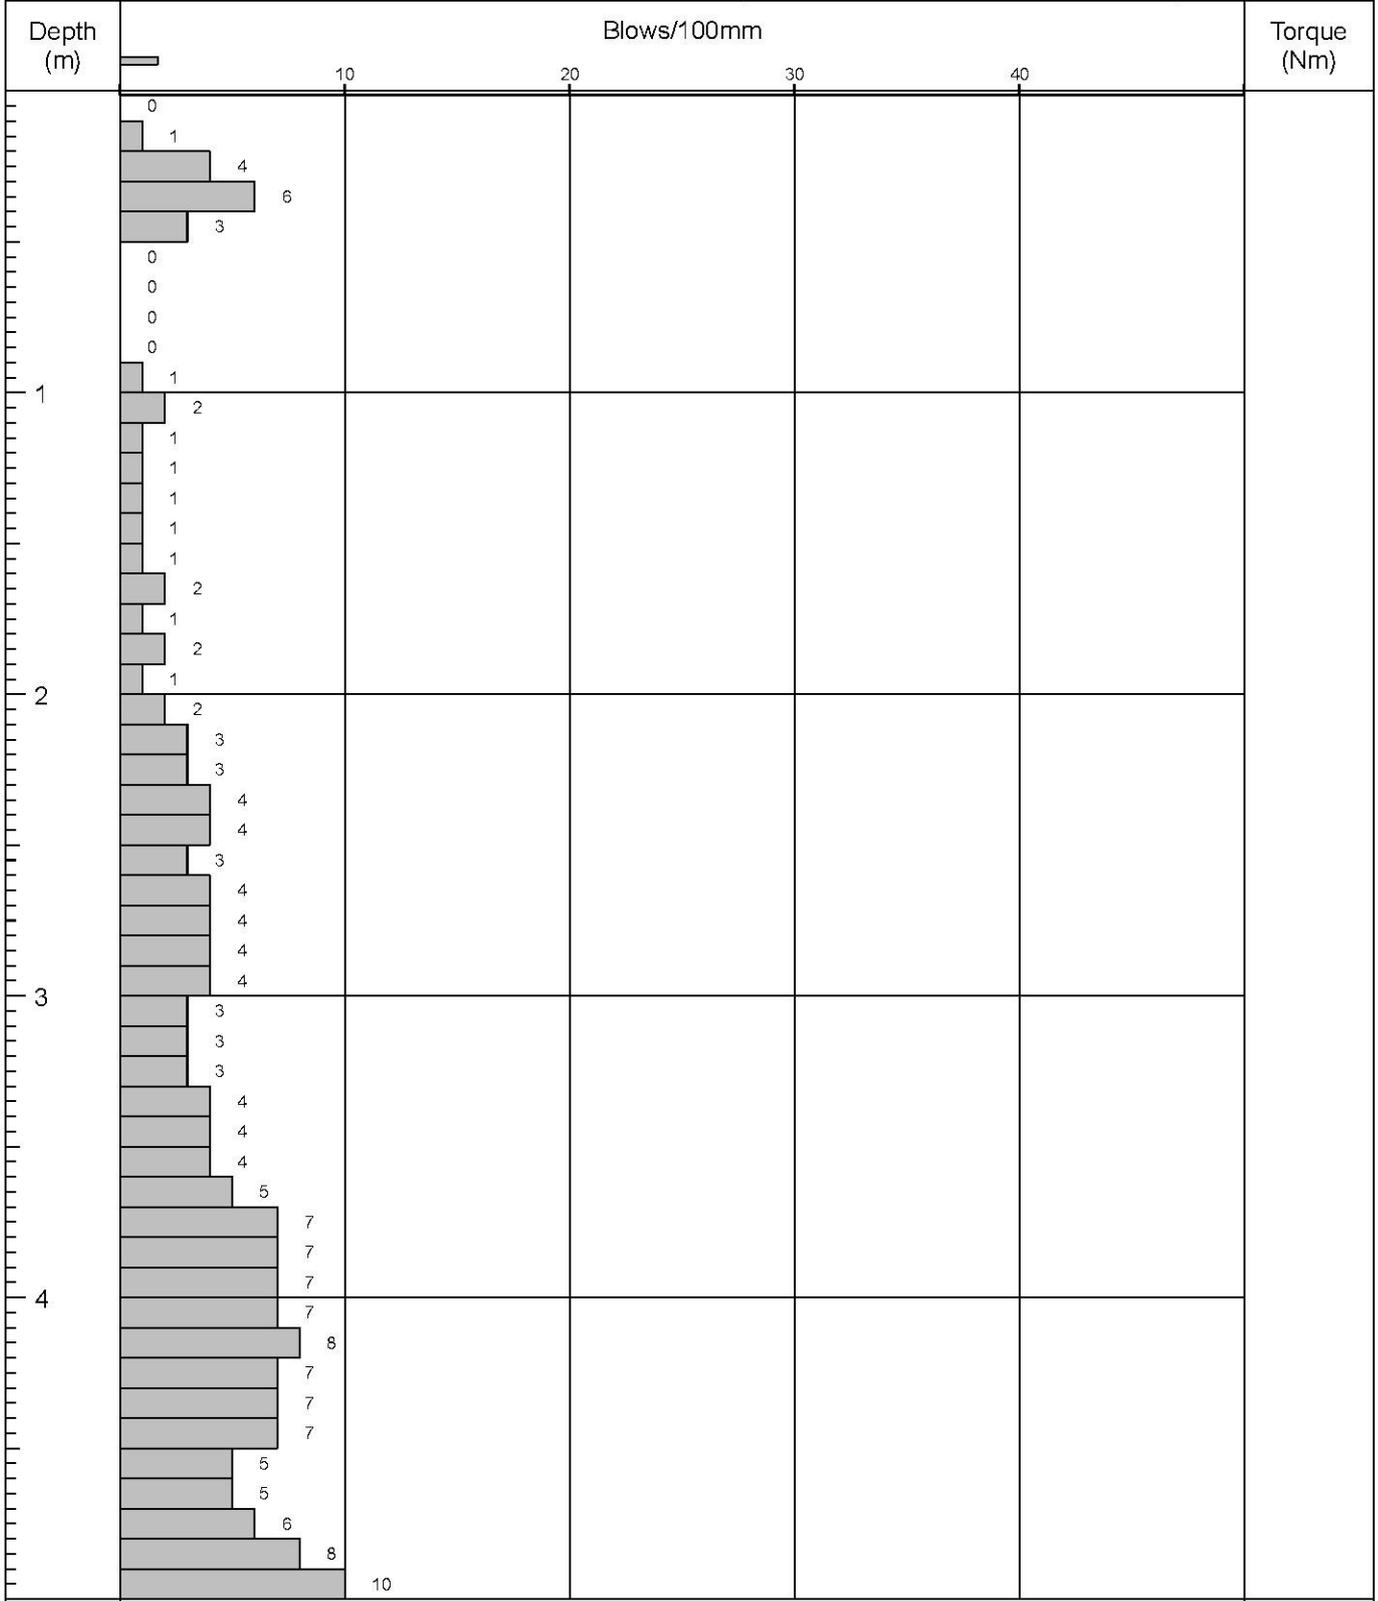
Remarks:	Fall Height	750	Cone Base Diameter	
	Hammer Wt	63	Final Depth	6.00
	Probe Type	DPH

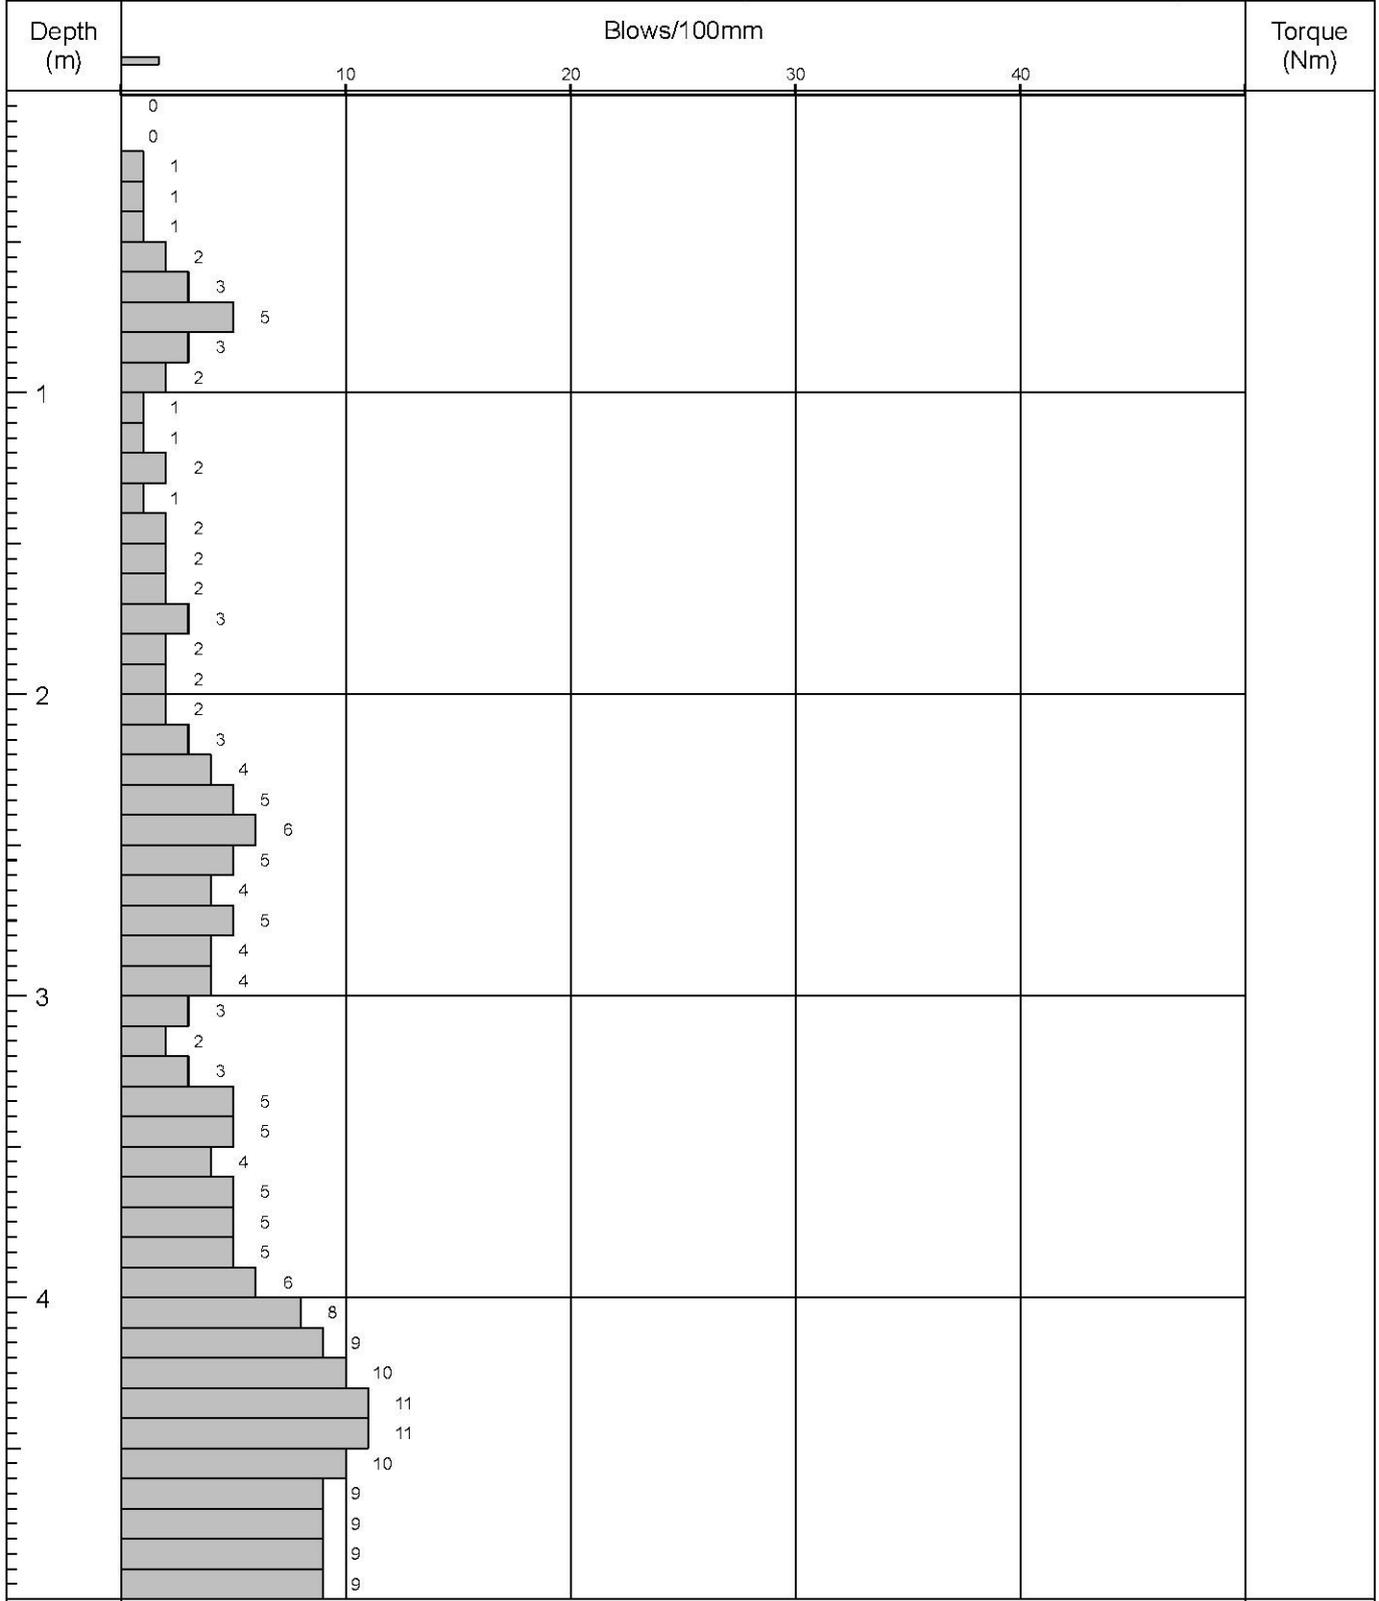
Remarks:	Fall Height	750	Cone Base Diameter	
	Hammer Wt	63	Final Depth	6.00
	Probe Type	DPH

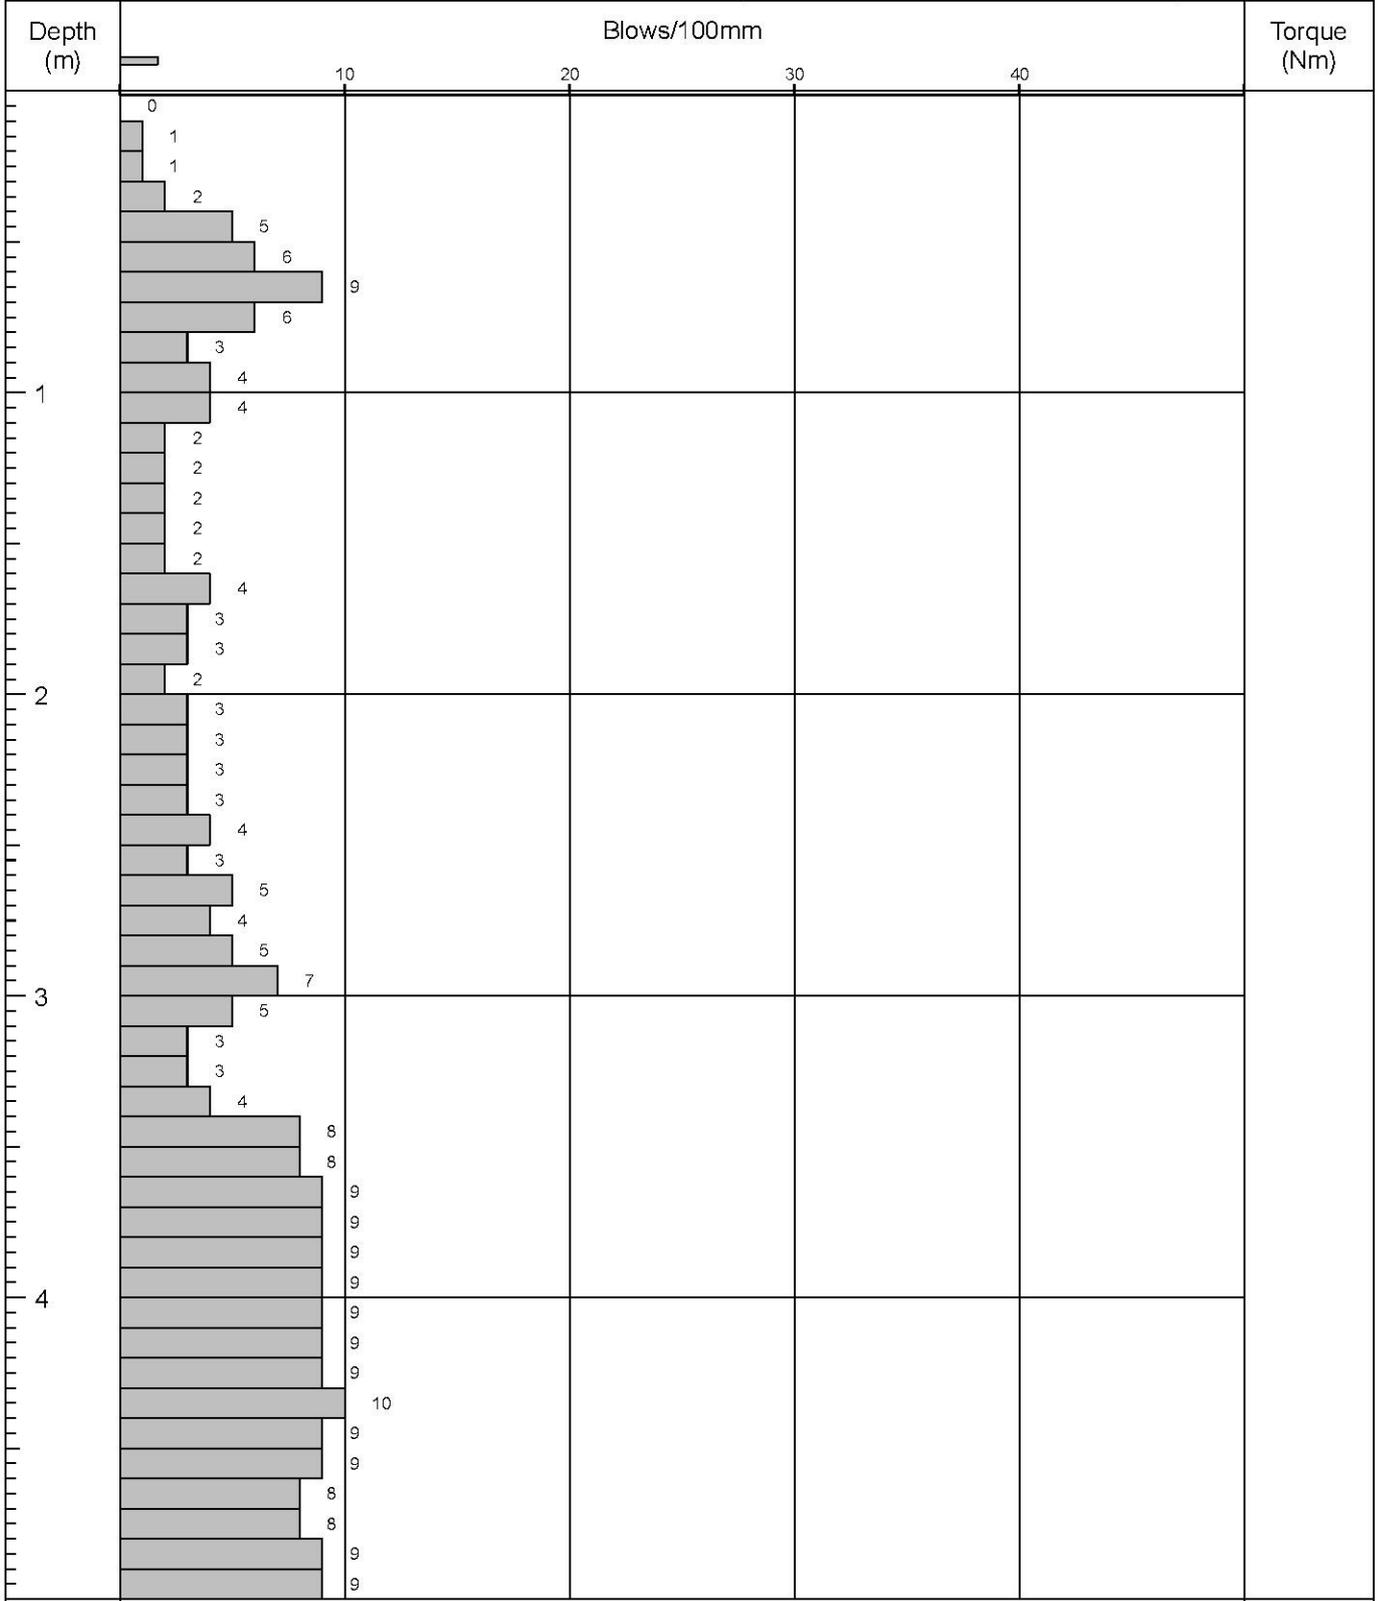
Remarks:	Fall Height	750	Cone Base Diameter	
	Hammer Wt	63	Final Depth	6.00
	Probe Type	DPH

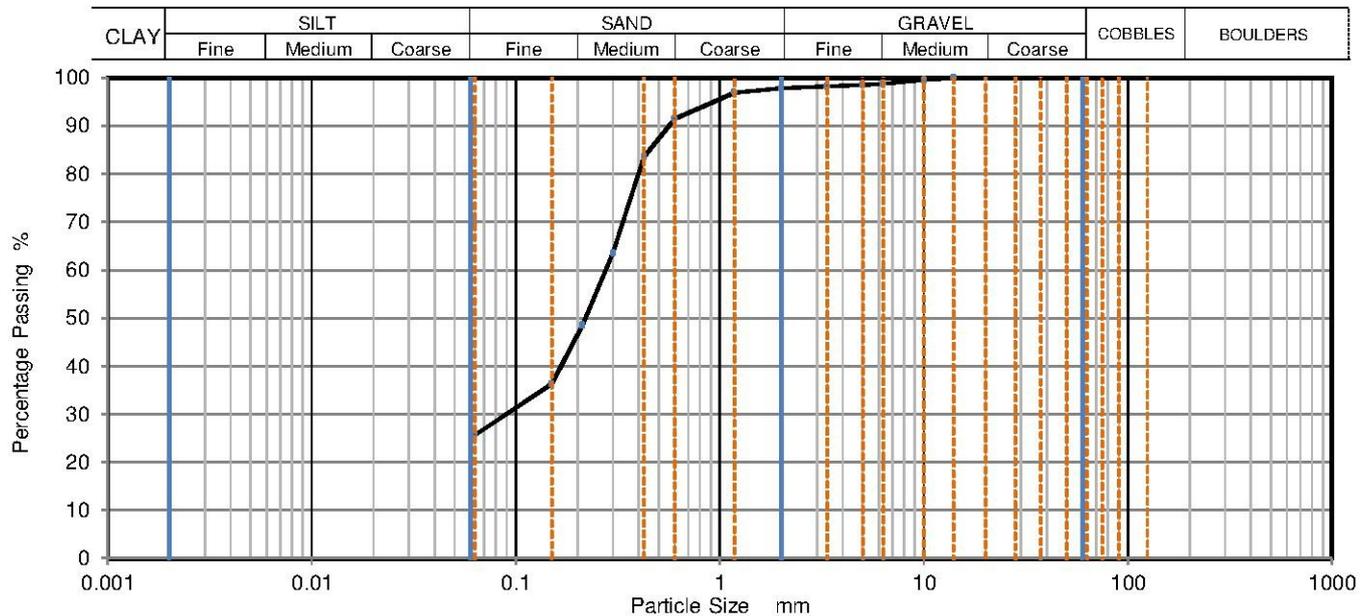
<b>PARTICLE SIZE DISTRIBUTION</b>				Job Ref	<b>1145</b>
				Borehole/Pit No.	WS1
Site Name	Romney Avenue, Folkestone			Sample No.	3
Soil Description				Depth, m	3.30
Specimen Reference	2	Specimen Depth	m	Sample Type	D
Test Method	BS1377:Part 2:1990, clause 9.2			KeyLAB ID	PBAL201810032

Sieving		Sedimentation	
Particle Size mm	% Passing	Particle Size mm	% Passing
14	100		
10	100		
6.3	99		
5	99		
3.35	98		
2	98		
1.18	97		
0.6	91		
0.425	84		
0.3	64		
0.212	49		
0.15	36		
0.063	26

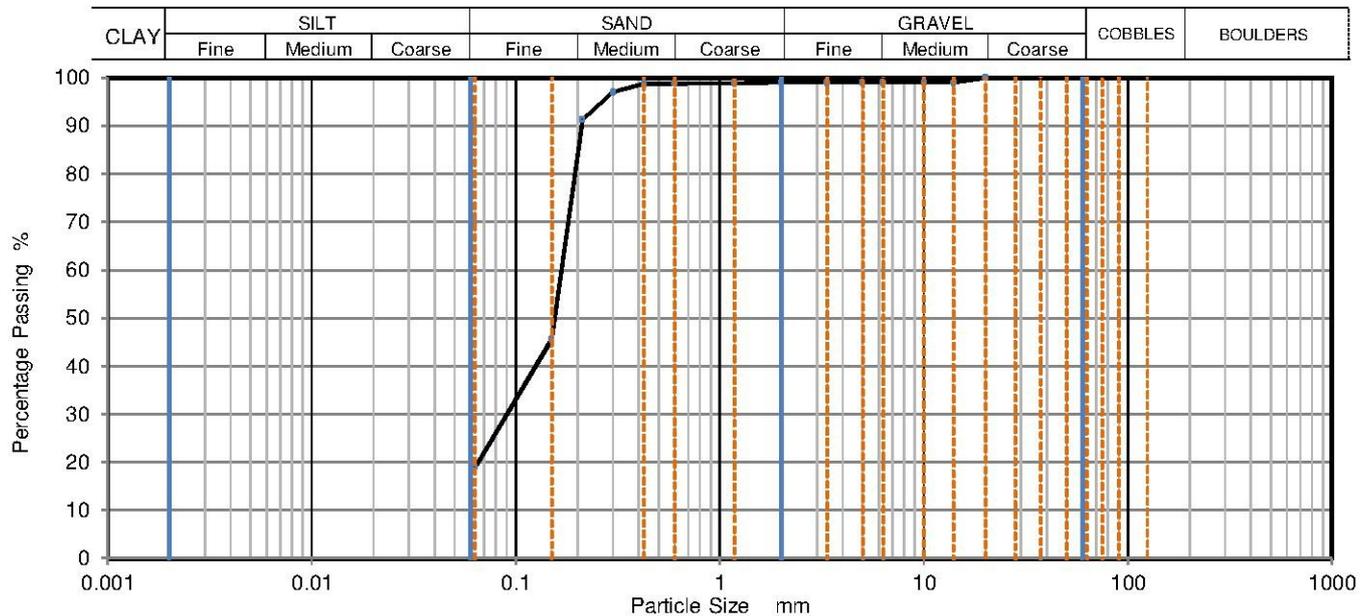
<b>PARTICLE SIZE DISTRIBUTION</b>				Job Ref	<b>1145</b>
				Borehole/Pit No.	WS1
Site Name	Romney Avenue, Folkestone			Sample No.	4
Soil Description	Olive grey brown clayey silty SAND			Depth, m	4.00
Specimen Reference	3	Specimen Depth	m	Sample Type	D
Test Method	BS1377:Part 2:1990, clause 9.2			KeyLAB ID	PBAL201810033

Sieving		Sedimentation	
Particle Size mm	% Passing	Particle Size mm	% Passing
20	100		
14	99		
10	99		
6.3	99		
5	99		
3.35	99		
2	99		
1.18	99		
0.6	99		
0.425	99		
0.3	97		
0.212	91		
0.15	46		
0.063	19

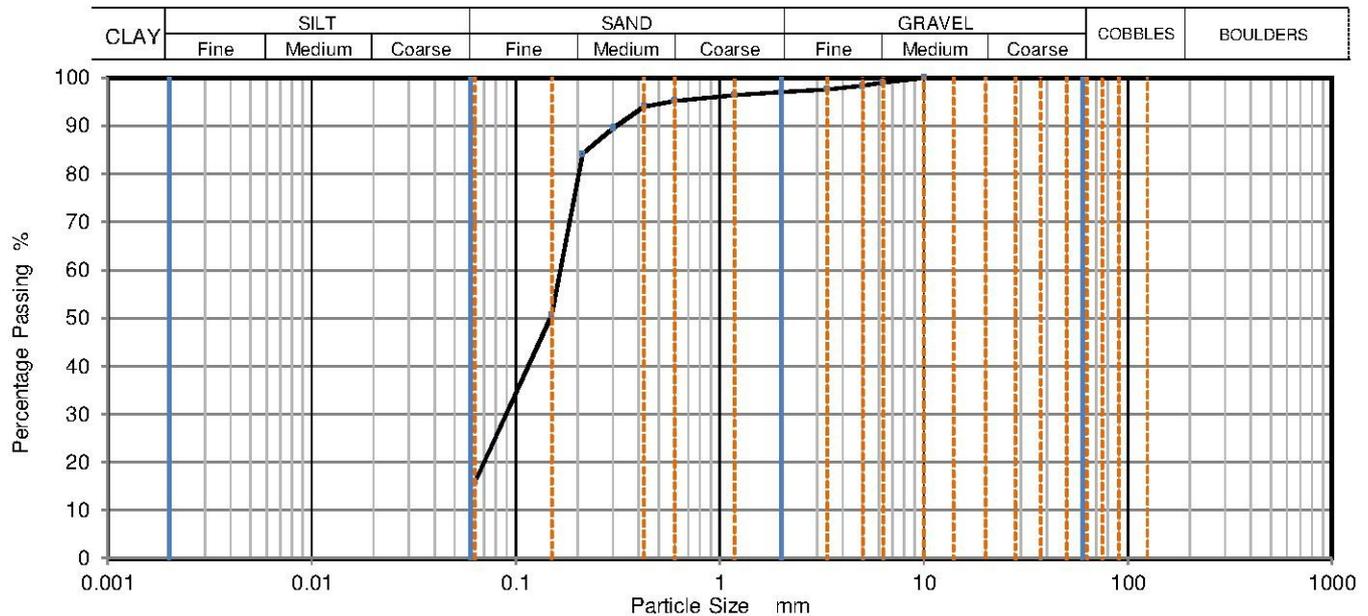
<b>PARTICLE SIZE DISTRIBUTION</b>				Job Ref	<b>1145</b>
				Borehole/Pit No.	BH1
Site Name	Romney Avenue, Folkestone			Sample No.	2
Soil Description	Grey silty SAND			Depth, m	1.50
Specimen Reference	2	Specimen Depth	m	Sample Type	B
Test Method	BS1377:Part 2:1990, clause 9.2			KeyLAB ID	PBAL201810081

Sieving		Sedimentation	
Particle Size mm	% Passing	Particle Size mm	% Passing
10	100		
6.3	99		
5	98		
3.35	98		
2	97		
1.18	96		
0.6	95		
0.425	94		
0.3	90		
0.212	84		
0.15	51		
0.063	16

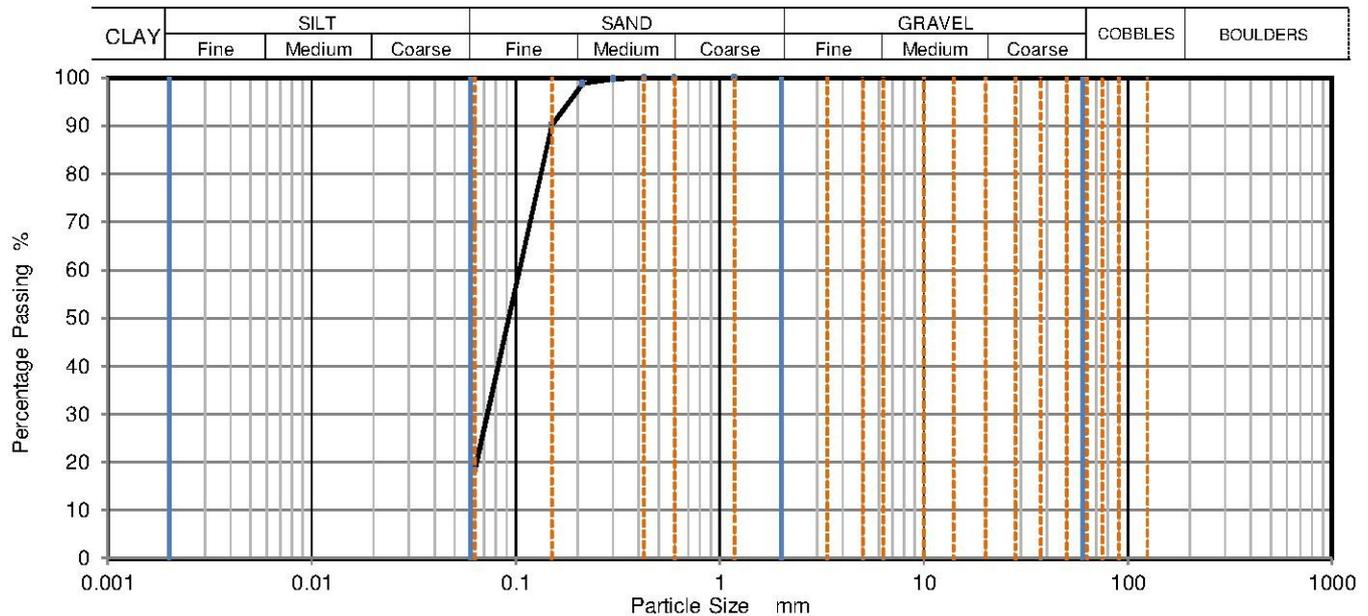
<b>PARTICLE SIZE DISTRIBUTION</b>				Job Ref	<b>1145</b>
				Borehole/Pit No.	BH1
Site Name	Romney Avenue, Folkestone			Sample No.	14
Soil Description	Grey silty SAND			Depth, m	9.50
Specimen Reference	2	Specimen Depth	m	Sample Type	B
Test Method	BS1377:Part 2:1990, clause 9.2			KeyLAB ID	PBAL2018100813

Sieving		Sedimentation	
Particle Size mm	% Passing	Particle Size mm	% Passing
1.18	100		
0.6	100		
0.425	100		
0.3	100		
0.212	99		
0.15	90		
0.063	18

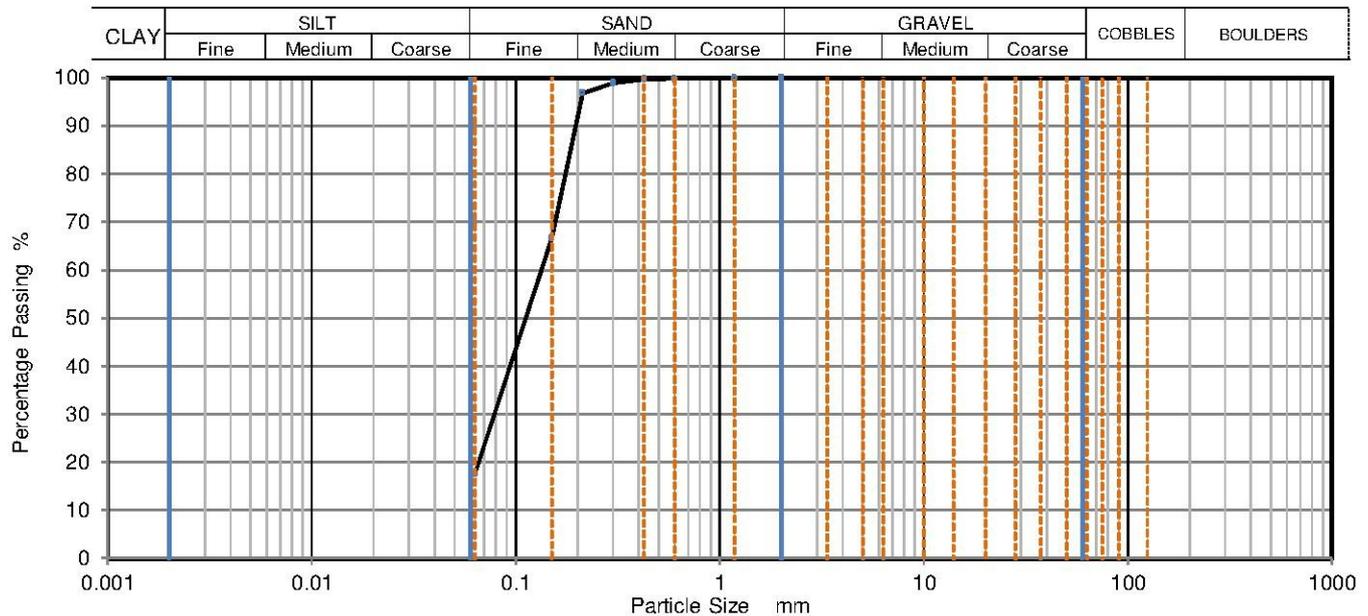
<b>PARTICLE SIZE DISTRIBUTION</b>				Job Ref	<b>1145</b>
				Borehole/Pit No.	BH1
Site Name	Romney Avenue, Folkestone			Sample No.	19
Soil Description	Grey silty SAND			Depth, m	15.00
Specimen Reference	2	Specimen Depth	m	Sample Type	D
Test Method	BS1377:Part 2:1990, clause 9.2			KeyLAB ID	PBAL2018100818

Sieving		Sedimentation	
Particle Size mm	% Passing	Particle Size mm	% Passing
2	100		
1.18	100		
0.6	100		
0.425	100		
0.3	99		
0.212	97		
0.15	67		
0.063	18

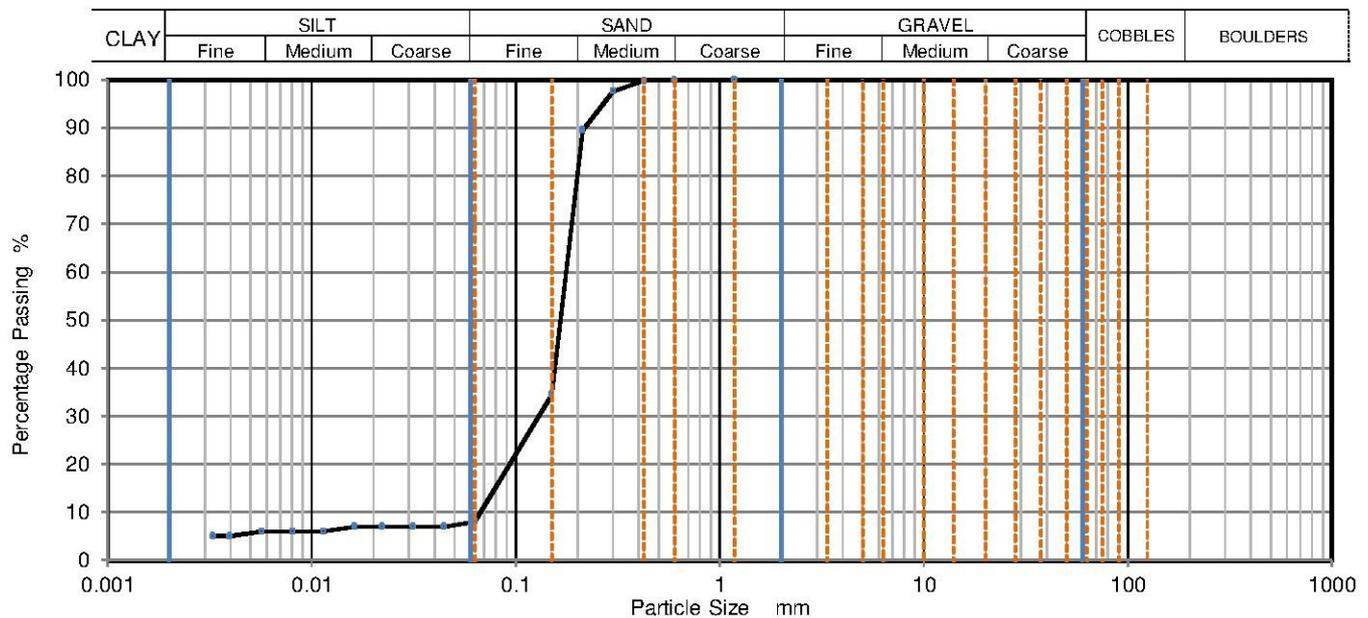
PARTICLE SIZE DISTRIBUTION				Job Ref	1145
				Borehole/Pit No.	WS4
Site Name	Romney Avenue, Folkestone			Sample No.	2
Soil Description	Grey brown clayey SAND			Depth, m	1.40
Specimen Reference	1	Specimen Depth	m	Sample Type	D
Test Method	BS1377:Part 2:1990, clauses 9.2 and 9.5			KeyLAB ID	PBAL2018101514

Sieving		Sedimentation	
Particle Size mm	% Passing	Particle Size mm	% Passing
		0.0630	8
		0.0631	8
		0.0445	7
		0.0314	7
		0.0222	7
		0.0162	7
		0.0114	6
		0.0081	6
		0.0057	6
		0.0040	5
		0.0033	5
		0.0017	5
		0.0017	5
1.18	100		
0.6	100		
0.425	100		
0.3	98		
0.212	90		
0.15	35		
0.063	8		
		Particle density (assumed)	
		2.68	Mg/m <sup>3</sup>

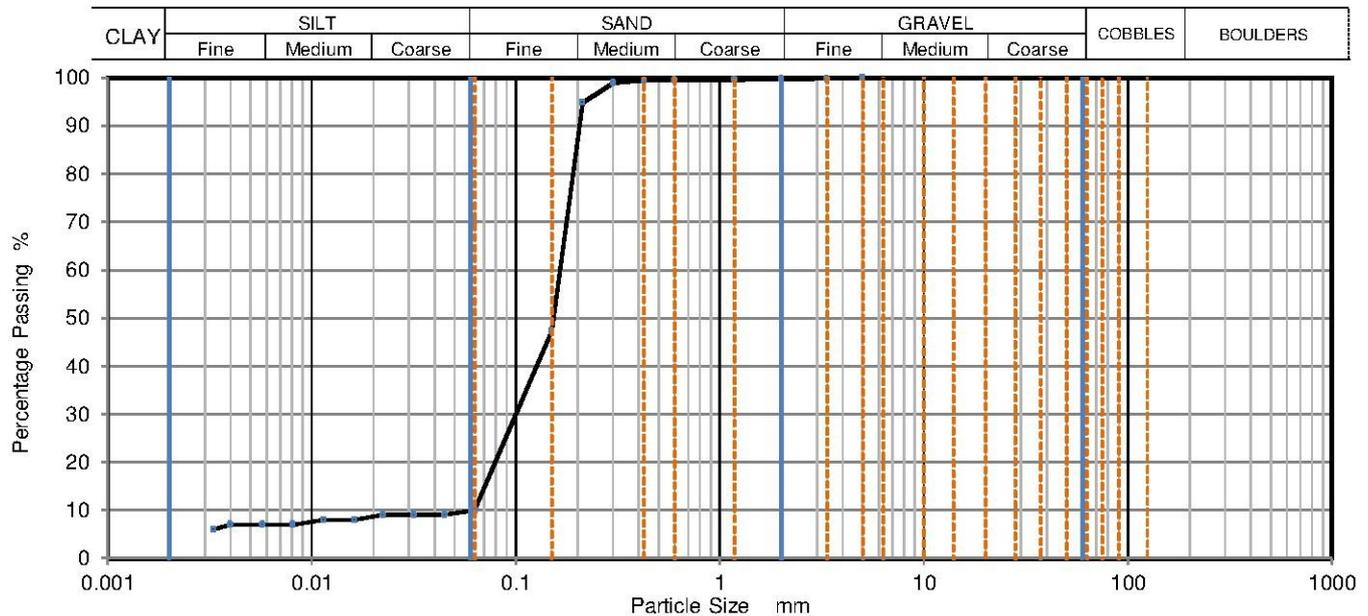
<b>PARTICLE SIZE DISTRIBUTION</b>				Job Ref	<b>1145</b>
				Borehole/Pit No.	BH2
Site Name	Romney Avenue, Folkestone			Sample No.	2
Soil Description	Grey brown clayey SAND			Depth, m	1.50
Specimen Reference	1	Specimen Depth	m	Sample Type	B
Test Method	BS1377:Part 2:1990, clauses 9.2 and 9.5			KeyLAB ID	PBAL2018100829

Sieving		Sedimentation	
Particle Size mm	% Passing	Particle Size mm	% Passing
		0.0630	10
		0.0635	10
		0.0448	9
		0.0316	9
		0.0223	9
		0.0162	8
		0.0114	8
		0.0081	7
		0.0057	7
		0.0040	7
		0.0033	6
		0.0017	6
5	100	0.0017	6
3.35	100		
2	100		
1.18	100		
0.6	100		
0.425	99	Particle density (assumed)	
0.3	99	2.68 Mg/m <sup>3</sup>	
0.212	95		
0.15	47		
0.063	10

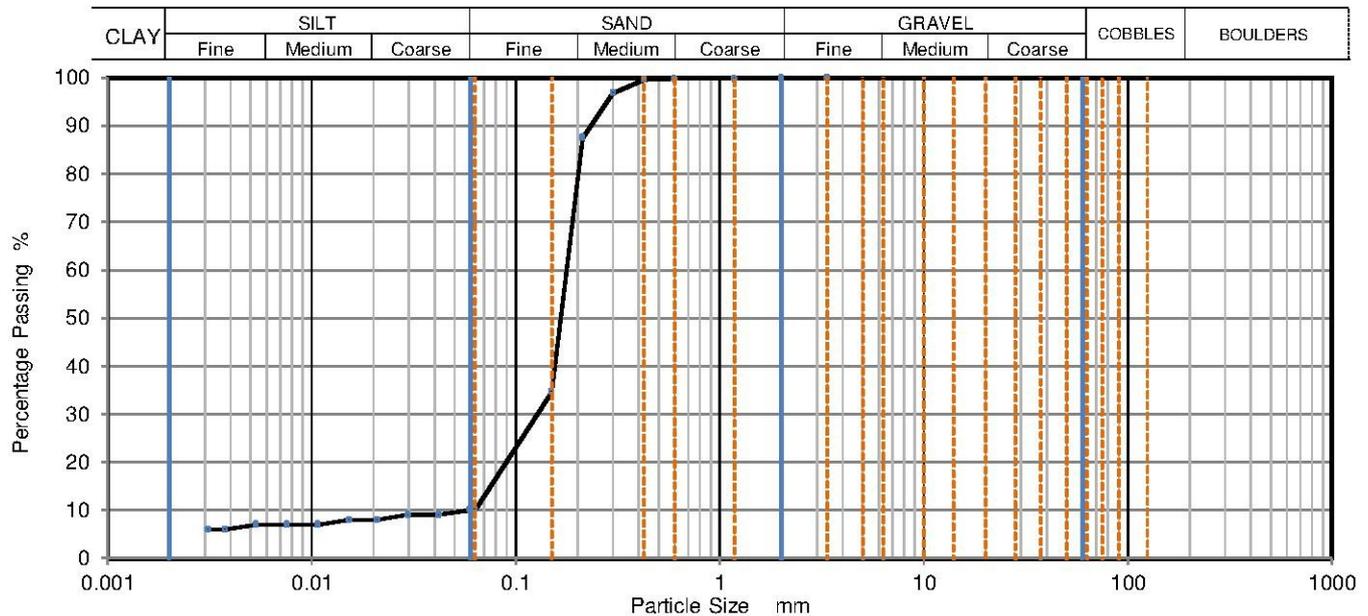
<b>PARTICLE SIZE DISTRIBUTION</b>				Job Ref	<b>1145</b>
				Borehole/Pit No.	WS3
Site Name	Romney Avenue, Folkestone			Sample No.	2
Soil Description	Grey brown clayey SAND			Depth, m	1.50
Specimen Reference	1	Specimen Depth	m	Sample Type	D
Test Method	BS1377:Part 2:1990, clauses 9.2 and 9.5			KeyLAB ID	PBAL2018101511

Sieving		Sedimentation	
Particle Size mm	% Passing	Particle Size mm	% Passing
		0.0630	10
		0.0594	10
		0.0419	9
		0.0296	9
		0.0209	8
		0.0152	8
		0.0107	7
		0.0076	7
		0.0053	7
		0.0038	6
		0.0031	6
		0.0016	6
		0.0016	6
3.35	100		
2	100		
1.18	100		
0.6	100		
0.425	100		
0.3	97		
0.212	88		
0.15	35		
0.063	10		
		Particle density (assumed)	
		2.68	Mg/m <sup>3</sup>

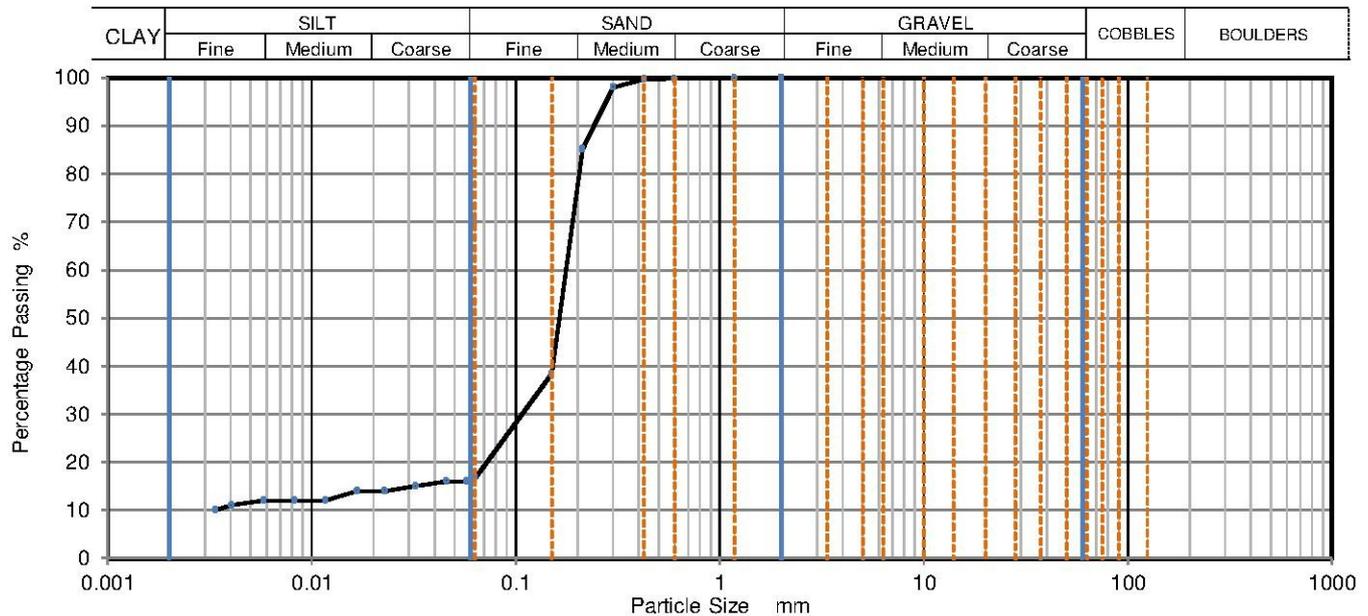
<b>PARTICLE SIZE DISTRIBUTION</b>				Job Ref	<b>1145</b>
				Borehole/Pit No.	WS1
Site Name	Romney Avenue, Folkestone			Sample No.	4
Soil Description	Olive grey brown clayey silty SAND			Depth, m	4.00
Specimen Reference	3	Specimen Depth	m	Sample Type	D
Test Method	BS1377:Part 2:1990, clauses 9.2 and 9.5			KeyLAB ID	PBAL201810033

Sieving		Sedimentation	
Particle Size mm	% Passing	Particle Size mm	% Passing
		0.0630	17
		0.0571	16
		0.0459	16
		0.0323	15
		0.0228	14
		0.0166	14
		0.0117	12
		0.0082	12
		0.0058	12
		0.0040	11
		0.0034	10
		0.0017	10
		0.0017	10
2	100		
1.18	100		
0.6	100		
0.425	100		
0.3	98		
0.212	85		
0.15	38		
0.063	17		
		Particle density (assumed)	
		2.68	Mg/m <sup>3</sup>

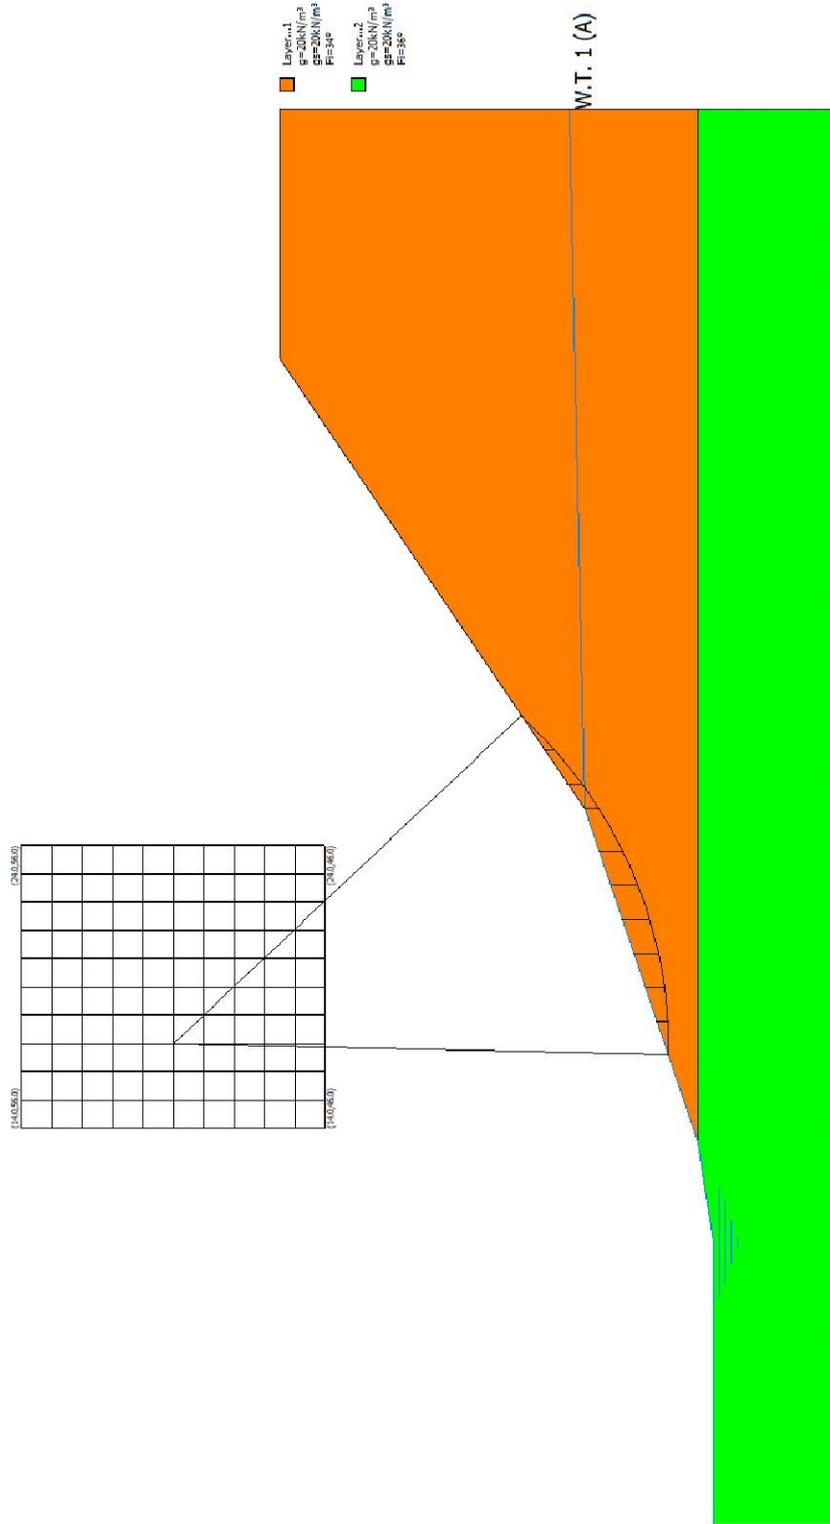
5.3.2 The factor of safety of the previously existing slope Section 1-1 was calculated as 1.03 with a shallow failure on the upper slope. From the Site's history (Section 2.6) the slope is considered to be natural. No indications of slope failure were observed, and published ground movement was low, so it is considered a reasonable assumption that the slope is stable but close to failure, as implied by the calculated safety value of Section 1-1 that is slightly greater than unity.

5.3.1 The factors of safety of each section are summarised on Table 5 along with a description of the failure mode. The graphical output from the final analysis on each section are presented in Appendix D.

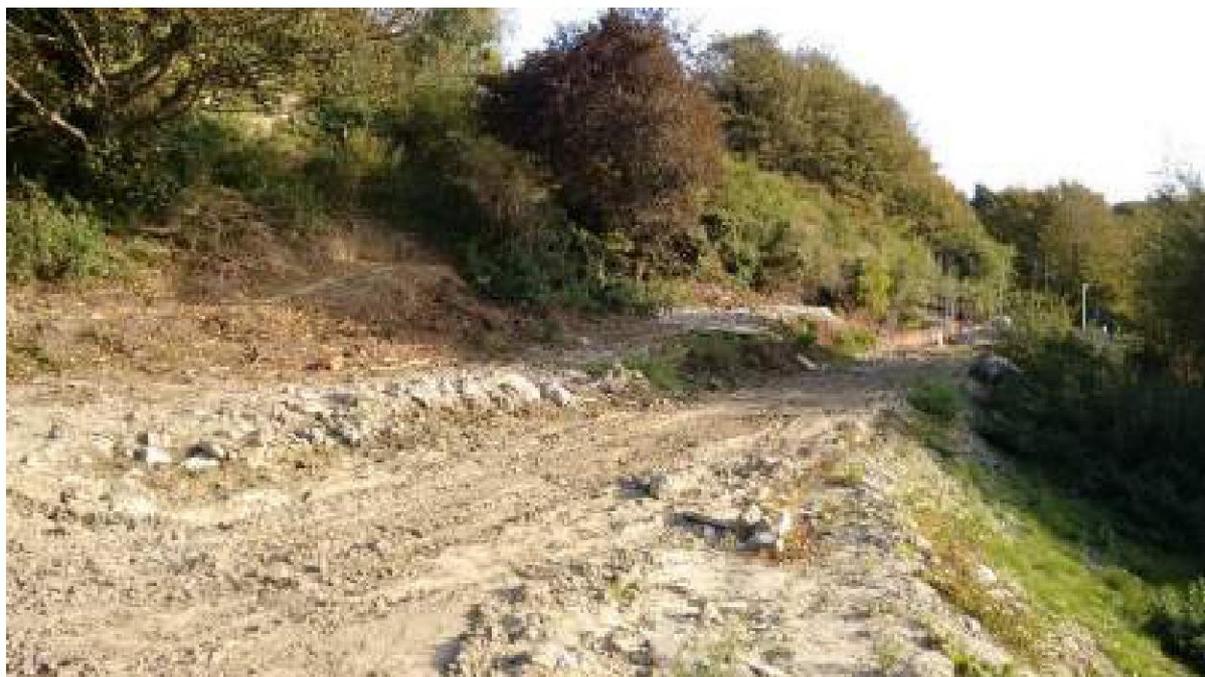
**View to south across Site showing filled area**
