# ARBORICULTURAL IMPACT ASSESSMENT

HUME PLANNING CONSULTANCY  
BARNSTORMERS, STONE STREET  
BARNSTORMERS, STONE STREET, STANFORD

REF. NO. 5935-LLB-RP-AB-0001

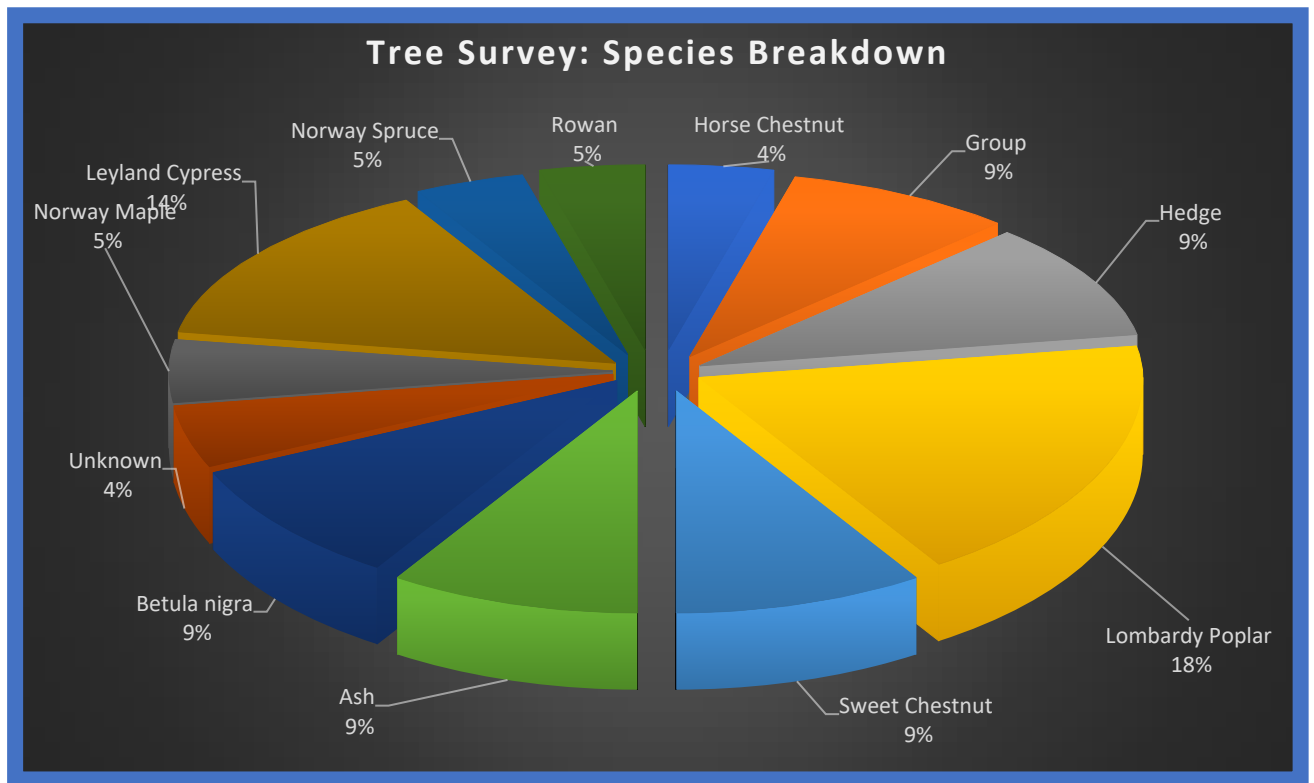
Figure 8 Species Distribution

- 3.7 A total of 18 individual trees, 2 tree groups and 2 hedges are the subject of this report which has been written in accordance with BS 5837

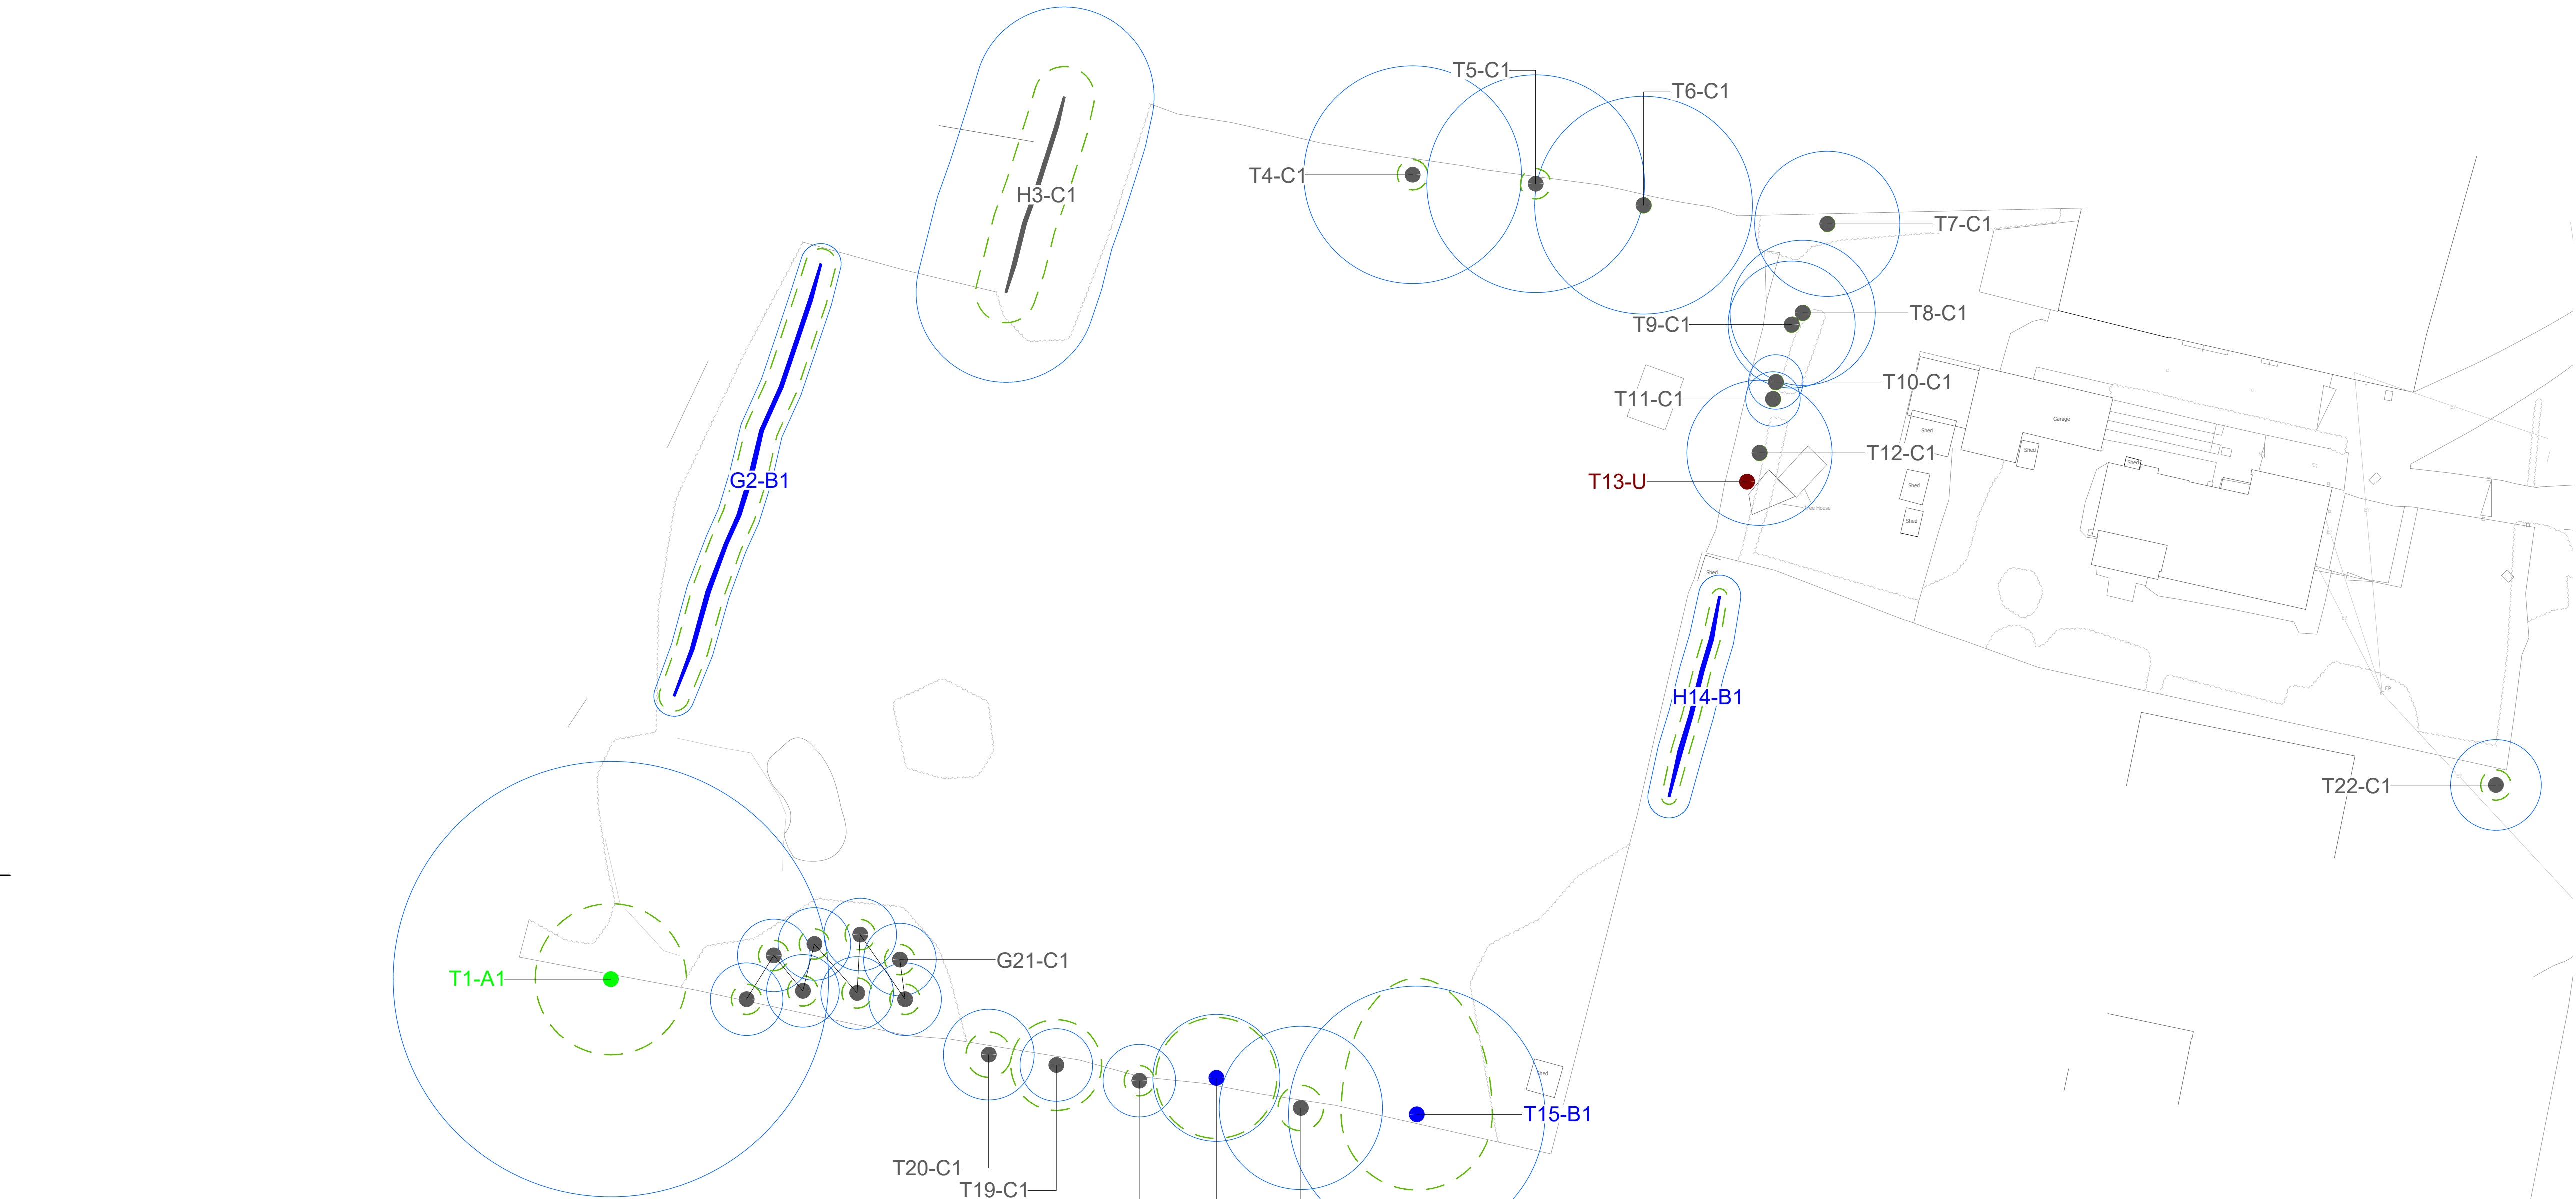
**ROOT PROTECTION AREAS (RPAs):**  
BS 5837: 2012 recommends that an area around each retained tree should be protected from disturbance and damage to tree roots by ensuring the prevention of compaction and contamination of the rooting environment.  
RPAs are calculated for all category A, B and C grade trees in accordance with the recommendation of the Standard, and are shown as dotted coloured lines according to the tree category.  
RPAs are calculated and shown unadjusted as a concentric circle centred on the trunk of each tree, but if there appear to be significant obstructions to root growth both natural and manmade they can be adjusted and where applicable reshaped to illustrate more accurately the likely distribution of roots.  
The RPAs are shown unadjusted on this plan.
